PHMSA Internal Quarterly Report

Project Title: *Dual Purpose PIG for Cleaning and Internal Integrity Assessment for Hazardous Liquid Pipelines*

Prepared by: *North Dakota State University and Stevens Institute of Technology*

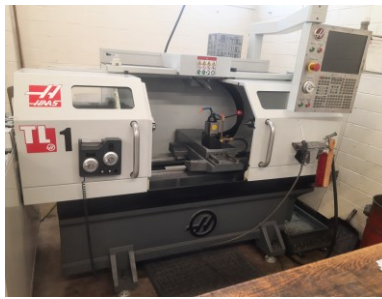
1. **CNC Lathe machine:** this is a high-powered machine that surpasses the manual machine in terms of capability and productivity, enabling more precise fabrication. It is a computerized machine with a visual programming system capable of converting various part geometries into a code interface. The CNC lathe machine was utilized to precisely cut the aluminum block into the prescribed dimensions and thread the dome cover, housing, and base holder.

Figure 1. Picture of (a) HAAS CNC Lathe machine TL-1.

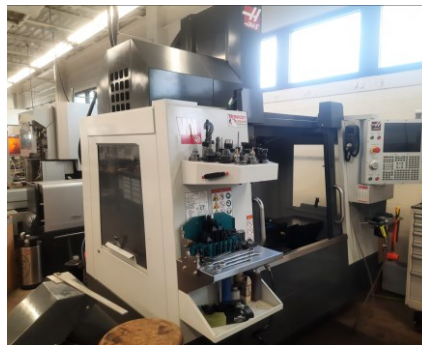
2. **CNC Mill machine:** this machine is equipped with advanced milling software that optimizes speed and performance, ensuring the necessary precision, rigidity, and stability for manufacturing. As with the lathe, jaws were specifically engineered and precisely shaped from the aluminum block to secure the components in place during the manufacturing process.

Figure 2. Picture of (a) HAAS CNC Mill machine VM 2.

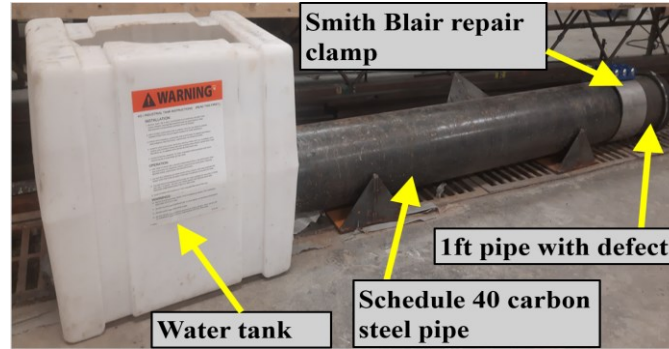
Pipelines usually suffer from various defects during their operation; some were already highlighted in Q3; they include corrosion, blockage, dents, cracks, leakage, and metal loss. These defects are a great challenge in the industry as they impede the operation of oil and gas networks. Images for some defects (blockage and corrosion) in various light conditions were obtained and presented in report #3. Further images were obtained for blockage, crack, and dent under static water conditions, as shown in Fig. 3, in which the setup in Q3 was modified. An 8-inch diameter pipe with a length of 1 ft was added to the end of the original piece, and each was severed with dent and crack. Meanwhile, the assembly of components for the pressured water test is now in progress.

Figure 3. Lab test set-up with 8-in-diameter schedule 40 pipe with various defects.
