UNDERSTANDING MAGNETIC FLUX LEAKAGE (MFL) SIGNALS FROM MECHANICAL DAMAGE IN PIPELINES – PHASE II

Final Report June 2008

Contract DTPH56-05-T-0001

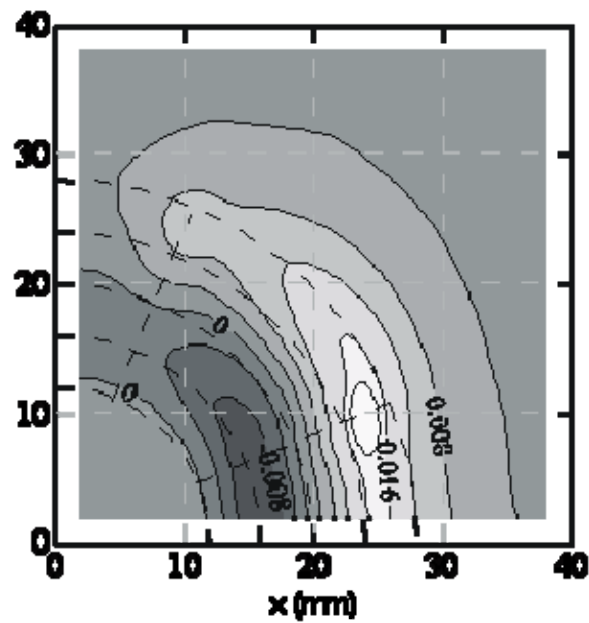
The overall FEA-modeled MFL_{radial} signal (radial component), incorporating both geometry and stress contributions, is shown in Figure 2 (note that this is a quarter-model representing the upper right quadrant). Figure 3 shows the experimental MFL_{radial} signal obtained from laboratory measurements on a 40-mm diameter circular dent of 7mm depth. The experimental (Figure 3) and modeling (Figure 2) results match very closely. Furthermore, since stress effects could readily be turned ‘on’ or ‘off’ in the magnetic FEA model, it was possible to identify the individual effects of stress and dent geometry. These modeling results enabled determination of the origin of each specific feature in the experimental result of Figure 3, specifically:

Figure 2: Quarter-model magnetic FEA result for the MFL signal (radial component) shown as a contour plot. This corresponds to the upper right-hand quadrant of the experimental signal shown in Figure 3. Both stress and geometry contributions to the MFL signal are included.

the same. The dent perimeter and weld line is indicated by the dotted line in the middle plot. In general the model results are similar to those found before for smaller circular dents (for example Figures 2 and 3 – without the stress effects included).

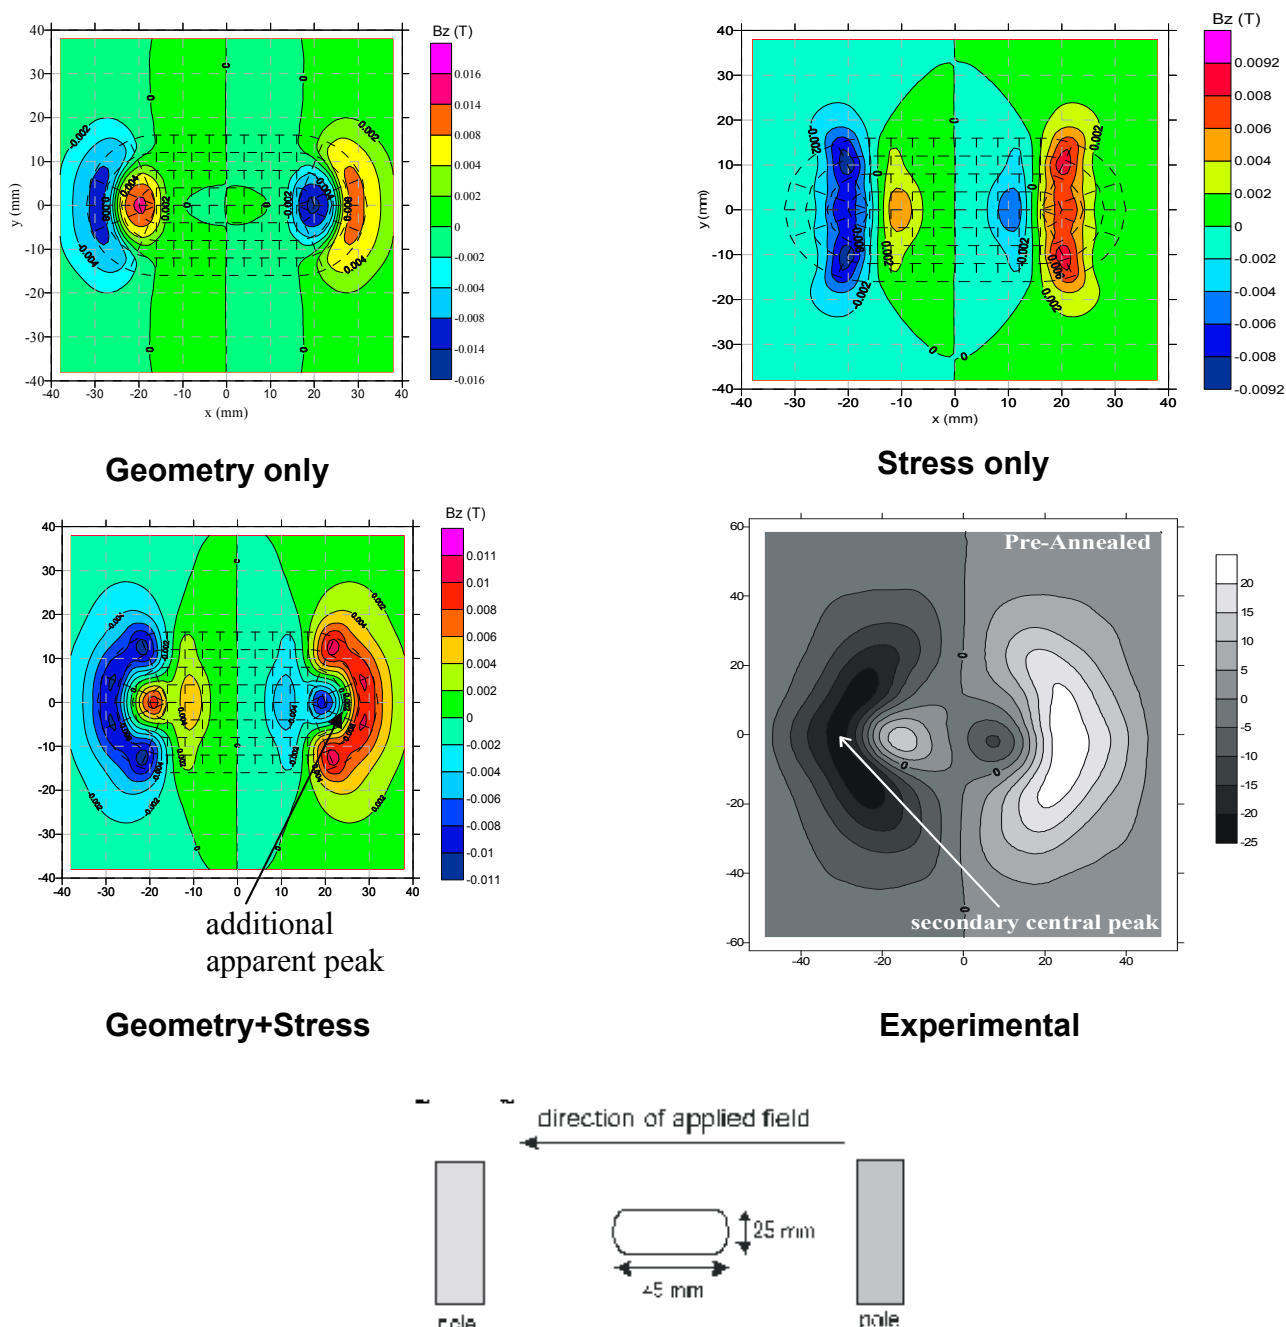
Figure 4 shows a typical MFL_{radial} result for an axial 2:1 dent, in this case depth of 6mm. The three color photos show the modeled result – the two at the top are the separate MFL signal contributions of geometry and stress, respectively, and the bottom left plot is the combined stress + geometry modeled result. The experimental result is shown on the bottom right, with good agreement shown.

Figure 4: MFL_{radial} result for an axially elongated 2:1 dent, 6mm deep. The relative dent and applied field orientation are shown in the schematic at the bottom. The three color photos show the modeled result – the two at the top are the separate contributions of geometry and stress, respectively, and the bottom color plot is the combined modeled result. The experimental result is shown on the bottom right, with good agreement apparent.

As seen in Figure 4, both geometry and stress have considerable and interesting effects on the axially elongated dent signals:

- The combined effect of geometry+stress on MFL_{radial} signals is very interesting in this case, since the dent sidewall stress contribution lies over the inner dent geometry peak but is of opposite polarity. This has two effects –

1. to diminish the size of the inner geometry peak; and
 2. to ‘create’ an apparent additional peak in the centre dent sidewall rim region. This peak is actually a composite of geometry+stress effects. While this additional peak appears fairly slight in the 2:1 aspect ratio dent, studies on the 4:1 aspect ratio dent indicated that this produces a very evident ‘additional peak’ close to the center of the dent.

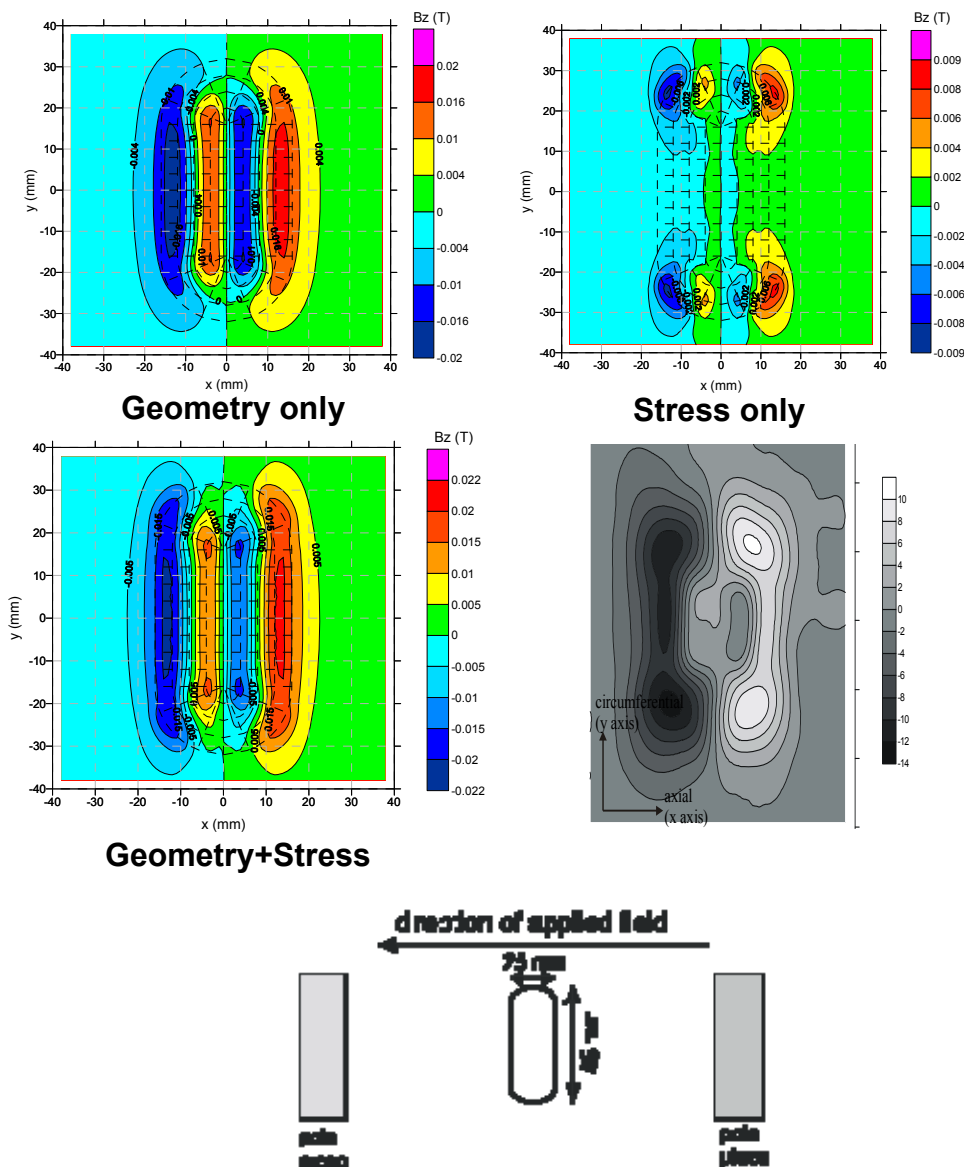
Figure 5 shows a typical MFL_{radial} result for a circumferential 2:1 dent, in this case of depth 6mm. The three color photos show the modeled result – the two at the top are the separate contributions of geometry and stress, and the one at the bottom is the combined modeled result. The experimental result is shown on the bottom right, with good agreement shown.

Figure 5: MFL_{radial} result for a circumferentially elongated 2:1 dent, 6mm deep. The relative dent and applied field orientation are shown in the schematic at the bottom. The three color photos show the modeled result – the two at the top are the separate contributions of geometry and stress, respectively, and the bottom color plot is the combined modeled result. The experimental result is shown on the bottom right, with good agreement apparent.

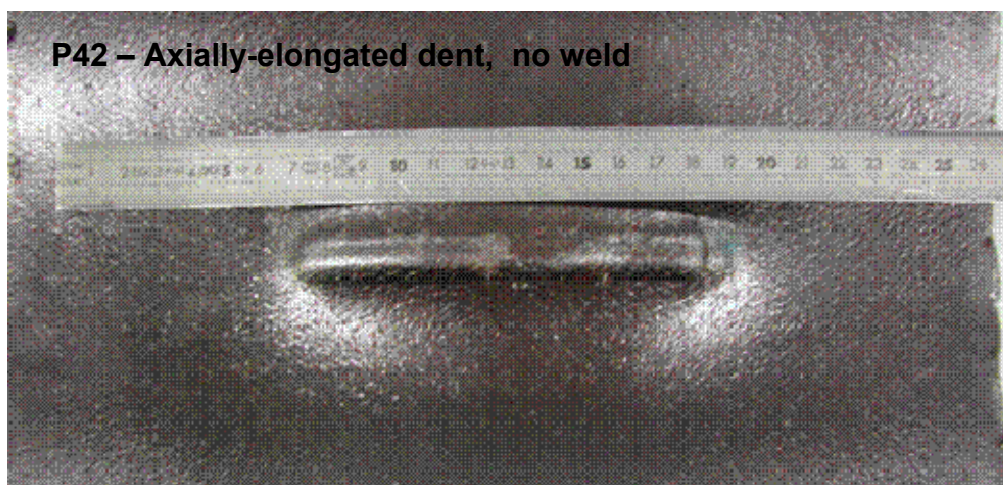
MFL measurements were made on the inside surface of all three axially-elongated dent samples. Figure 39 shows the inside surface photos of all three circular dents, Figure 40 shows the MFL_{axial} component plots, and Figure 41 the MFL_{radial} component plots. For comparison, Figure 34 shows the MFL_{axial} modeling result, and Figure 35 the MFL_{radial} modeling result. On Figures 40 and 41 the approximate dent perimeter location is indicated with a red dashed line, and the MFL peaks that arise from the geometry of the dent rim (as deduced from the MFL models results of Fig 34 and 35) are indicated with a DR annotation.

Figure 39: Inside surface photos of all three coupons containing axially-elongated dents. Samples are labeled accordingly.

P56: Axially elongated dent with partial re-rounding: This dent has much more significant re-rounding than the other two axially elongated dents – in fact it has the appearance of two adjacent circular dents as seen in Figure 39. The MFL_{axial} (Figure 40) plot appears as one would expect for two adjacent axial dents – with two sets of similar polarity peaks side by side. It should be noted that due to the large size of the dent the step size of the scanning probe was necessarily large, thus the closely adjacent peaks are not clearly resolvable. The MFL_{radial} (Figure 41) plots also indicate peaks associated with adjacent circular dents. There may also be some stress indications present in this result, although it is difficult to determine because of problems with the scan – the geometry changes were so significant in this case that the probe would occasionally become temporarily halted during the scanning process.

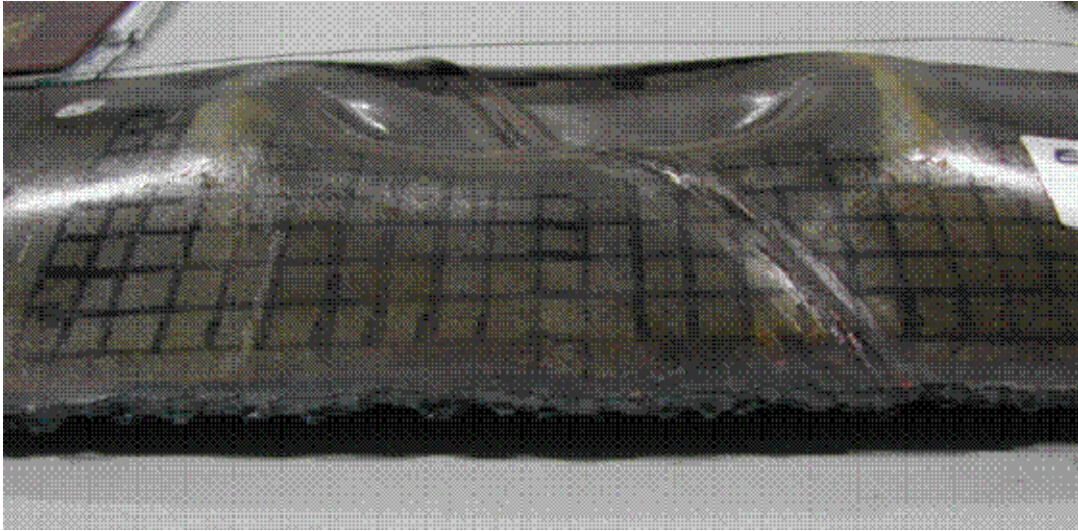
Figure 42: Side view of sample P43 – showing the interesting geometry that leads to the MFL signals in Figures 40 and 41.

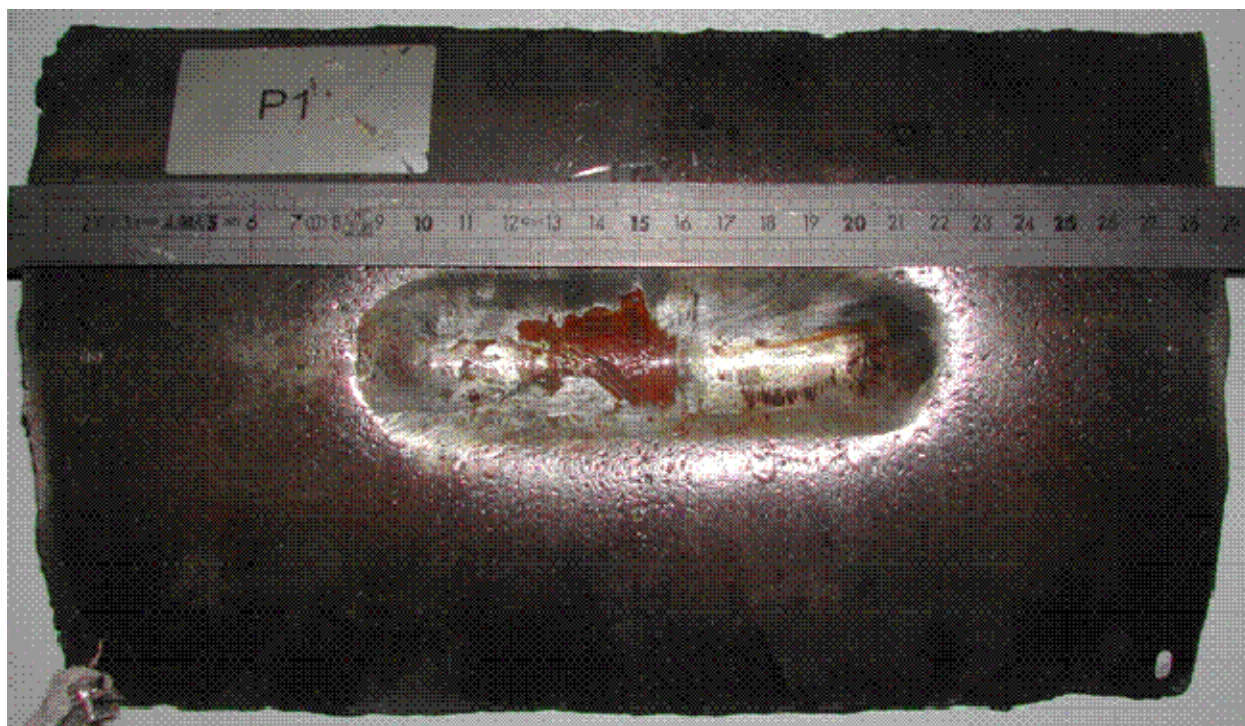
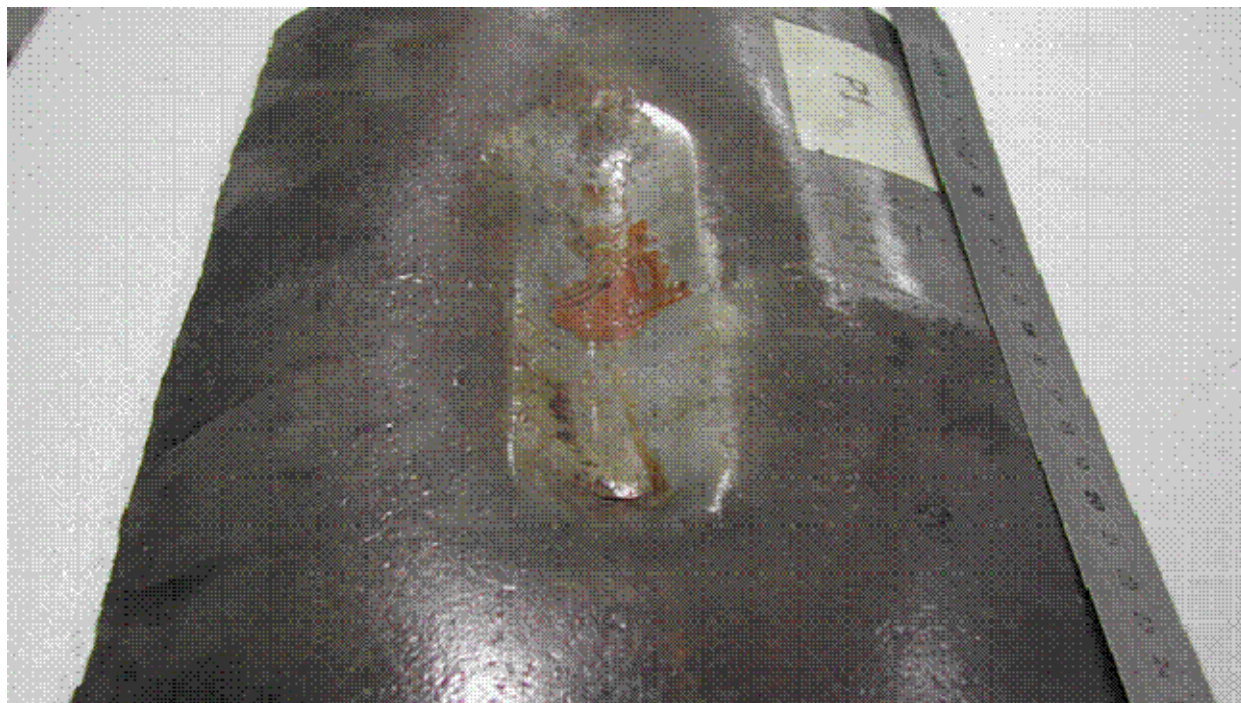
Plain axial dent of size ~14 cm long and 5cm wide. Strain gauges seen mounted at outside wall in centre of dent. A circumferential crack is located at one end of dent – this extends through to the other side.

This was a test sample that a plain dent was made in – no gouge. It was then ground on nearly all the dent surface (outside). After that it was wound with a clockspring, and then pressure tested. It failed via the circumferential crack seen at the end of the dent.

Figure P1:1: Outer pipe wall – a) top view and b) end-on view of P1 elongated dent.

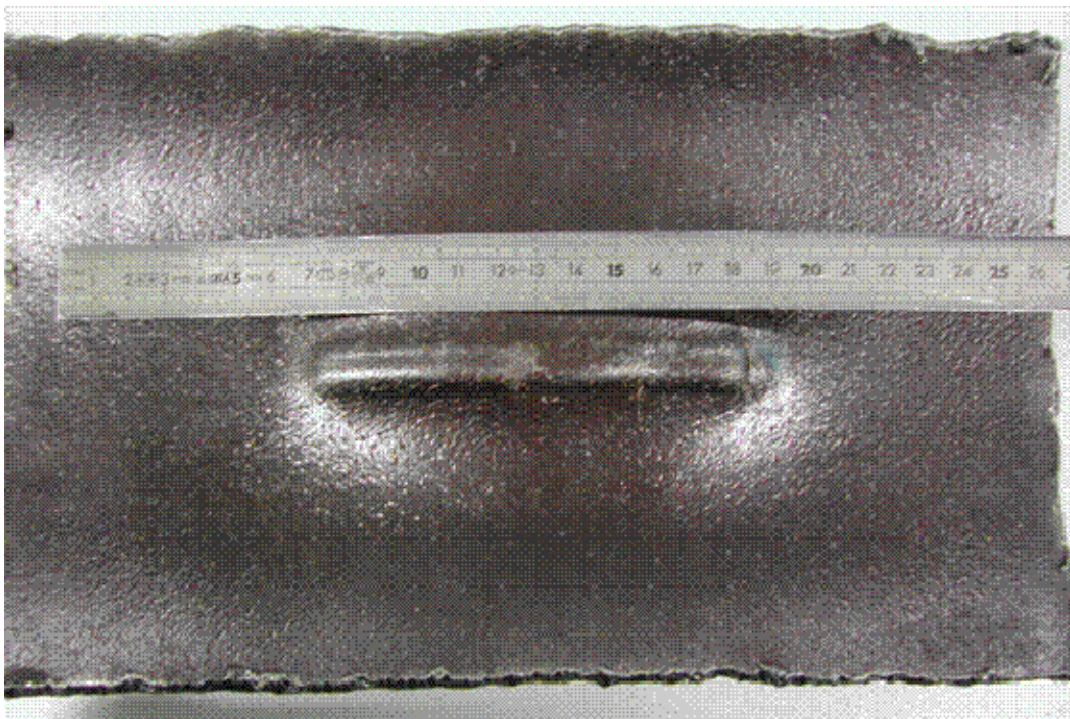
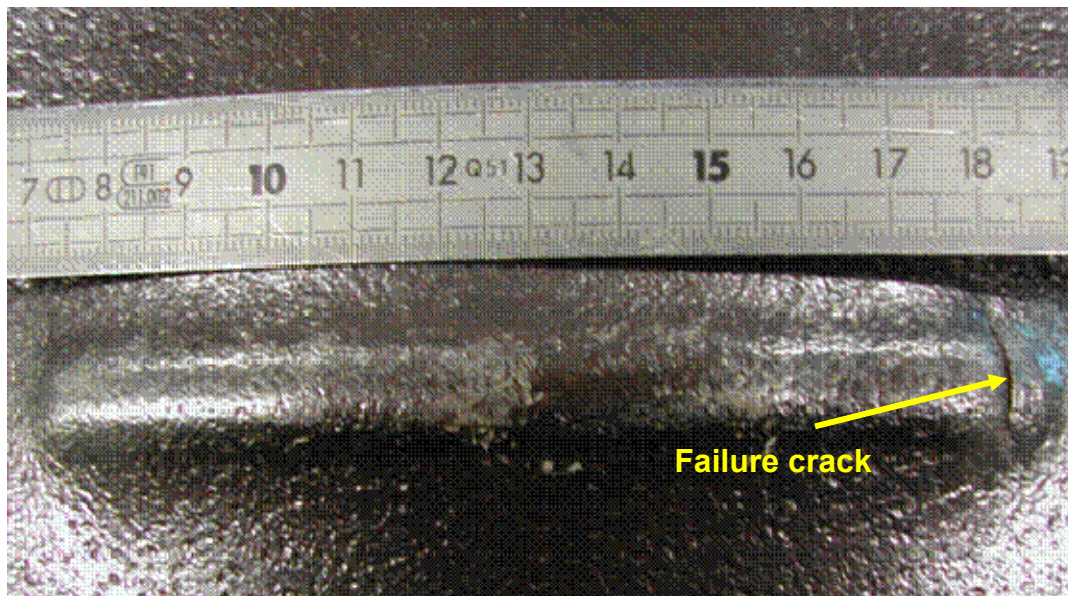
Figure P1:2: Inner pipe wall – a) overall plan view and b) close-up view of dent.

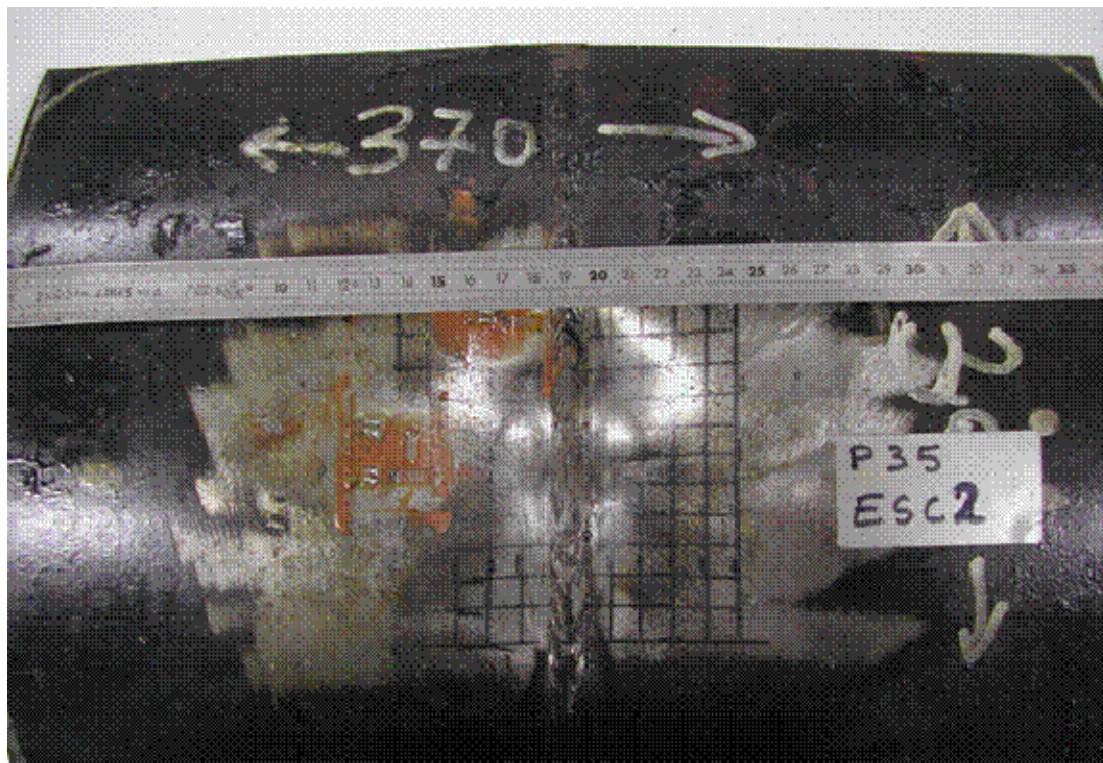
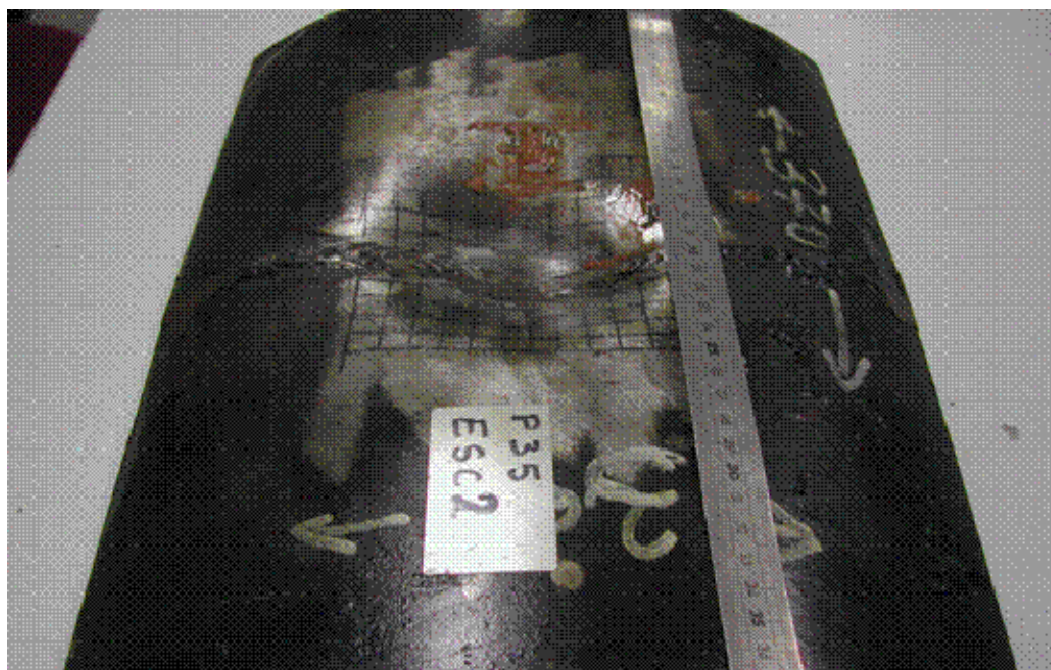
Plain circular dent of size ~13 cm diameter - located on the top of a girth weld. It has been ground also – particularly at the top of the girth weld itself.

This was a test sample – plain dented and then ground across the dent outside. The weld is quite rough and at the inside surface the weld has cracked where it was likely pressure tested.

Figure P35:1: Outer pipe wall – a) top view and b) end-on view of P35 circular dent with girth weld.

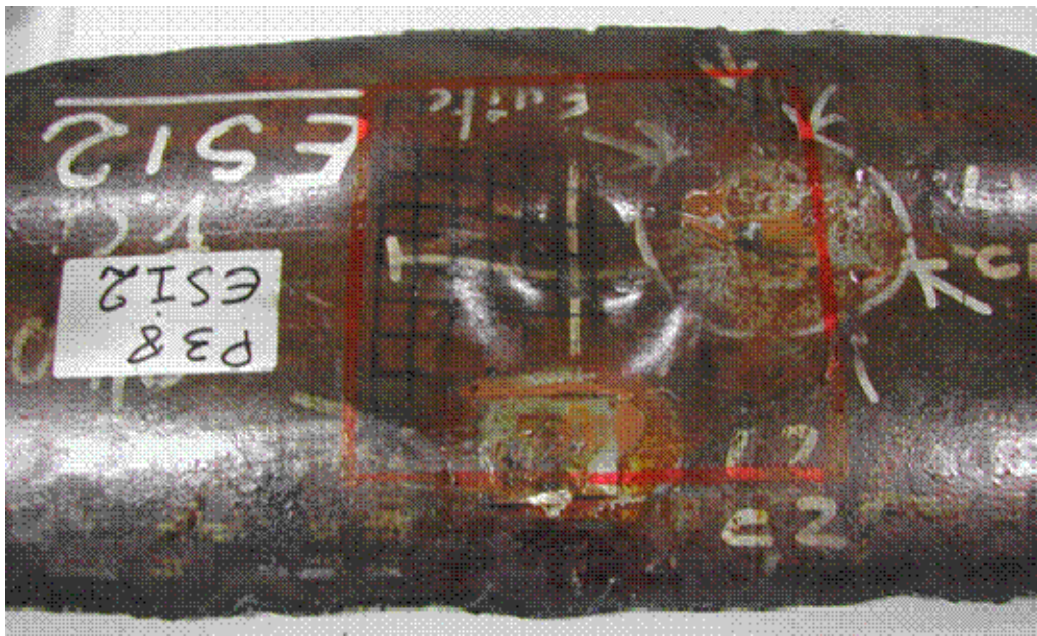
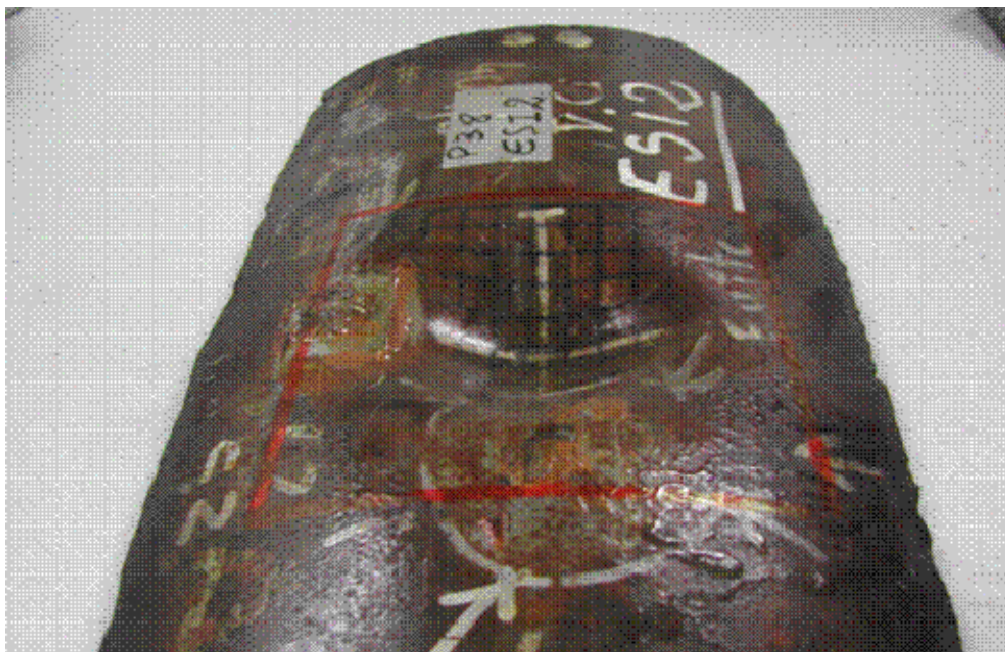
Plain circular dent of size ~8 cm diameter – it has a very clean axial weld running through the middle of it – the weld is almost not noticeable from the outside (no scarf at all). This has been ground also and then looks like it failed during a pressure testing procedure.

There are strain gauges located in the dent rim region in two locations. The red region indicates the approximate scan region.

Figure P38:1: Outer pipe wall – a) top view and b) end-on view of P38 circular dent. This coupon has an axial weld running through the centre of the defect, although it is difficult to see from the outside surface.

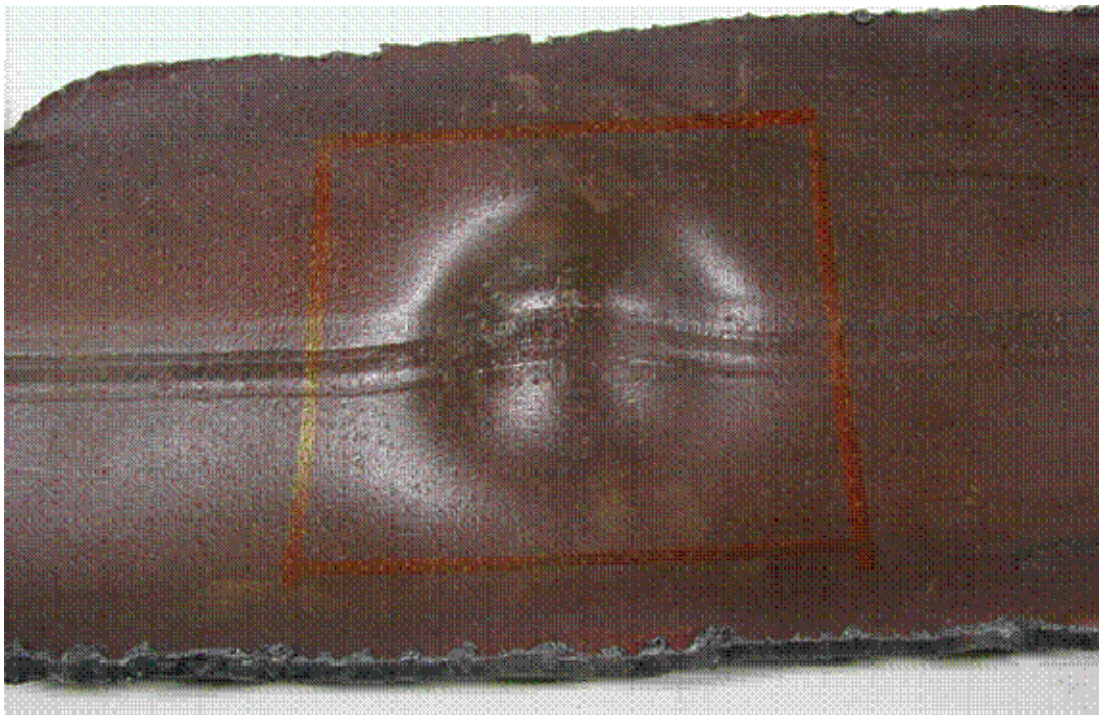
Figure P38:2: Inner pipe wall – a) plan view and b) side-on view of P38 circular dent. Although the axial weld was difficult to see on the outer surface (Figure P38:1) it is clearly visible in these two photos.

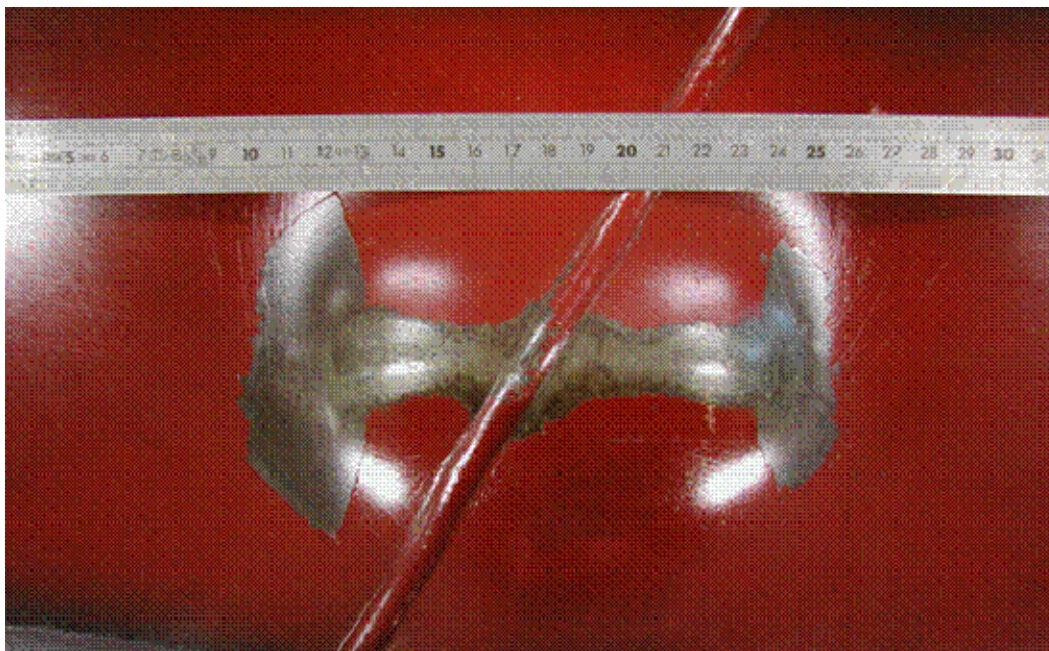
Figure P43:2: Inner pipe wall – a) top view and b) end-on view of P43 elongated dent over the top of a spiral weld. No grinding marks are evident on this surface.

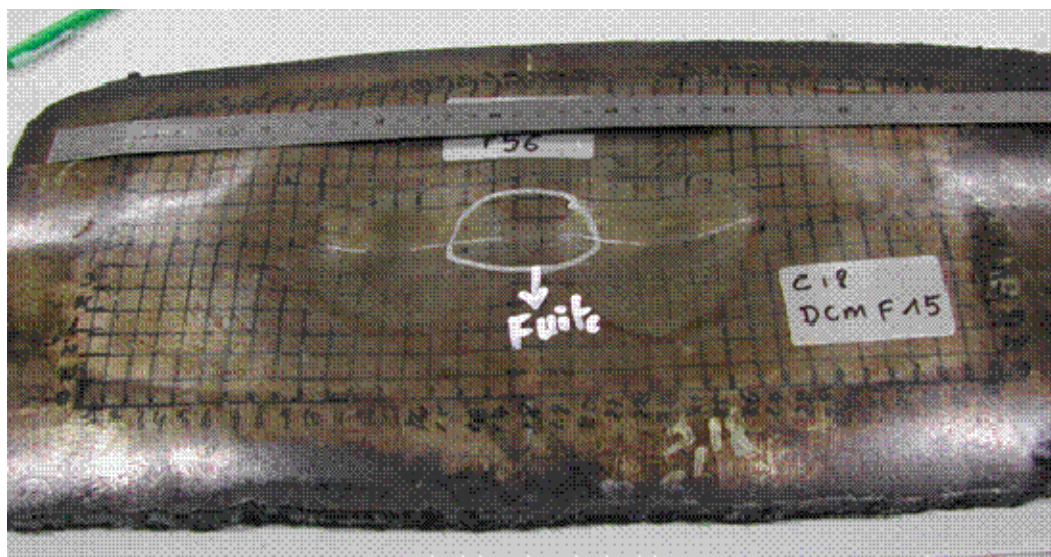
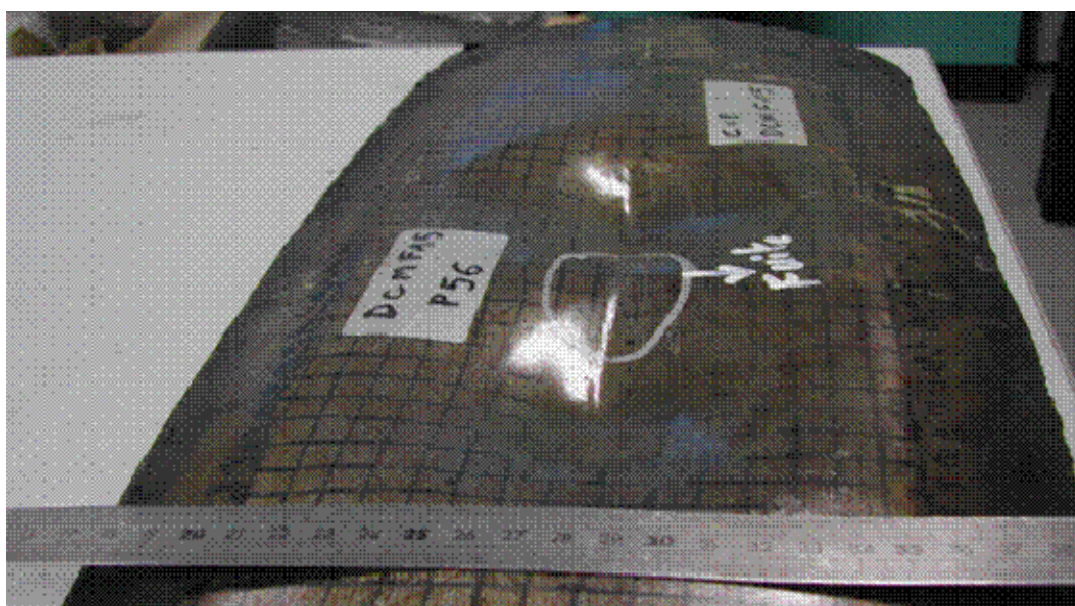
This is an elongated dent of total size ~19 cm long and 8cm wide. Upon pressure testing the centre region re-rounded but the ends of the dent (corresponding to the indenter corners) did not reround as much as the middle. This created a feature which looks like 2 axially adjacent plain axial dents. No other features except some ‘humps’ at the ends and a bit of a gouge at the centre. No cracking apparent.

Figure P56:1: Outer pipe wall – a) top view and b) end on view of P56 elongated dent which has partially re-rounded.

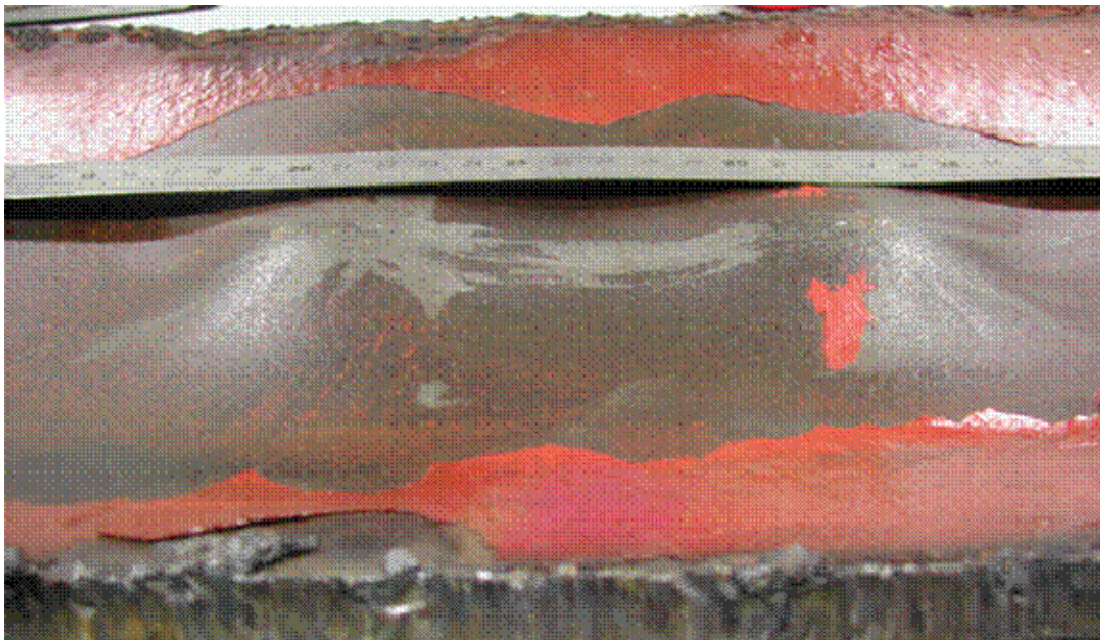
Figure P56:2: Inner pipe wall – a) side view and b) end on view of P56 elongated dent which has partially re-rounded.

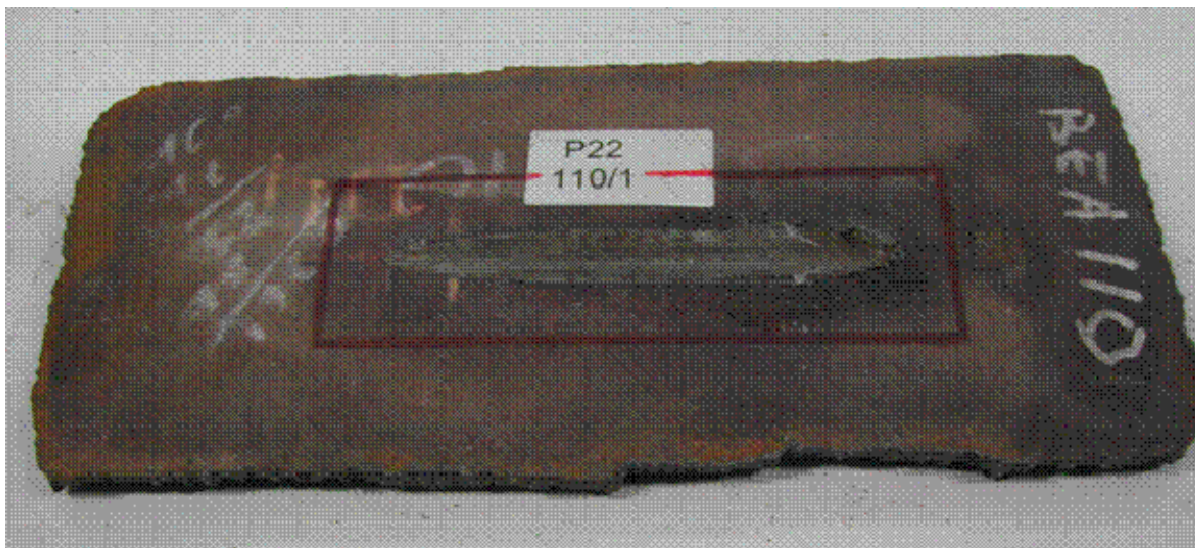
Figure P22:1: Outer pipe wall – a) top view and b) end-on view of P22 gouge.

There is a long significant gouge of 17 cm length – but with almost no indication on the inner surface of the pipe. So this is an excellent example of a ‘gouge without a dent’. At one end of the gouge there is material exfoliated but still clinging to the surface. On the inside surface there is no apparent geometrical perturbation, except a very slight ‘bump’ near the end of the gouge that has the exfoliated metal.
