Final Report

Department of Transportation Phase I SBIR Contract Number: DTRT57-09-C-10046

Digital Imaging of Pipeline Mechanical Damage and Residual Stress

David Jablonski, Ph.D., Principal Investigator
JENTEK Sensors, Inc.
110-1 Clematis Avenue
Waltham, MA 02453-7013
Tel: 781-642-9666
jentek@shore.net

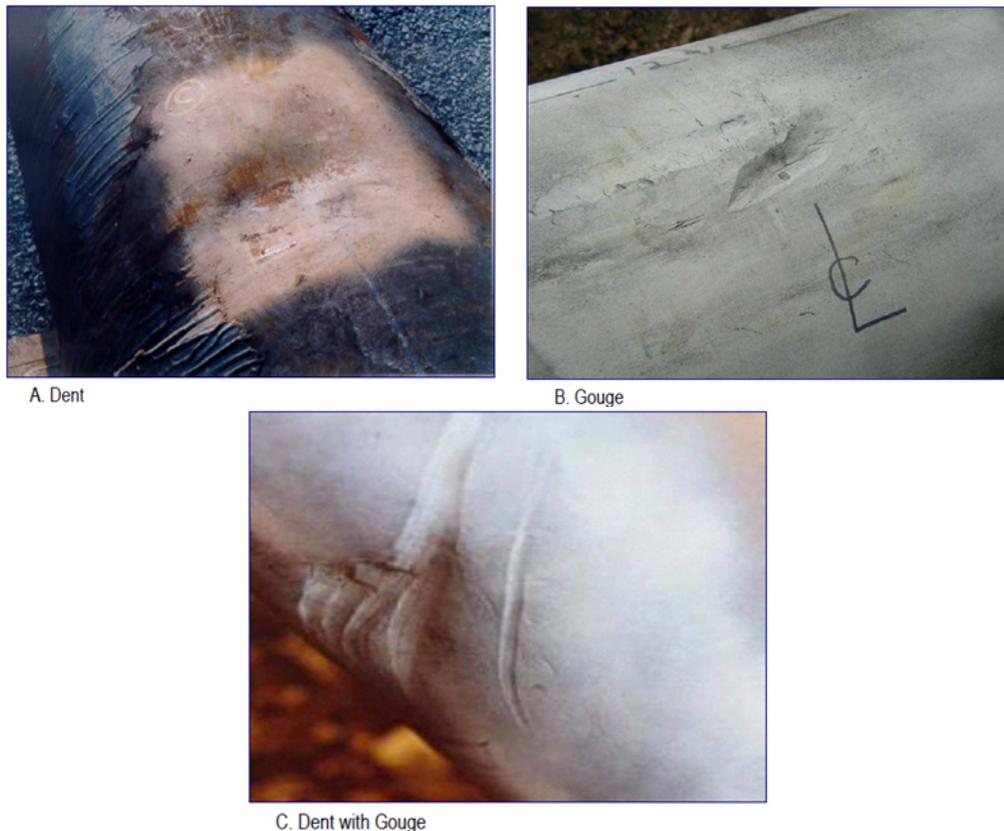
Figure 1. Examples of mechanical damage in pipelines [Baker, 2009]

The basic types of mechanical damage in pipelines include dents and gouges, or a combination of both as shown in Figure 1. In addition to these basic types of mechanical damage, cracks may be present in the dents or gouges. In some cases the dent may not be very visible because it has been re-rounded by the internal pressure in the pipe, thus making these types of mechanical damage very difficult to detect. This type of damage should show up as an area of high residual stress due to the deformation done in the mechanical damage event and the re-rounding with internal pressure. We did locate a number of pipeline samples with mechanical damage for this program; however we did not have any samples that had re-rounding of the dents. One goal would be to estimate the size of the mechanical damage prior to re-rounding to support risk assessment efforts.

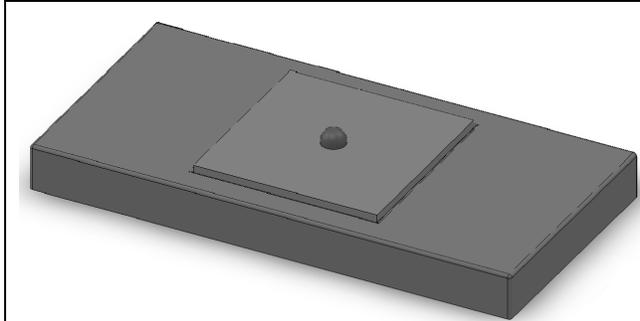
Figure 2. CAD rendering of fixture used to dent plates for mechanical damage simulation

JENTEK has simulated mechanical damage due to dents in flat plates of 4130 steel using a procedure similar to that used by Clapham². We chose to simulate dents in the range that would require either a repair or replacement action for 6-inch, schedule 40, 10 or 5 pipes. We obtained flat plates of 4130 steel in the annealed condition with thicknesses that are approximately equal to wall thicknesses of schedule 40, 10 and 5 pipes. These plates which were 0.25, 0.125 and 0.080 inches in thickness were cut to a 6-inch by 6-inch size and indented with a hardened steel ball with either 25/32 inch (~20 mm) diameter or 1.575 inch (~40mm) diameter steel ball. The setup for making this dent is shown in Figures 2 to 4. The base that the steel plates rested on had a 3-inch diameter hole (see Figure 3). The amount of indentation was controlled by measuring the displacement of the hydraulic ram with a dial indicator, as shown in Figure 4. The final dent size obtained by this method is less than the value indicated on the dial indicator, since this deflection is also affected by the elastic deflections of both the plate and press structure. After some initial experiments, with an existing fixture provided with the press, produced unsymmetrical deformation, we developed a special fixture that allowed us to produce symmetric deformation.

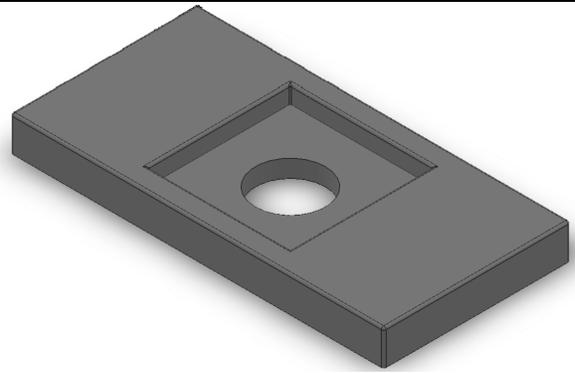
Figure 3. CAD rendering of lower plate showing 3 inch diameter hole that supports the plate to be dented for mechanical damage simulation

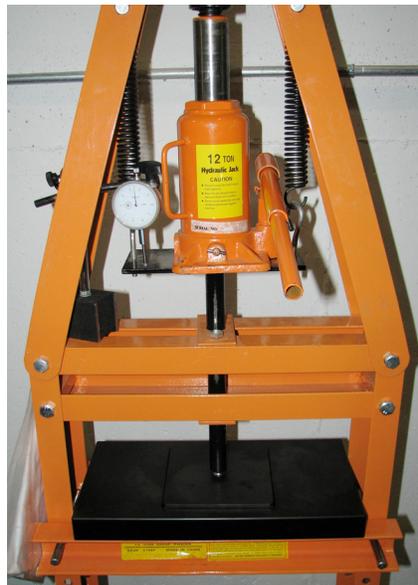
Figure 4. Hydraulic press with fixtures used to dent plates to simulate pipeline mechanical damage.

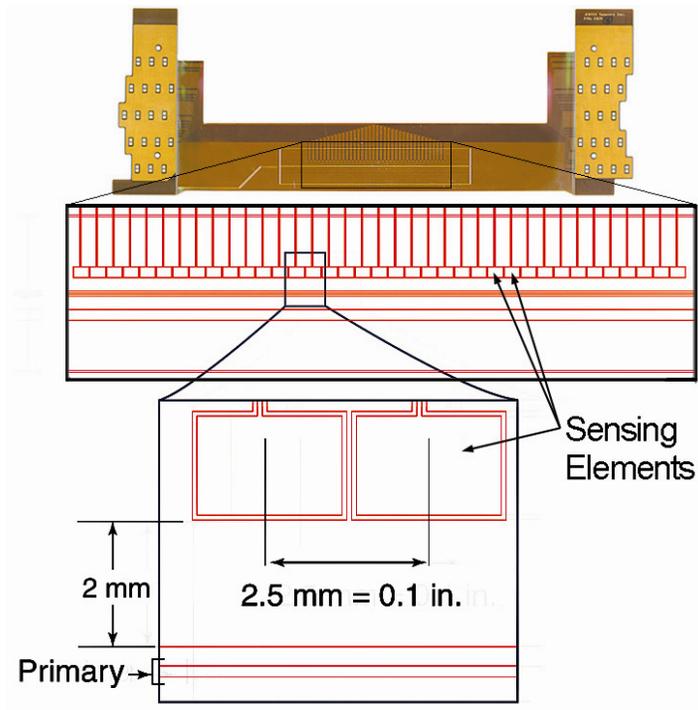
Figure 5. FA24 MWM-Array sensor.

We selected 3 different standard sensor designs. All 3 sensors can be used for scanning to obtain lift-off and permeability maps for these steel plates. The sensors we used were the FA24, FA26 and FA28, which are shown in Figures 5 to 7. The FA28 sensor has relatively small dimensions and is useful for very high spatial resolution images of the material condition. In contrast, the FA24 and FA26 sensors have larger dimensions and are better suited for creating high spatial resolution images with moderate stand-off distances or lift-offs.

The FA24 and FA26 sensors have the same drive winding to sense element spacing of 0.0878 inches (2 mm), but the sense element is twice as long for the FA24 (0.1 inches) versus 0.05 inches for the FA26. The FA28 has a smaller sense element to drive winding spacing of 0.01 inches and a smaller sense element length of 0.04 inches. After measuring the size of the mechanical damage, we determined that the FA28 sensor could not accommodate the large amount of lift-off for these specimens, so we concentrated on the FA24 and FA26. The FA26 sensor showed better sensitivity to spatial property variation because the sense elements are smaller.

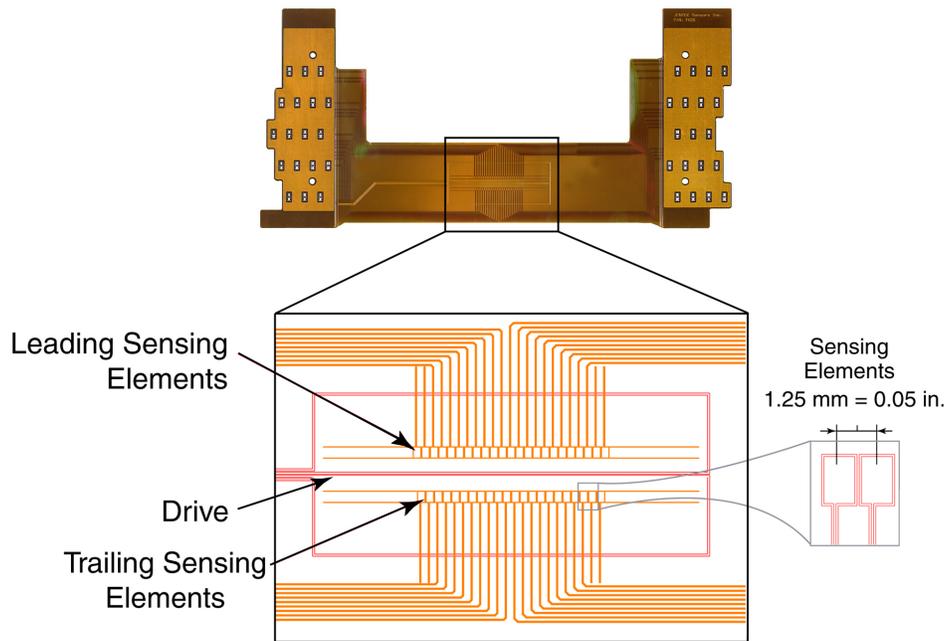
Figure 6. FA26 MWM-Array sensor.

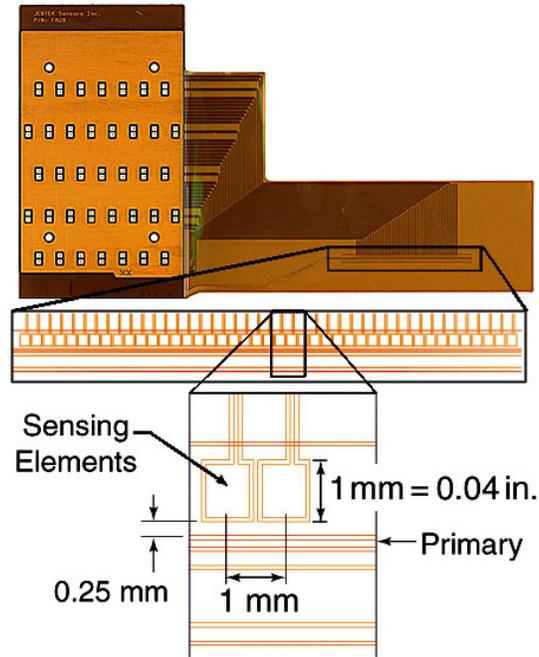
Figure 7. FA28 MWM-Array sensor.

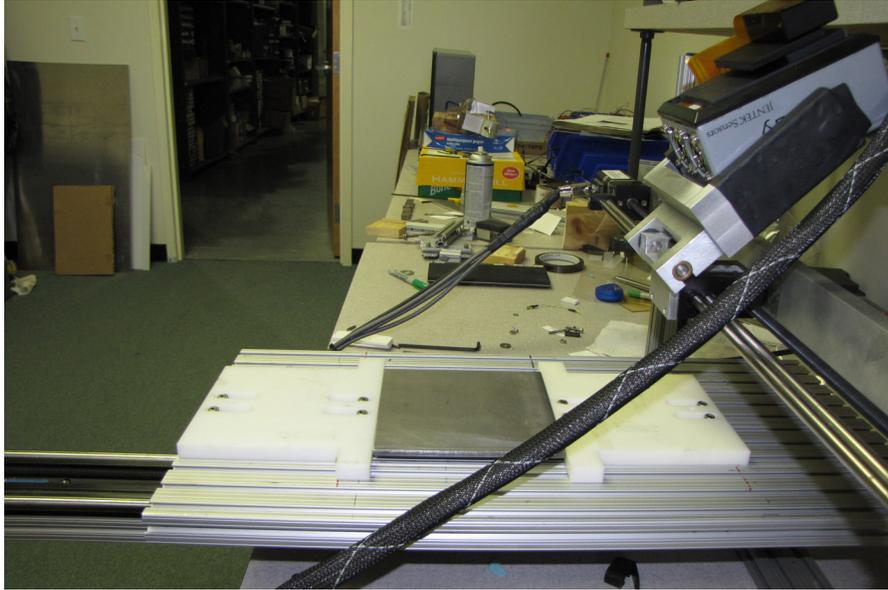
Figure 8. Test setup used to scan dented steel plate showing FA-26 MWM-Array mounted on soft foam.

The test setup for scanning the plates is shown in Figures 8 and 9. The sensors are mounted on a probe unit, and there is either a layer of foam between the sensor and the probe, or a rigid piece of plastic between the probe unit and sensor. The use of soft foam allows the sensor array to better conform to the surface geometry of the dent and permits relative permeability measurements relatively close to the indentation site; the use of a hard backing or a rigid shim is better for providing depth profile estimates across the entire damage area. When the intent of the measurement was to measure the geometry and depth of the mechanical damage site, a hard backed sensor was used. When the intent was to map the residual stress through permeability measurements a soft foam backed sensor was used. The results of these two separate types of measurements are presented separately.

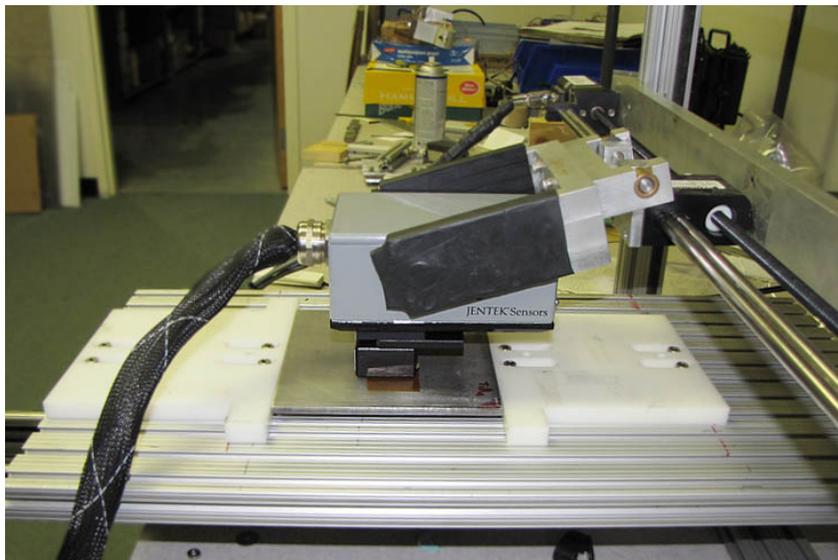
Figure 9. Test setup to scan dented steel plate with MWM-Array.

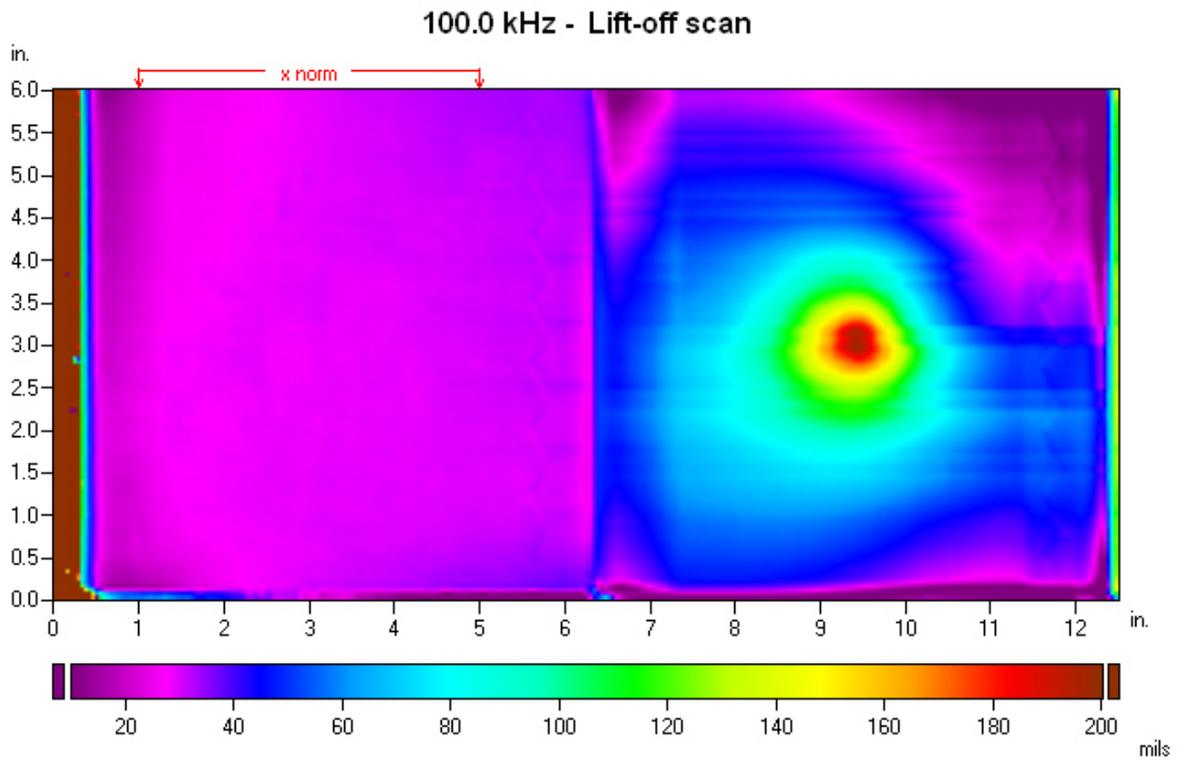
Figure 10. Lift-off C-scan images for the control plate (left) and T4R4 front side (right): condition as dented.

Figures 10 through 21 show the lift-off images from these plates on both the front and back sides. These measurements were made before and after annealing the plates. The annealing process did not change the lift-off images, so we have only shown the lift-off image after annealing for only one plate. The lift-off images after annealing for the other plates are available, but they are not shown in this report since they do not offer any additional value.

As expected, the lift-off images show larger lift-off values as the press indentation is increased. The lift-off images do not change after annealing which indicates the dent geometry did not change and, since the annealing should only affect the permeability values. **The use of measurement grids provides independent estimates of the lift-off and permeability values.** This result was confirmed by comparing the lift-off measurements with the dial indicator before and after the plates were annealed.

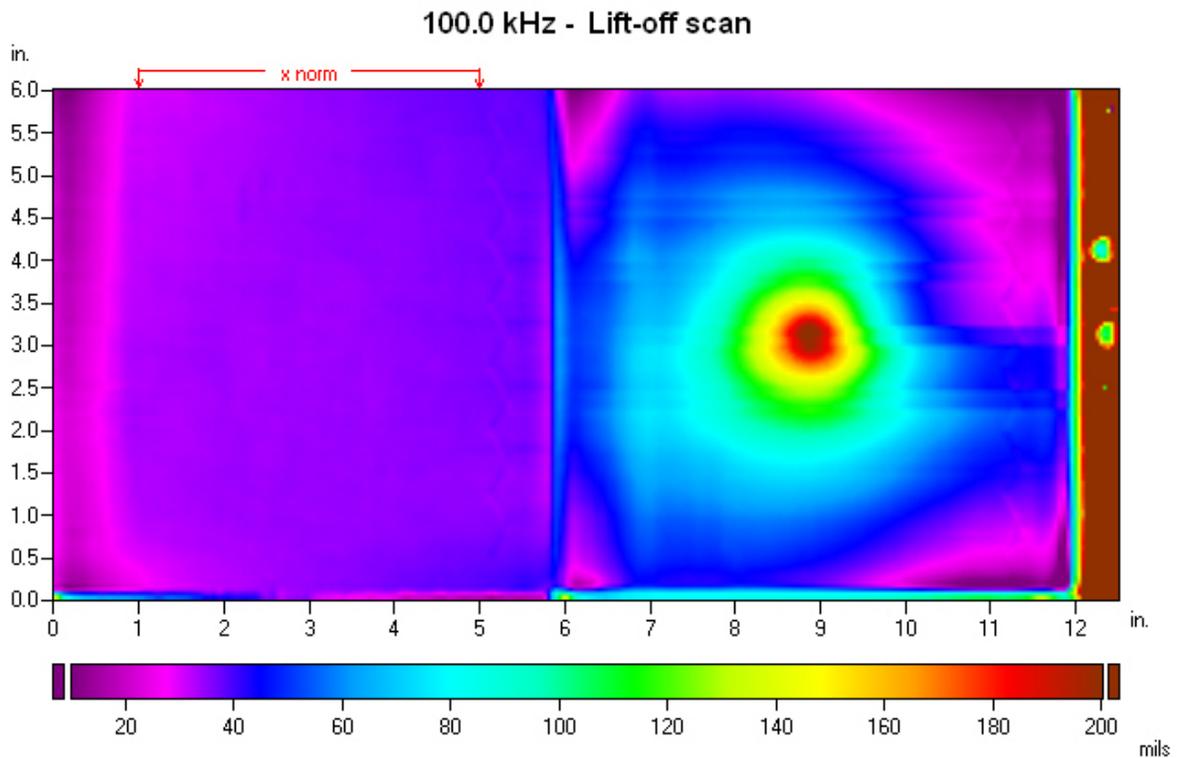
Figure 11. Lift-off C-scan images for the control plate (left) and T4R4 front side (right): condition as annealed.

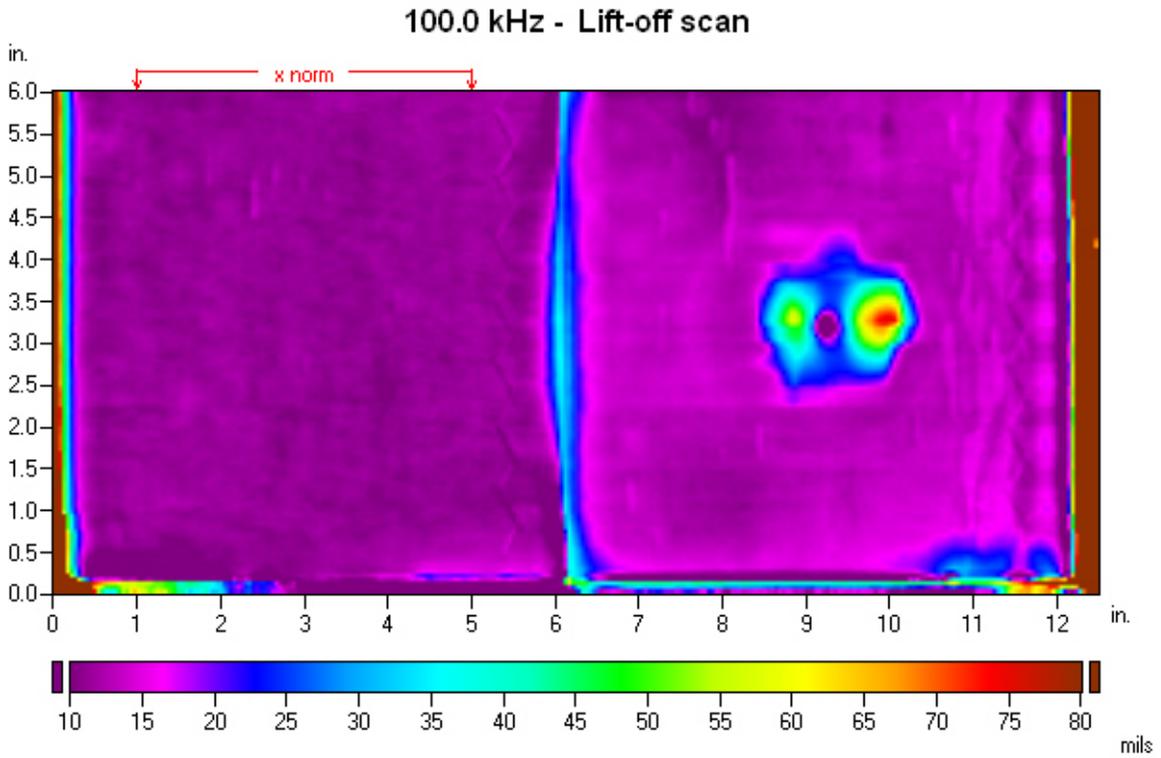
Figure 12. Lift-off C-scan images for the control plate (left) and T4R4 back side (right): condition as dented.

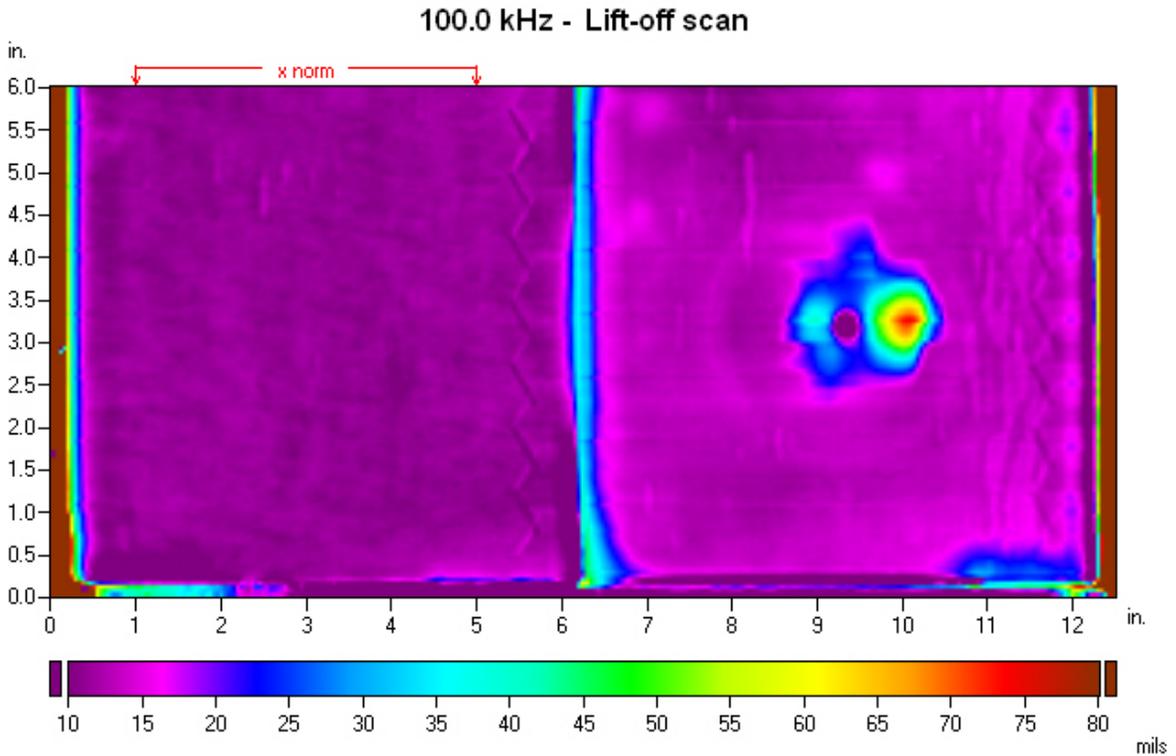
Figure 13. Lift-off C-scan images for the control plate (left) and T4R4 back side (right): condition as annealed.

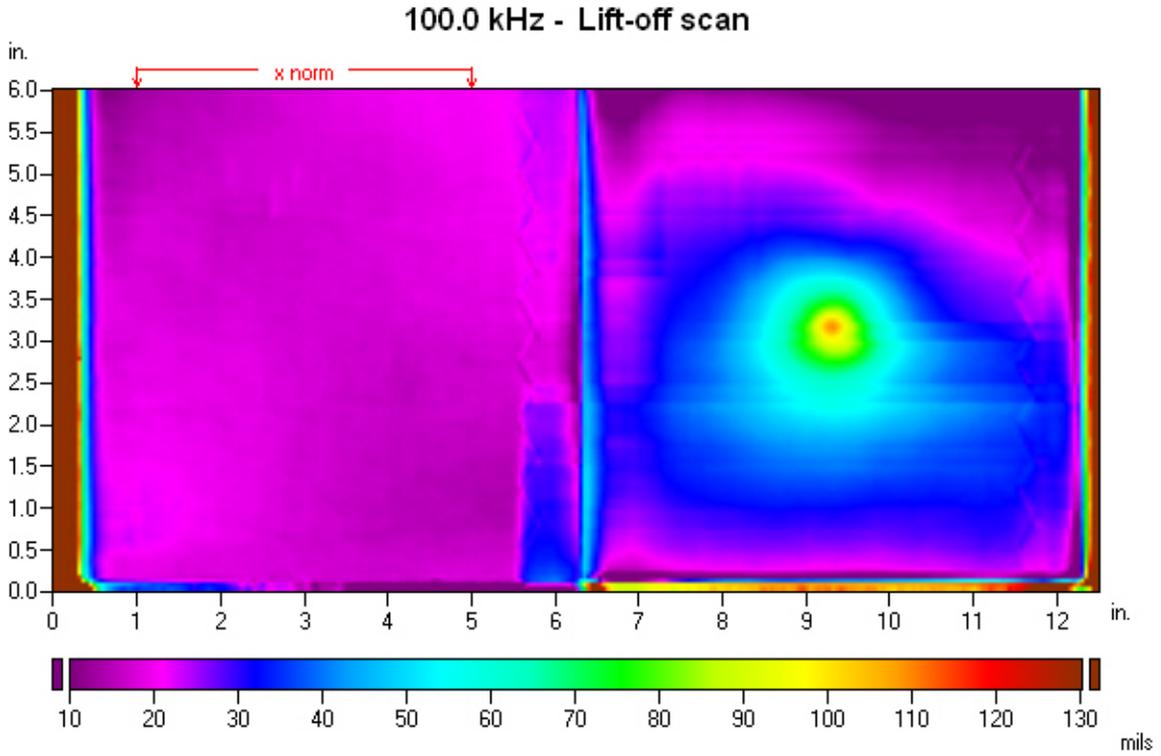
Figure 14. Lift-off C-scan for B4R4 front side: condition as dented.

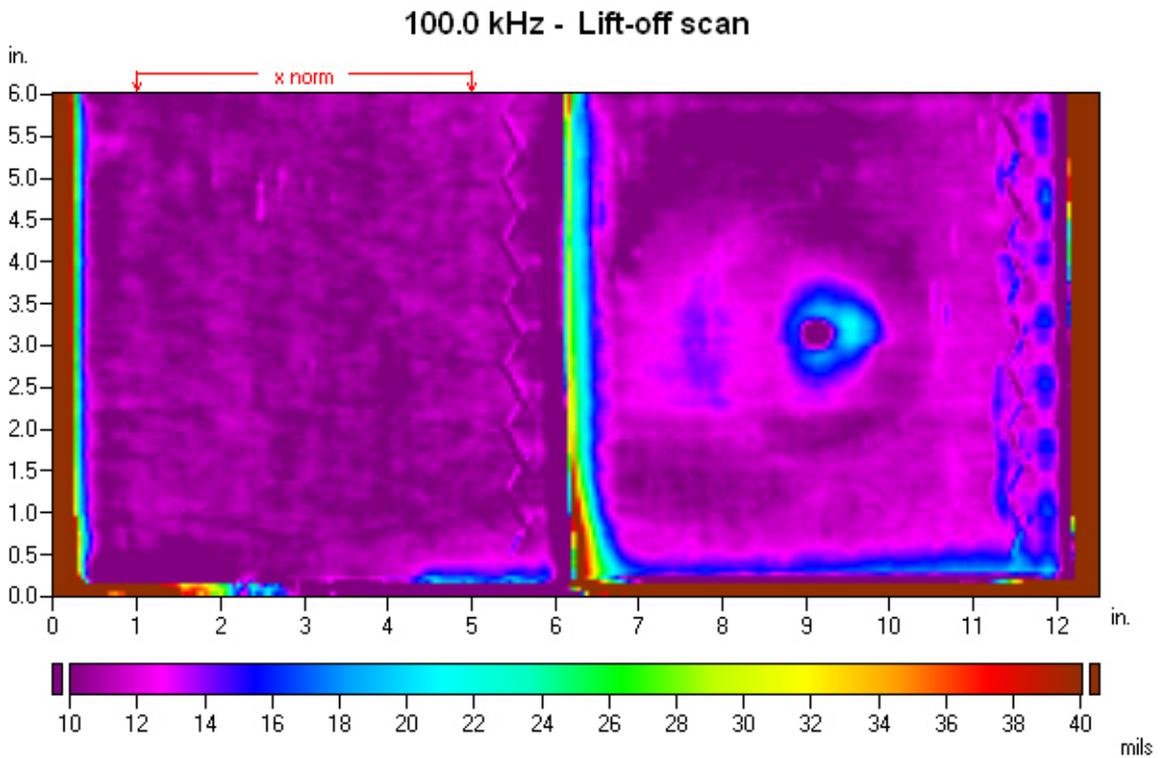
Figure 15. Lift-off C-scan for B4R4 back side: condition as dented.

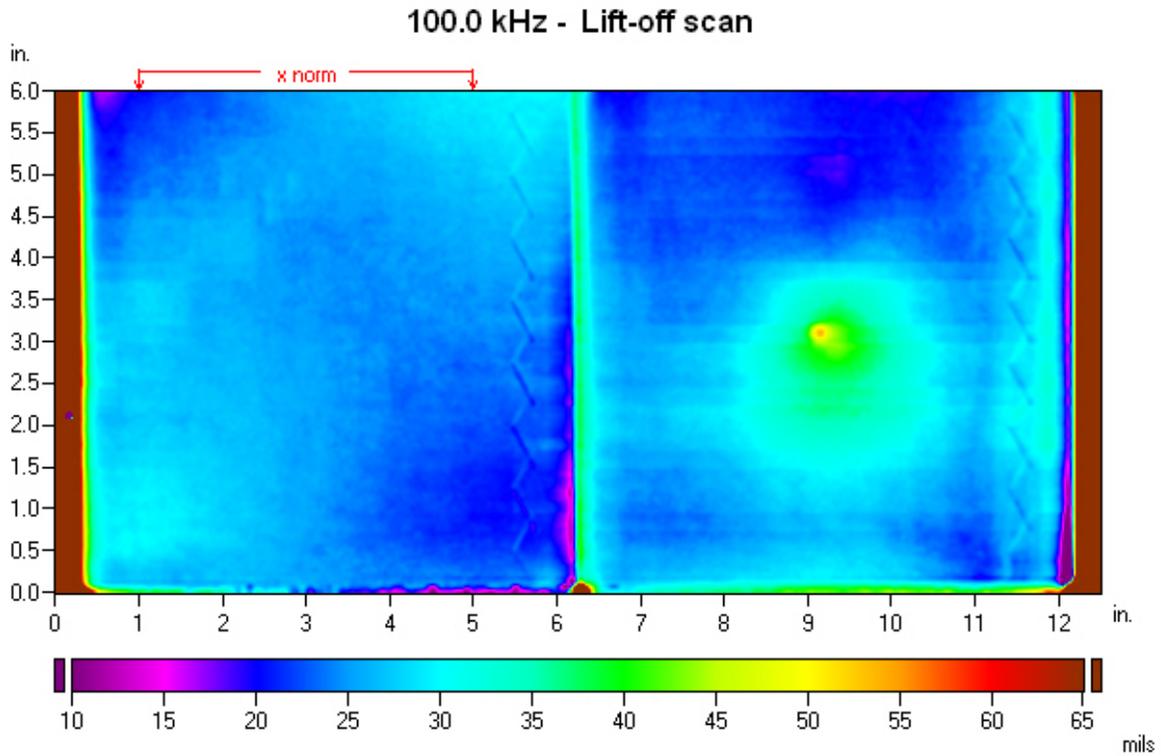
Figure 16. Lift-off C-scan for T1R1 front side: condition as dented.

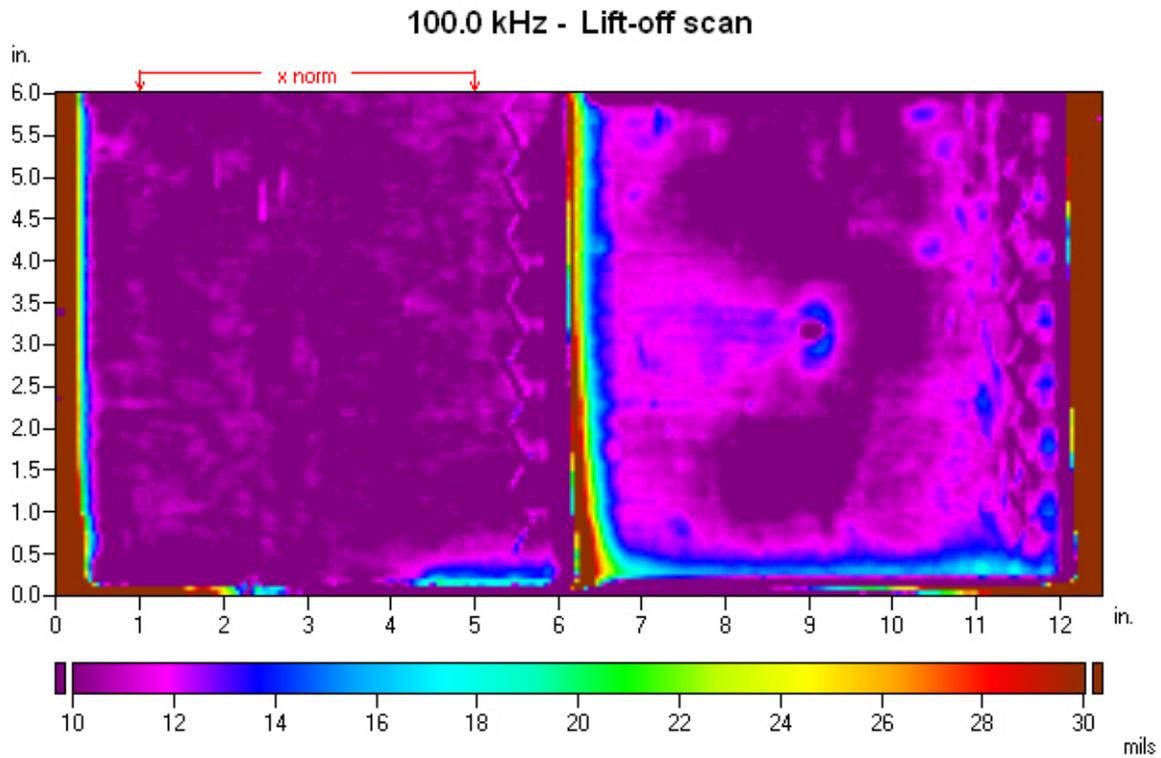
Figure 17. Lift-off C-scan for T1R1 back side: condition as dented.

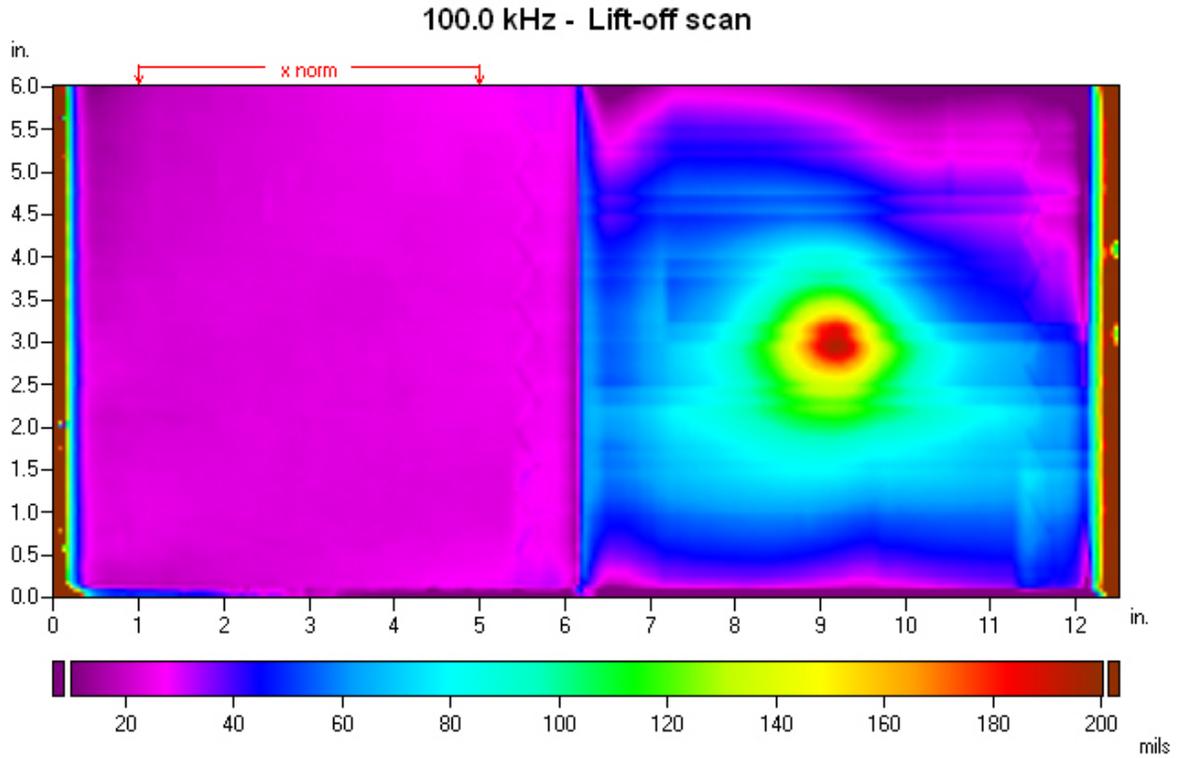
Figure 18. Lift-off C-scan for B4L4 front side: condition as dented.

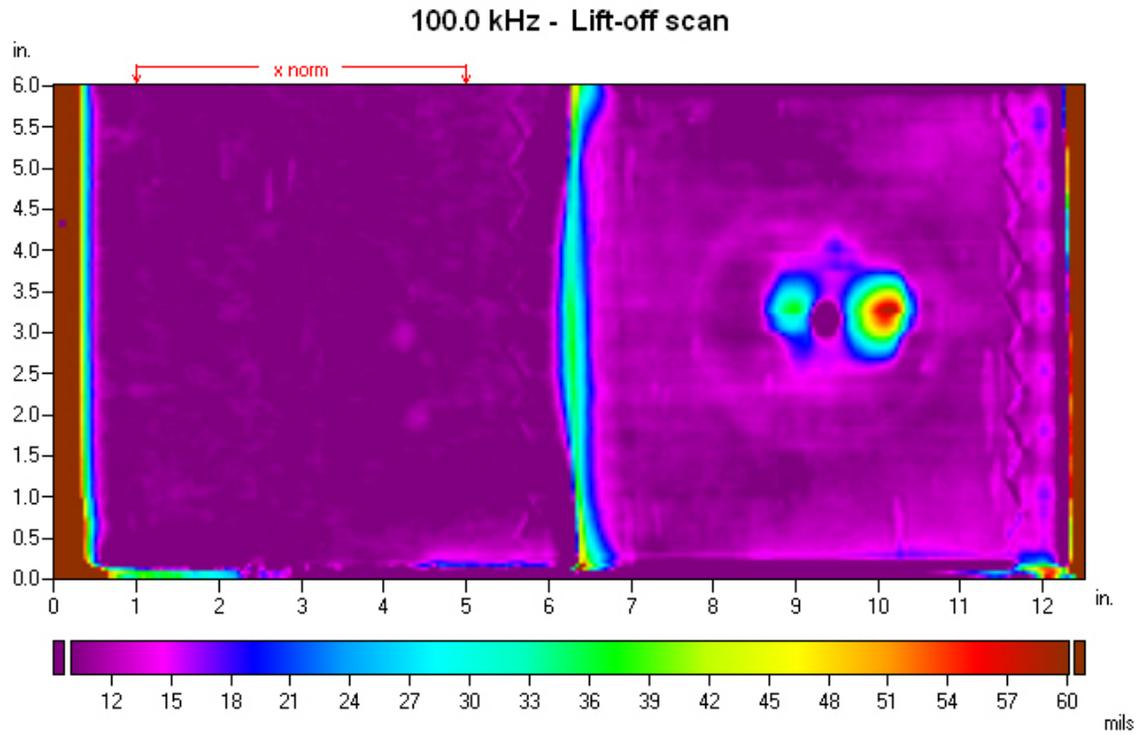
Figure 19. Lift-off C-scan for B4L4 back side: condition as annealed.

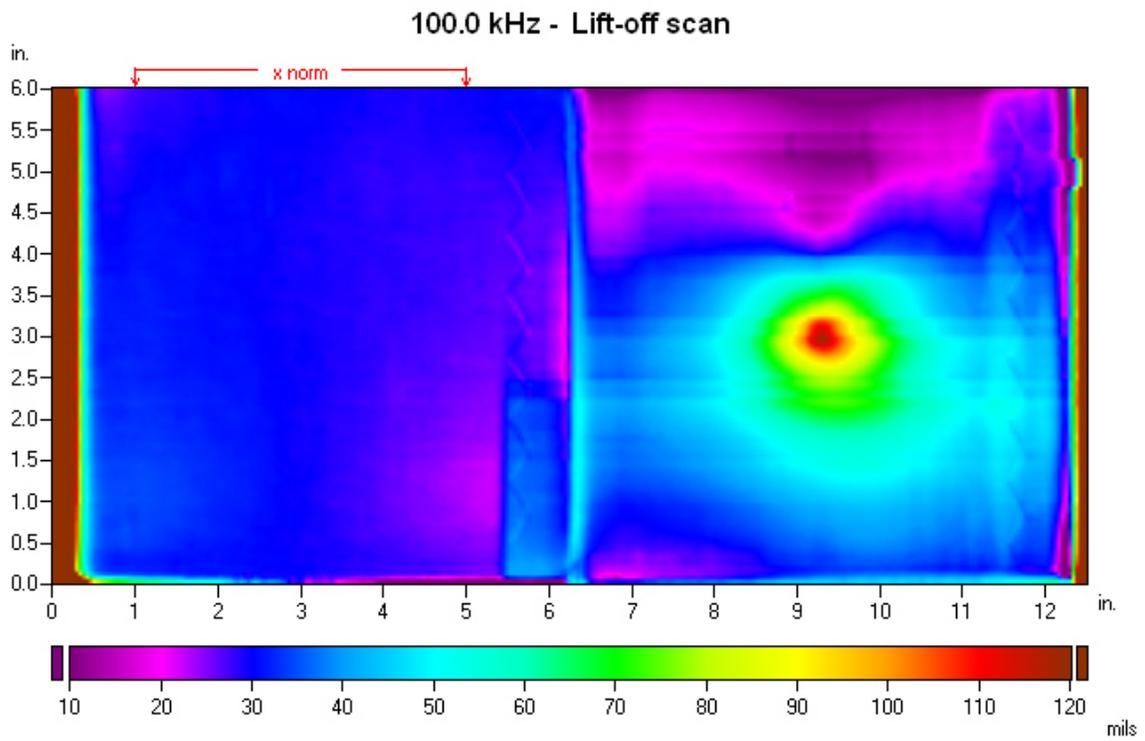
Figure 20. Lift-off C-scan for T4L4 front side: condition as dented

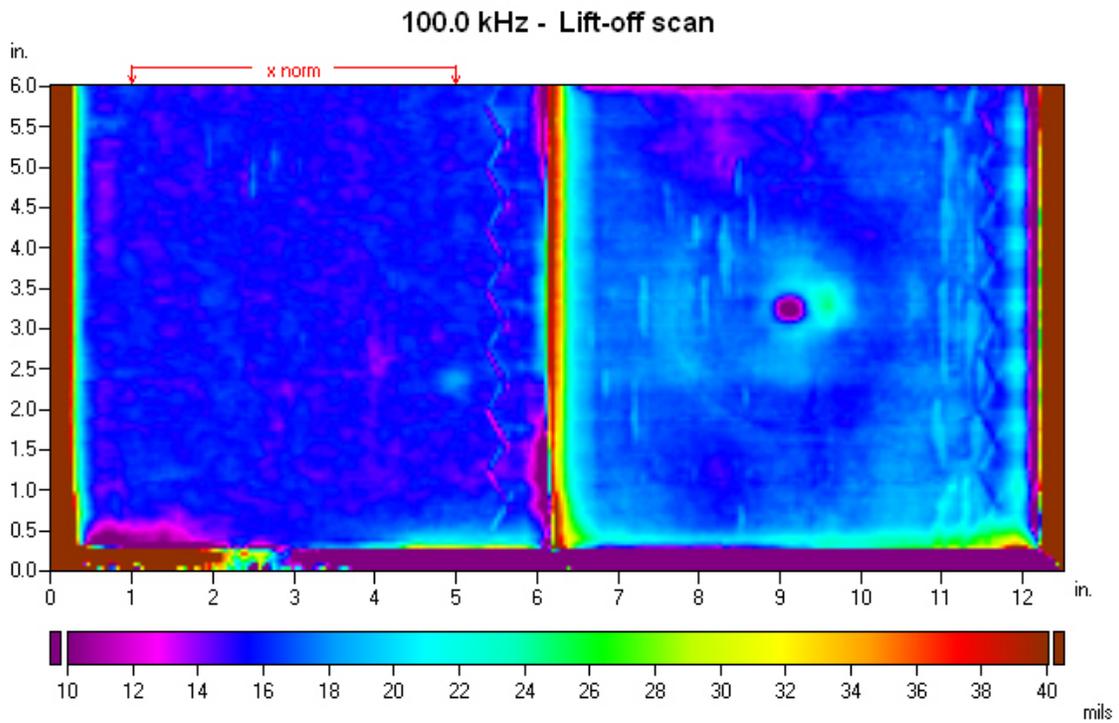
Figure 21. Lift-off C-scan for T4L4 back side: condition as dented

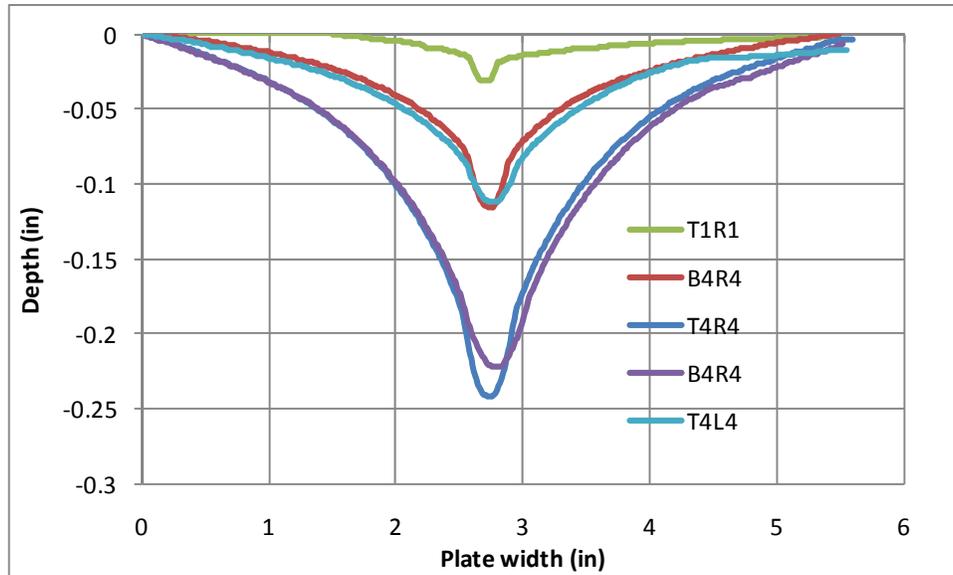
A comparison of the dent depths as measured by the digital dial indicator is shown in Figure 22. The dent depth is primarily controlled by the deflection imposed by the hydraulic press. Changing the indenter ball from 0.782 to 1.575 inch diameter has very little effect on the depth of the dent.

Figure 22. Dent depths as measured by the digital indicator for all 5 plates tested.

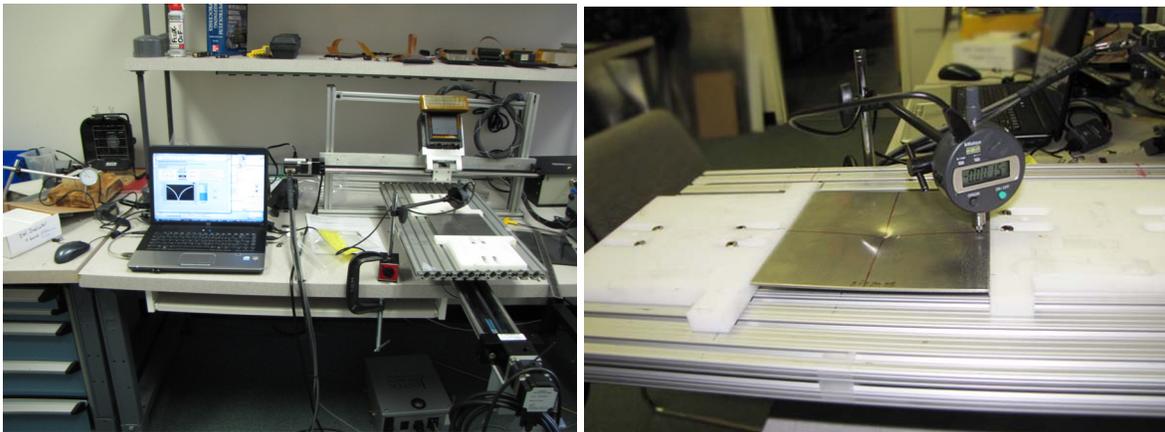
We also made comparisons between the lift-off B-scans at the center line of the dent to the measurements made with the digital dial indicator. The experimental setup to measure the depth with the dial indicator is shown in Figure 23.

Figure 23. Photos of setup used to measure dent profile with a digital dial indicator.

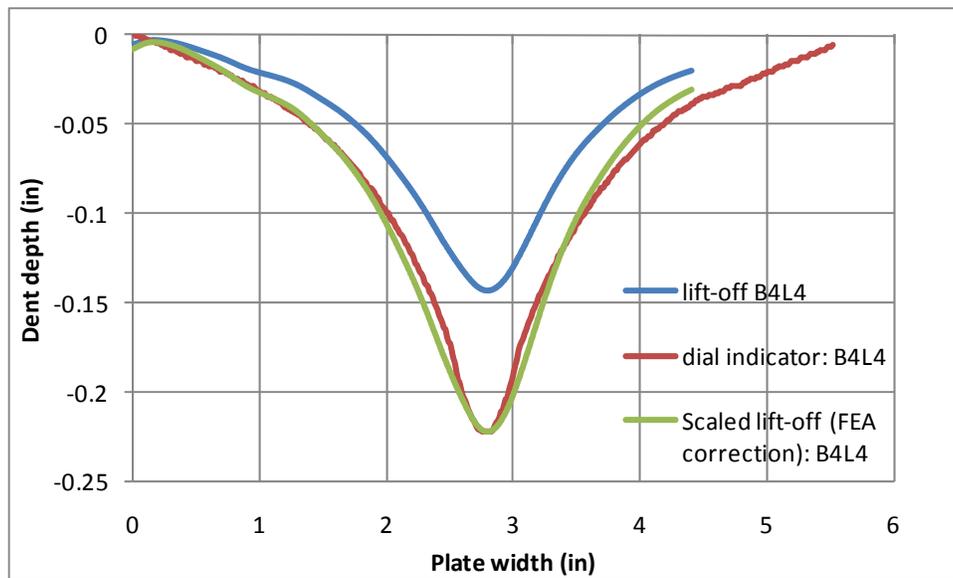
Figure 24. Dent profiles for plate B4L4 based on lift- dial indicator measurements and scaled lift-off (scale factor 1.55).

To accurately compare the MWM-Array lift-off measurements to those from the digital dial indicator, the sensor lift-off from the steel plates surface was corrected to subtract any lift-off due to both the shim used and any air gap caused by non-uniform bending of the plate. These results are shown in Figures 24 to 27. In all cases, as expected, the MWM-Array measured lift-off is less than the depth measured by the digital dial indicator. The measurement grid used to convert the impedance to lift-off and permeability assumed that the part has uniform planar layers with constant properties. This allows the grids (pre-computed databases) to be generated rapidly using the late Prof. James Melcher's layered media formulas. In the case where the layers are not uniform, but curved as in the dented samples, these assumptions break down

Also shown in the plots in Figures 24 to 27 are scaled lift-off values, which simply mean the measured lift-off was multiplied by a constant factor. For plates T4R4 and B4L4, which had dents of approximately the same depth, we used a scale factor of 1.55, and for plates B4R4 and T4L4 which had shallower dents of approximately the same size, we used a scale factor of 1.35. Once these scaling factors are applied to the lift-off measurements, they agree with the results from the digital dial indicator. These scale factors were empirically determined by finding the best fit of the lift-off measurements to the dial indicator measurements. Later a finite element simulation was performed to calculate these scale factors from the geometry changes. As shown in the next sections, the empirically determined scale factors were the same as those calculated with the finite element analysis.

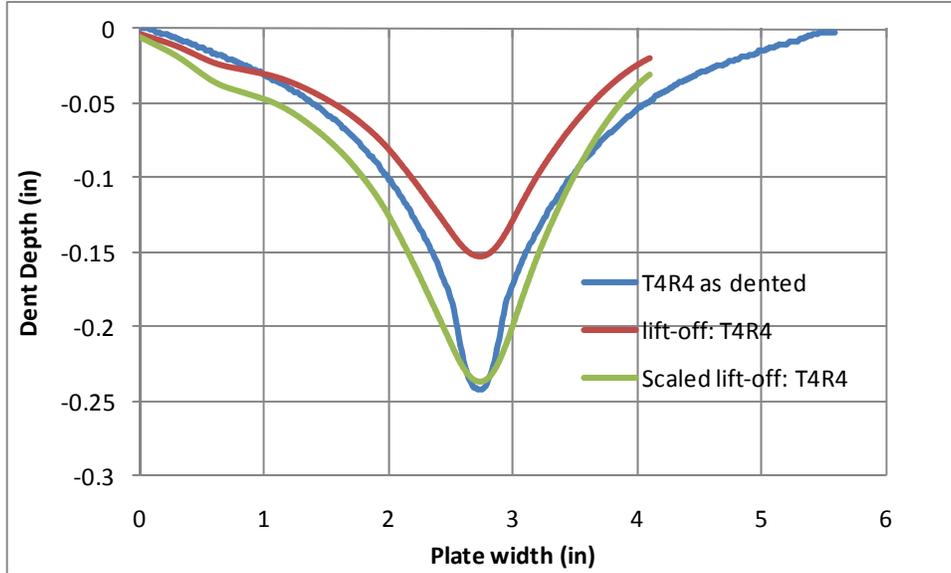
Figure 25. Dent profiles for plate T4R4 based on lift- dial indicator measurements and scaled lift-off (scale factor 1.55).

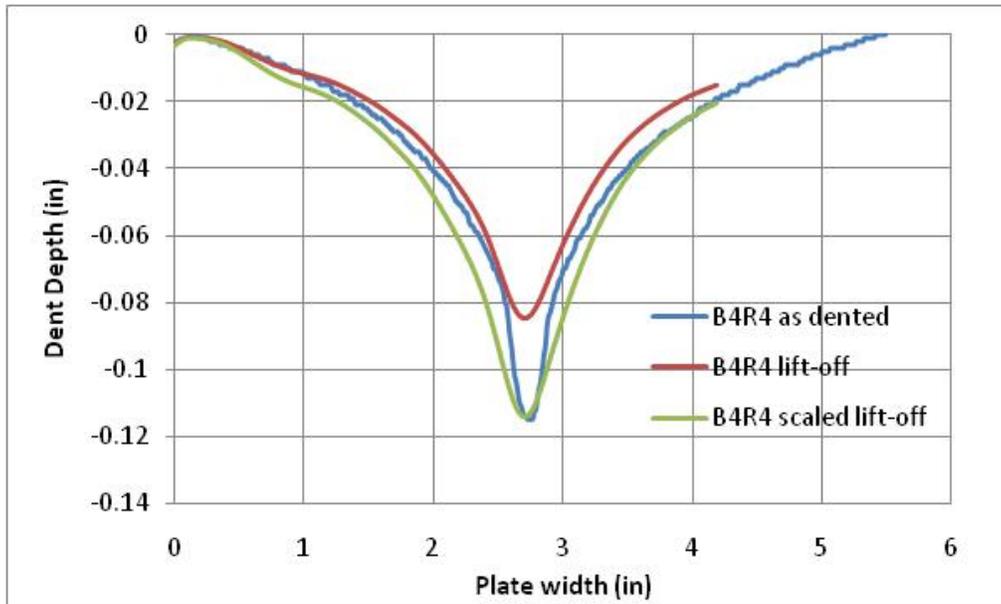
Figure 26. Dent profiles for plate B4R4 based on lift- dial indicator measurements and scaled lift-off (scale factor 1.35).

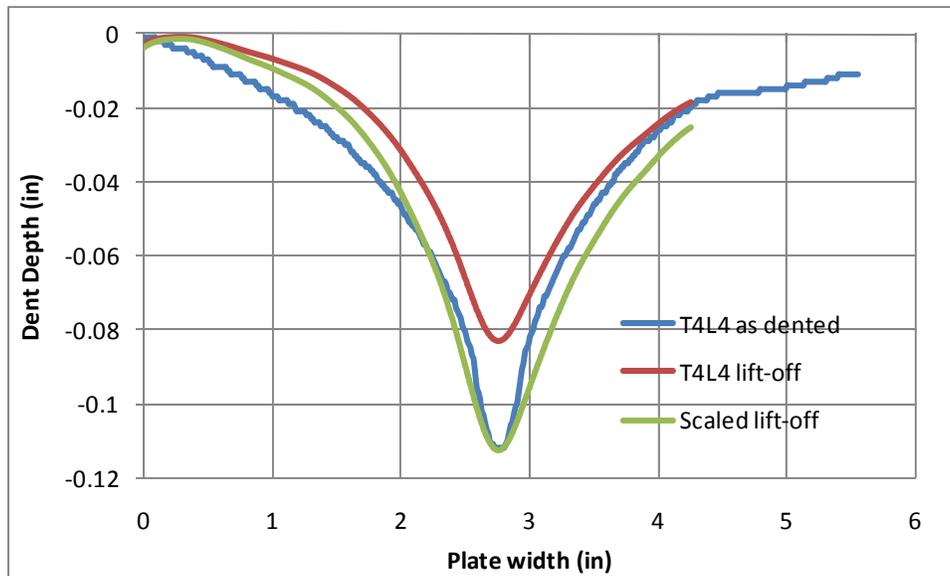
Figure 27. Dent profiles for plate T4L4 based on lift- dial indicator measurements and scaled lift-off (scale factor 1.35).

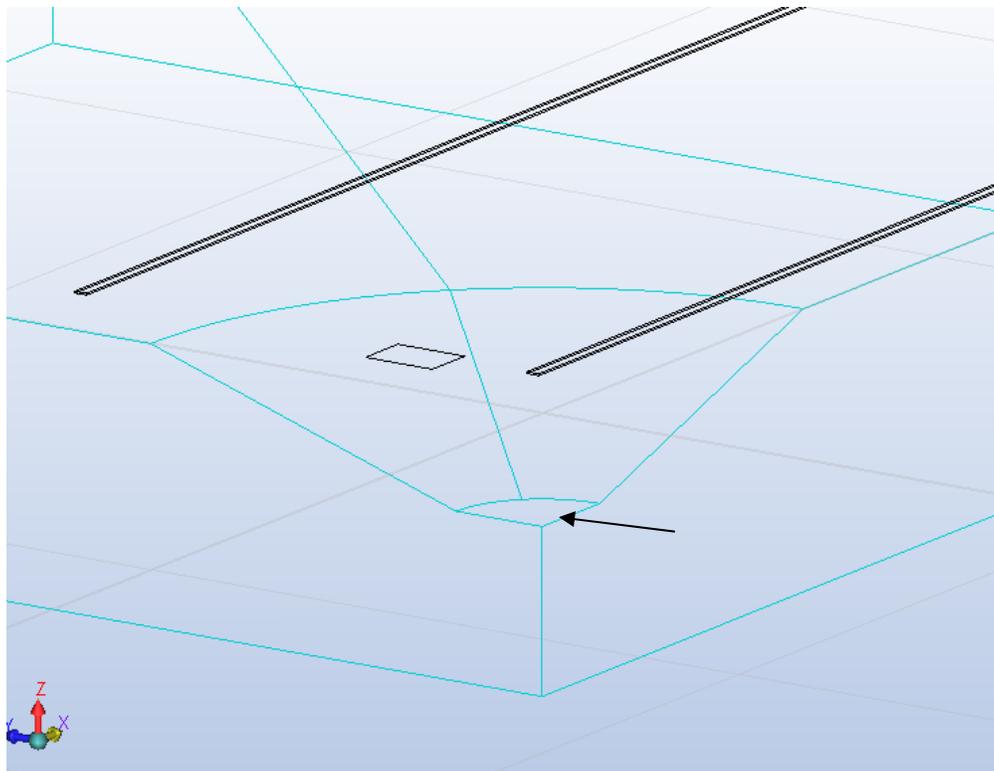
Figure 28. Quarter-section of the model geometry for an FA26 sensor centered over a dent in a steel plate.

A series of simulations were performed to determine the effect of the geometry changes associated with mechanical damage, such as dents on the effective property estimates of an MWM-Array. In this case, the geometry of Figure 28 was assumed. Due to symmetry, only a quarter of the geometry needed to be solved in the model calculation. An FA26 sensor was centered over a dent in a 6.35 mm thick steel plate. The upper surface of the plate was then deformed to simulate the presence of the dent; for the relatively high excitation frequencies considered here, of 10 or 100 kHz, the inspecting magnetic field from the sensor does not penetrate through the thickness of the plate and the sensor responds to near-surface properties in the plate. The dent itself contained a flat central section of diameter 5.08 mm and a larger area of deformation where the depth varied linearly from the surface to the central section. The FA26 sensor response was calculated as the depth of the central section and the diameter of the larger region were varied. The responses were processed using standard permeability/lift-off measurement grids to yield effective material properties. The nominal properties of the steel plate were a relative permeability of 40 and an electrical conductivity of 3.75%IACS. A nominal lift-off of 0.762 mm (0.030-in.) was assumed to simulate inspecting through a rigid plate.

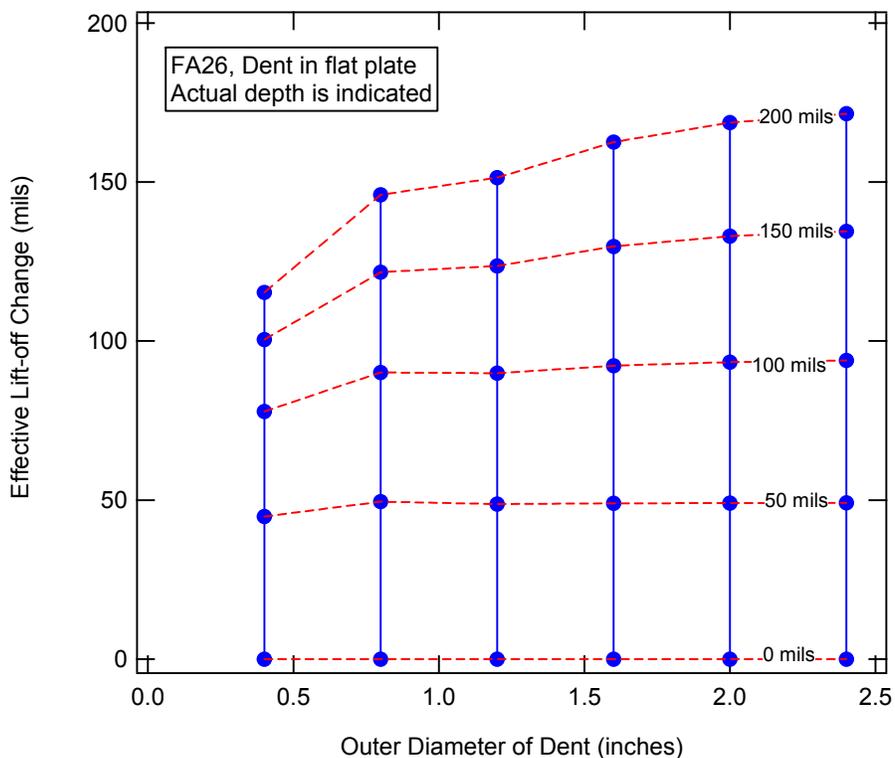
Figure 29 shows the predicted change in effective lift-off as the depth and diameter of the dent are varied. This change in the effective lift-off is calculated by estimating the lift-off with the flaw present and subtracting the nominal lift-off; this yields an estimate of the depth of the dent itself. In general, for large dent diameters and shallow depths, the change in the material geometry is small and the predicted lift-off change is in rough agreement with the actual depth. However, for large depths and for small dent diameters, the predicted change in lift-off is smaller than the actual depths. This indicates that the measured, effective lift-off changes need to account for the geometry changes in order to yield a reasonable dent depth estimate. The simplest way to do this correction is to scale the measured response using the ratio of the predicted to actual depths either from Figure 30 or from empirical measurements on a series of plates dented to different depths.

Figure 29. Predicted change in effective lift-off as the diameter and depth of a dent in a flat plate are varied.

Figure 30 shows the predicted lift-off correction factor to compensate for geometric effects on the lift-off estimate for the dent depth. These curves were obtained from the data of Figure 29 and indicate how the correction factor changes with the width and depth of the dent. For a shallow dent, the correction factor is near one, which indicates that the lift-off value provides a good estimate of the dent depth. However, for deep and narrow dents, the correction factor can be significant.
