Final Report

Department of Transportation Phase I SBIR Contract Number: DTRT57-09-C-10046

Digital Imaging of Pipeline Mechanical Damage and Residual Stress

David Jablonski, Ph.D., Principal Investigator
JENTEK Sensors, Inc.
110-1 Clematis Avenue
Waltham, MA 02453-7013
Tel: 781-642-9666
jentek@shore.net

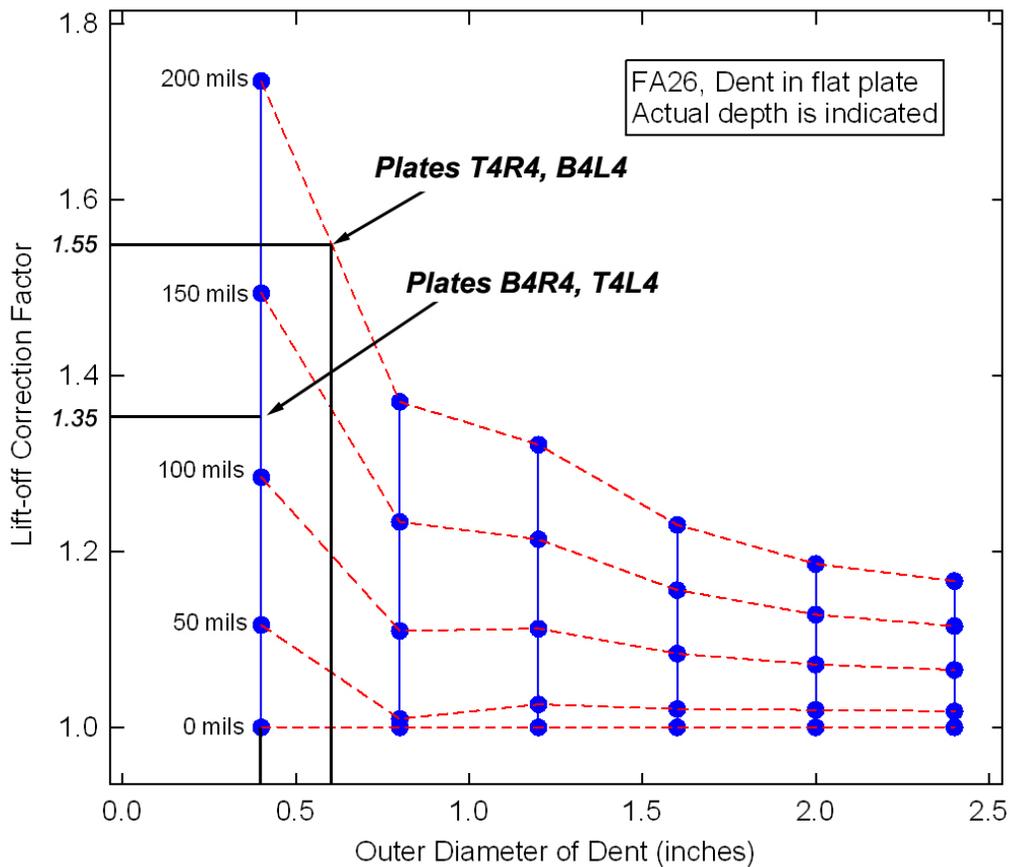
Figure 30 shows the predicted lift-off correction factor to compensate for geometric effects on the lift-off estimate for the dent depth. These curves were obtained from the data of Figure 29 and indicate how the correction factor changes with the width and depth of the dent. For a shallow dent, the correction factor is near one, which indicates that the lift-off value provides a good estimate of the dent depth. However, for deep and narrow dents, the correction factor can be significant.

In Figure 30, the T4R4 and B4R4 plates had dents ~ 200 mil in depth and the diameter of ~ 0.60 inches. From Figure 30 the scale factor is 1.55, which is what we found empirically for the data. Also in Figure 30, for plates B4R4 and T4L4, the dents were ~ 110 mils in depth and the diameter was ~0.40 inches. Again using Figure 30 the scale factor is 1.35, which is what we found empirically for the data. These calculated correction factors and our experimental measurement confirm that **accurate dent depth and geometry can be made using MWM-Arrays and grids corrected for the non-planar geometry** that occurs in a pipe with mechanical damage.

Figure 30. Predicted lift-off correction factors to compensate for the geometry effect on the lift-off estimate.

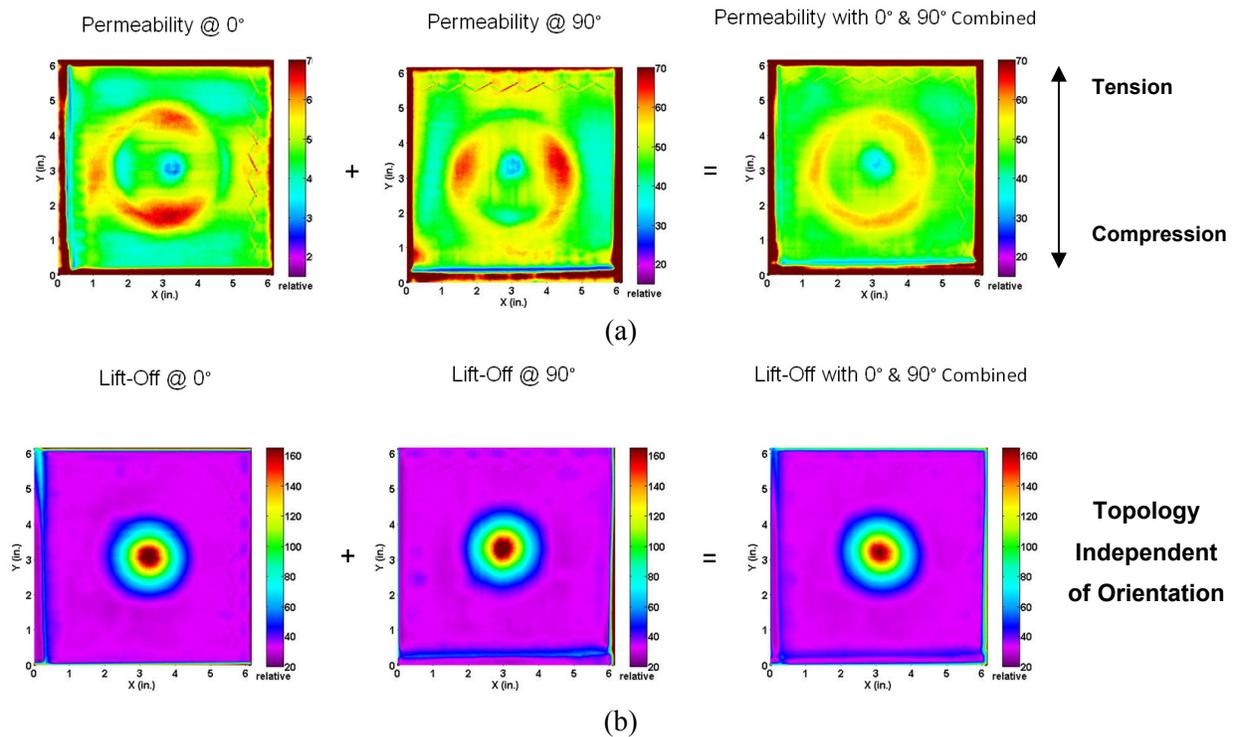
Figure 31. (a) Three images of a circular mechanical damage site. The image on the left and center are images of the magnetic permeability in the perpendicular and parallel directions relative to the scan direction. The image on the right is the average of these two images (at each pixel), providing a measure of the residual stress at that location. Note that this data was taken through a 0.03-in. insulating layer, to demonstrate inspection through coatings. **(b)** The three lift-off (surface topology or *magnetic profilometry*) images corresponding to the same orthogonal and averaged images as in Figure 31(a). As you can see, the lift-off images are the same (as expected) while the permeability (or residual stress) shows directional properties.

Figure 31(a) shows three images of MWM-Array measured permeability of a circular mechanical damage site. The image on the left and center are images of the magnetic permeability in two orthogonal directions. The image on the right is the averages of these two images (at each pixel), and, since the magnetic permeability of steels is known to vary with stress, this image provides a measure of the residual stress at that location. A relative increase in the magnetic permeability for this material represents an increase in tensile stresses (or an increase in susceptibility to stress corrosion cracking or fatigue crack initiation and growth).

Figure 31(b) shows the three lift-off (surface topology, or *magnetic profilometry*) images corresponding to the same images for two orthogonal directions and averaging these images. The lift-off images are the same for all two directions (as expected) while the permeability (or residual stress) shows directional properties.

The results presented in Figure 31 show that a more accurate measurement of the permeability change and residual stress around a mechanical damage site can be obtained by averaging the 0° and 90° permeability images obtained in orthogonal orientations around a mechanical damage site. We investigated use of additional orientations around the mechanical damages site by making measurements at +45° and -45° orientations. These are shown in Figure 35, with the averaged images shown in Figure 36. Clearly there is a slight improvement by averaging all four orientations, but the improvement is marginal compared to the use averaging of two images at orthogonal orientations from each other.

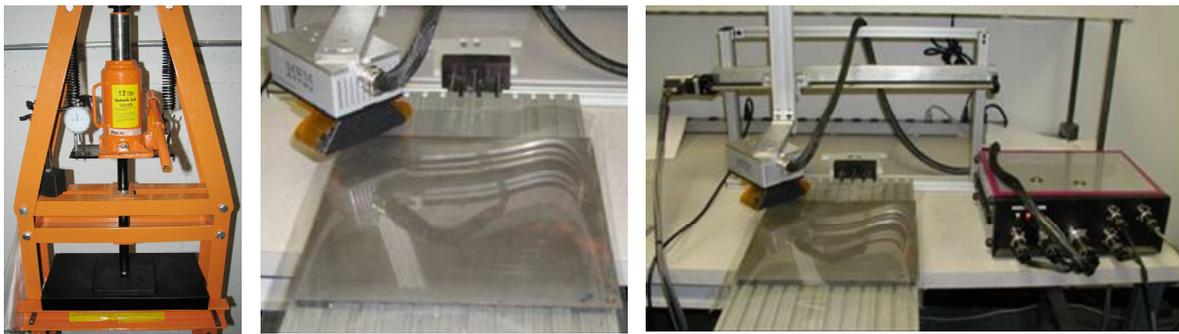
Figure 32. Photographs of the load frame used for sample preparation, test measurement setup, and the JENTEK GridStation System with the probe and MWM-Array.

Figure 32 provides photographs of the loading frame used for sample preparation and MWM-Array scanning test setup and JENTEK GridStation system with the probe and MWM-Array (flexible eddy current sensor). Figure 33 provides an illustration of the two MWM-Array drive winding orientations (of course in the test setup the part is rotated, not the sensor). Note that in follow-on efforts a V-shaped MWM-Array could be fabricated that has an integrated + and – 45 degree angle drive with separate sensing element arrays to enable data capture in a single pass.

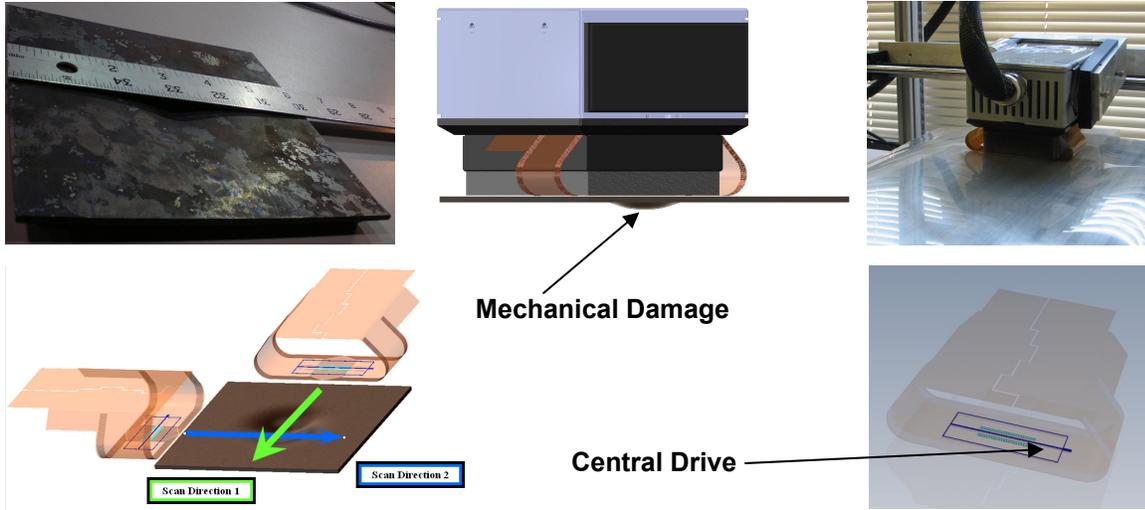
Figure 33. Illustration of the MWM-Array drive winding orientation during scanning with the drive in the two orthogonal orientations.

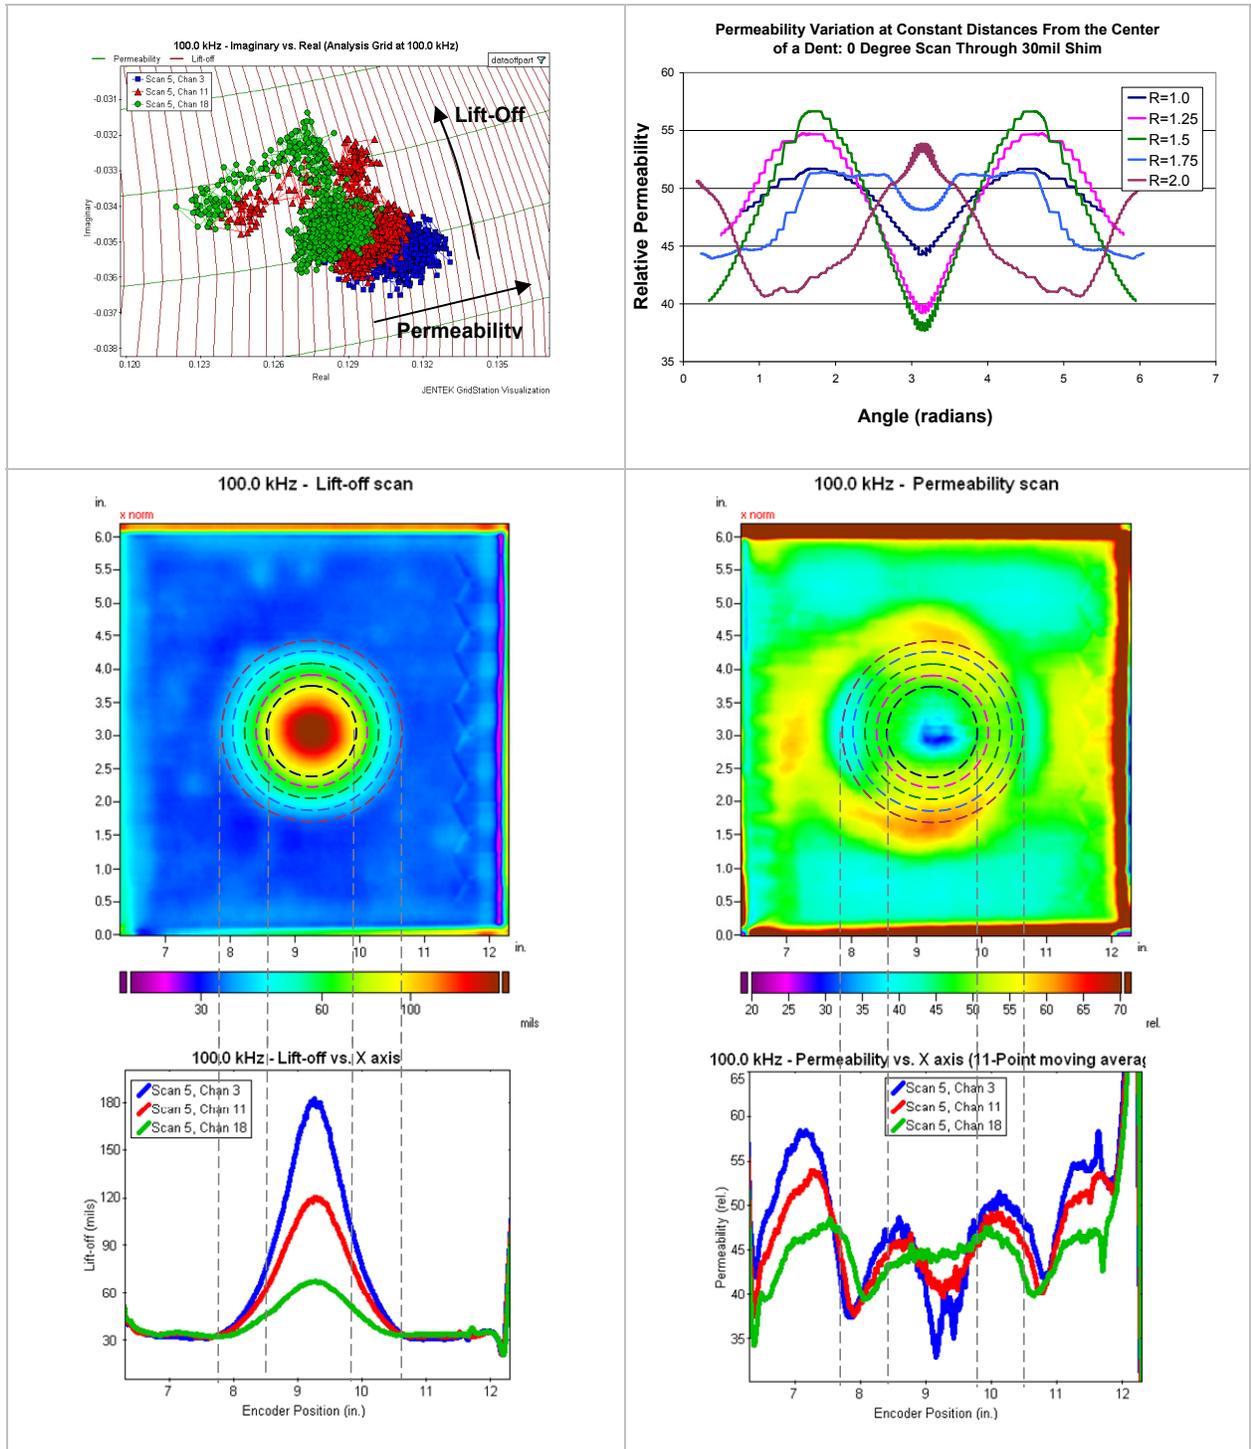
Figure 34. Top Left: JENTEK measurement grid (the grid methods enable independent imaging of the surface topology and magnetic permeability at the same). Middle Left: The lift-off (surface topology) image. Bottom Left: B-Scan of surface topology. Top Right: Changes in permeability at constant radii from the center of the dent. Middle Right: The magnetic permeability image (the dotted circles are of varying radius from the center of the dent). Bottom Right: B-Scan of magnetic permeability.

Figure 34 provides an interesting visualization of these results. The JENTEK grid methods, using measurement grids (pre-computed databases) such as shown in Figure 34 (top left), enable independent imaging of the surface topology (using magnetic profilometry) while at the same time in the same scan an image of the magnetic permeability (residual stress pattern) is provided. As shown in Figure 34 (middle left), the surface topology is extremely smooth as intended, but, the residual stresses are highly varied (middle right). The pattern that shows a decrease in permeability at the center of the dent and then an increase in the permeability approximately 1 inch from the dent center is consistent with finite element simulations from the literature by Clapham [2]. These finite element simulations show that the stress is compressive in the center of the dent and gradually transitions to tension away from the dent and then back to a state of zero stress at a larger distance from the dent center. Our results show a slightly more complicated stress state. We believe that the method used to make the dents did introduce a more complex stress state, because the part was supported too close to the indentation to allow a smooth transition of the residual stresses. This resulted in the more complex response shown in the permeability B-scans. This is an exciting and somewhat unexpected result. Thus, in continuing work, we will modify the denting process to produce various patterns of surface topology and residual stress variations. We also plan to model the elastic-plastic behavior to understand the mechanical denting process itself. Note that this data was taken through a 0.03 in. insulating layer, to demonstrate inspection through thin coatings.

Note from the data in Figure 34, even though the very smooth surface topology image (from the magnetic profilometry) can accurately measure the dimensions of a mechanical damage site, it is most interesting that local stress concentrations can occur even when the surface topology variation is more gradual. This is critical for assessment of mechanical damage sites. In follow-on efforts, we hope to analyze these stress patterns and even run fatigue tests to demonstrate the correlation between these patterns and both static strength reduction and fatigue damage evolution from various mechanical damage sites. This ability to perform rapid magnetic profilometry and residual stress imaging has the potential to provide significantly new inspection and characterization capabilities. While the work to date has been limited to near-surface analysis, on-going work aimed at development of a low frequency measurement capability with solid-state sense elements should be able to provide near-surface profilometry, wall thickness and *volumetric (3-D) residual stress imaging, in relatively thick pipeline walls (up to 1 in.)*.

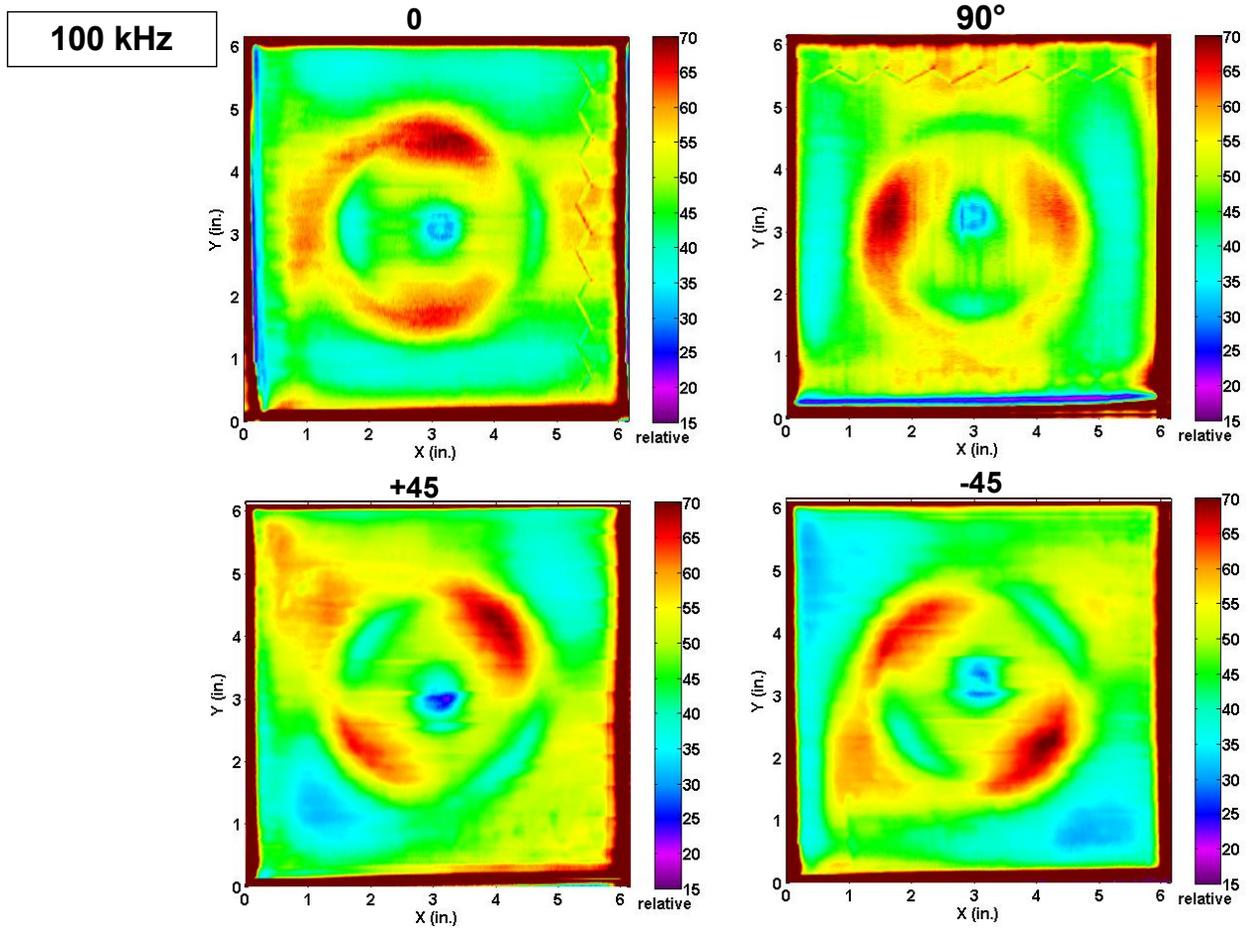
Figure 35. Four permeability images obtained by scanning circular mechanical damage site in different orientations. The top two images were obtained by scanning in the 0° and 90° orientations and the bottom two images were obtained by scanning in the 45° and -45° orientations.

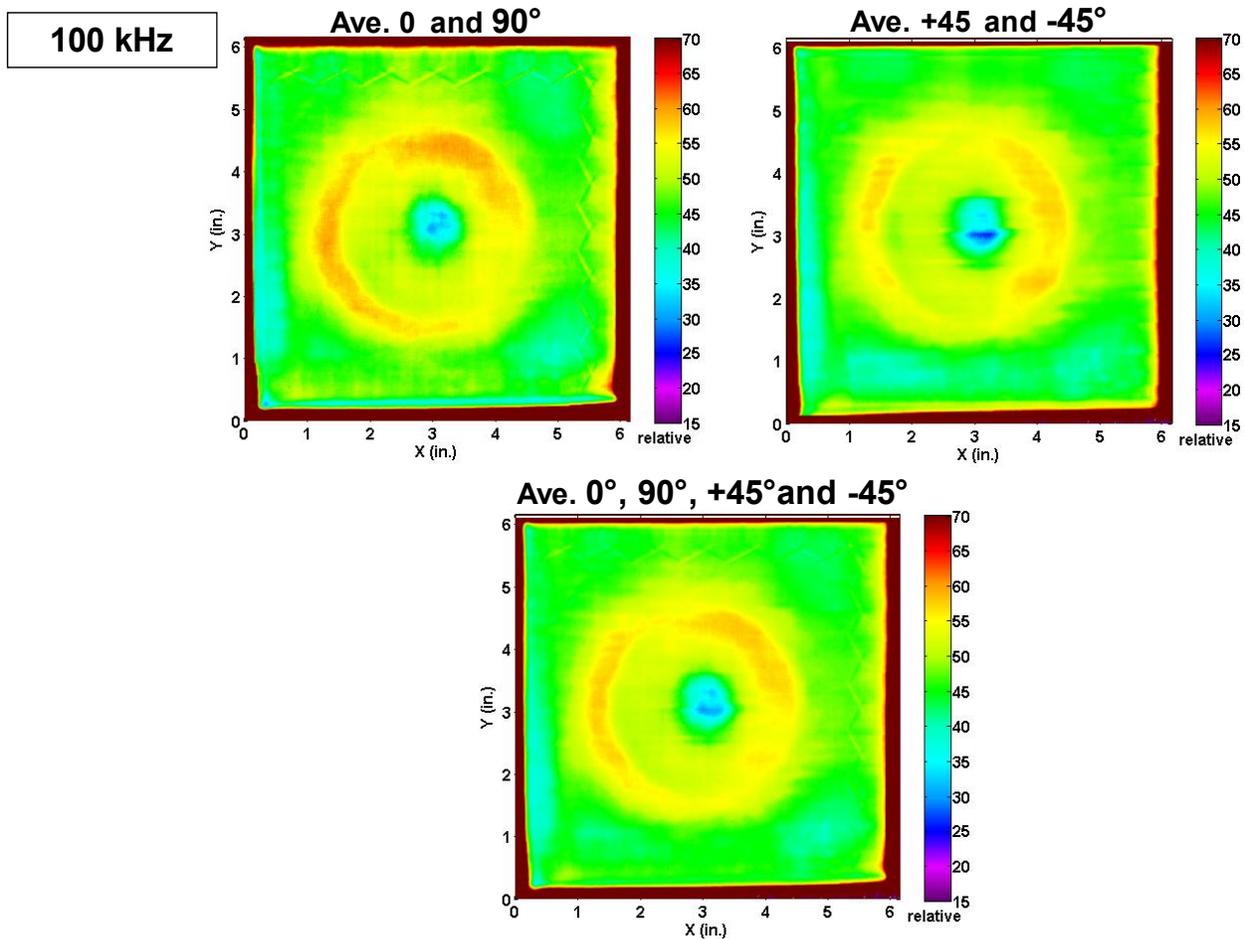
Figure 36. Top left: averaging of 0° and 90° permeability images for a circular mechanical damage site; Top right: averaging of 45° and -45° permeability images for a circular mechanical damage site; and Bottom: averaging of 0°, 90°, 45° and -45° permeability images for a circular mechanical damage site.

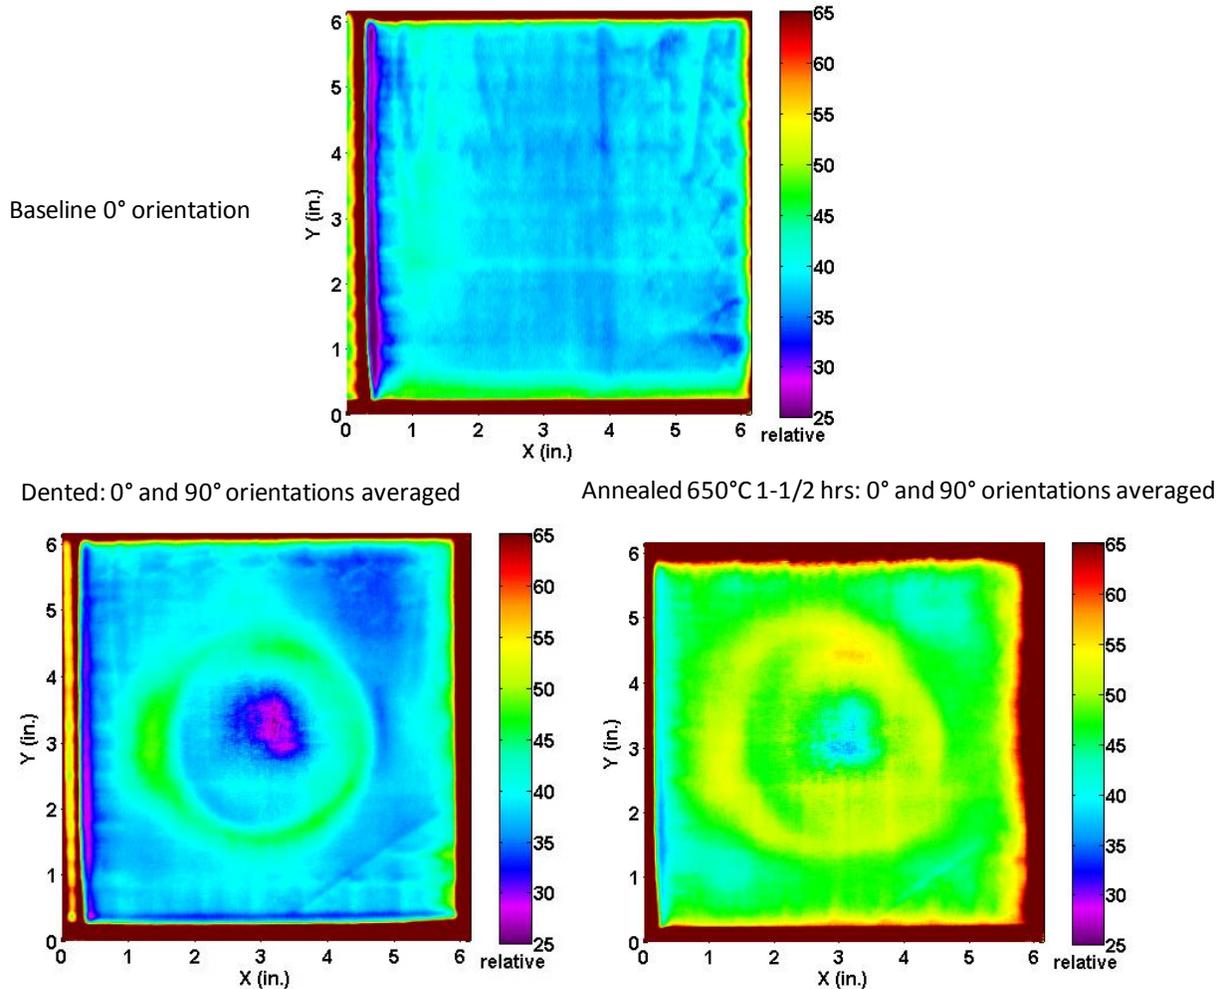
Figure 37. Top; baseline permeability of un-dented plate, bottom left: permeability image from the average of the 0° and 90° permeability images after denting, bottom right: permeability image from the 0° and 90° permeability images after annealing at 650°C for 1-1/2 hours.

The previous section reported on an experimental technique to obtain a more accurate measure of the residual stress (i.e. permeability variation) around a symmetric mechanical damage site by averaging permeability images at 0° and 90°. For the previous section, measurements were not made on the plate before annealing, so it was difficult to quantify the effect of annealing. Consequently we repeated some of the work with a new un-dented plate, T5R5 (thickness 0.125 in), and dented it with a 1.575 inch diameter ball to a deflection of 0.30 inches on the press. We measured the baseline permeability before we dented the plate and then we measured permeability at 0° and 90° after denting and then after annealing at 650°C for 1-1/2 hours. The results are shown in Figure 37. As expected after denting, there is a permeability decrease in the center of the dent which is in compression and there is a ring of higher permeability approximately 1-1/2 inches from the center, which represents tensile stresses. After annealing, the permeability in the center has increased, indicating the compressive stresses have been partially relaxed; however there is a diffuse ring of higher permeability (indicated in yellow) between 1-1/2 and 2 inches from the center of the ring. It is likely that this increase in permeability is due to the geometry changes that are not modeled in the standard permeability/lift-off measurement grids; this effect can be corrected by using modified grids that model the geometry changes. We will pursue an investigation of this effect if we obtain additional funding to characterize pipeline mechanical damage.

Based upon these results and results presented previously, we believe we have demonstrated the feasibility of using permeability C-scans to characterize residual stresses in pipeline mechanical damage sites.

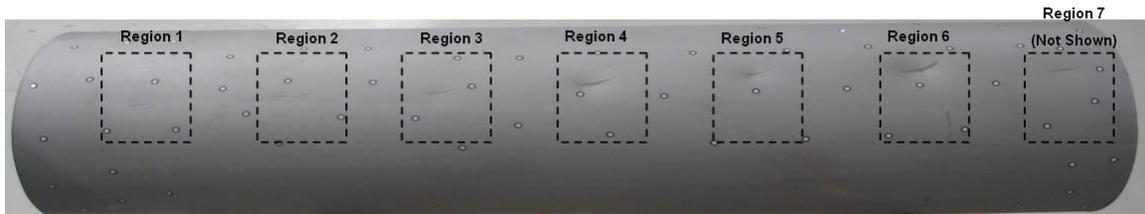
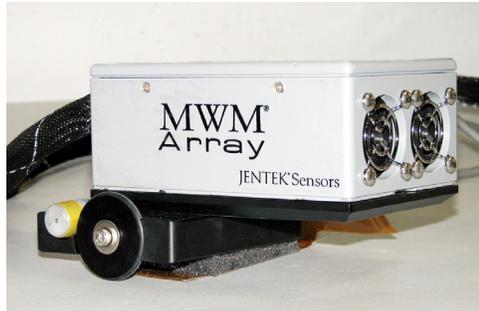
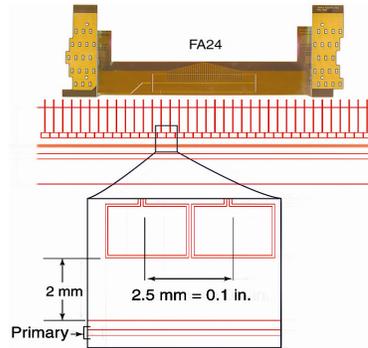
Several measurements were performed on a 16-in. diameter pipeline section at RTD that included seven discrete regions of mechanical damage. The damage regions consisted of a combination of dents and gouges and the severity of the damage varied in shapes and sizes. Figure 38a shows the pipeline section and the mechanical damage regions are highlighted. A complete axial scan, over six of the seven damage sites, was performed with an FA24 sensor. The standard manual scanning cart was used. An air-shunt calibration was performed and the data was processed using permeability/lift-off measurement grids. A 0.010-in. thick Mylar shim was placed over the entire length of the pipeline section with regions of mechanical damage. Figure 38b shows a photograph of the probe with the FA24 MWM-Array sensor and the scanning cart used.

Figure 38. (a) The 5-foot long, 16-in. diameter pipeline section at RTD with seven regions of mechanical damage sites. (b) Pictures of scanning cart and sensor used for these measurements.

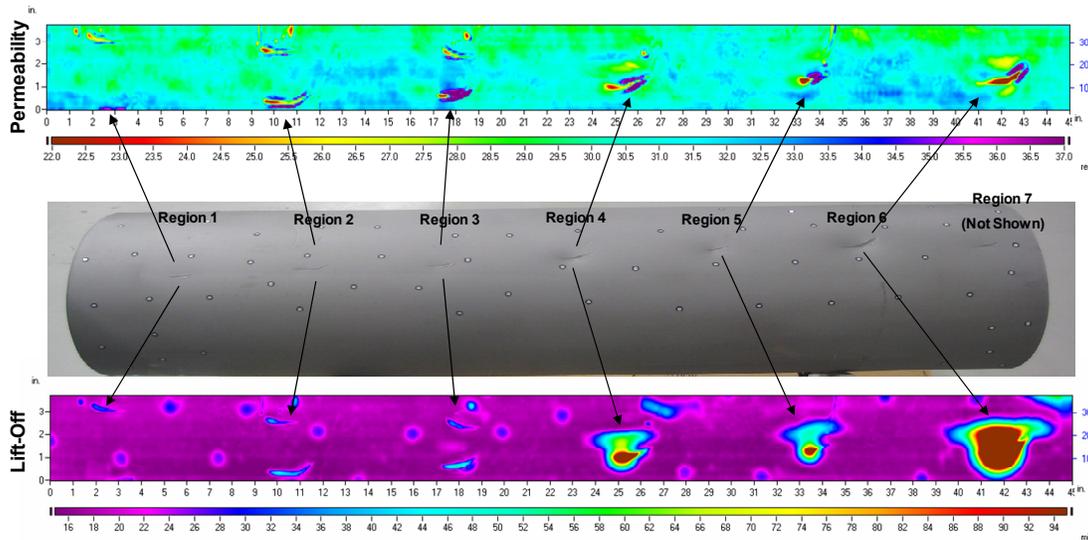
Figure 39 shows property images obtained with the FA24 sensor through 0.010-in. clear Mylar sheet. Note that only six of the seven mechanical damage sites are shown on the composite lift-off and permeability scan images. The manual scanning cart has a front wheel encoder and since the seventh region was too close to the edge of the pipeline section, it was difficult to obtain an axial scan of that particular region. Also note that the markers on the pipeline section only appear in the lift-off scan images and not in the permeability scans. This demonstrates reliable independent measurement of lift-off (topography) and permeability (related to residual stress).

Figure 39. Complete axial scan images of Lift-off (top) and Permeability (bottom) with the FA24 sensor. The mechanical damage regions appear in both the images, although the marker locations are only visible in the lift-off image. The mechanical damage Region 7 is not shown in the property images.

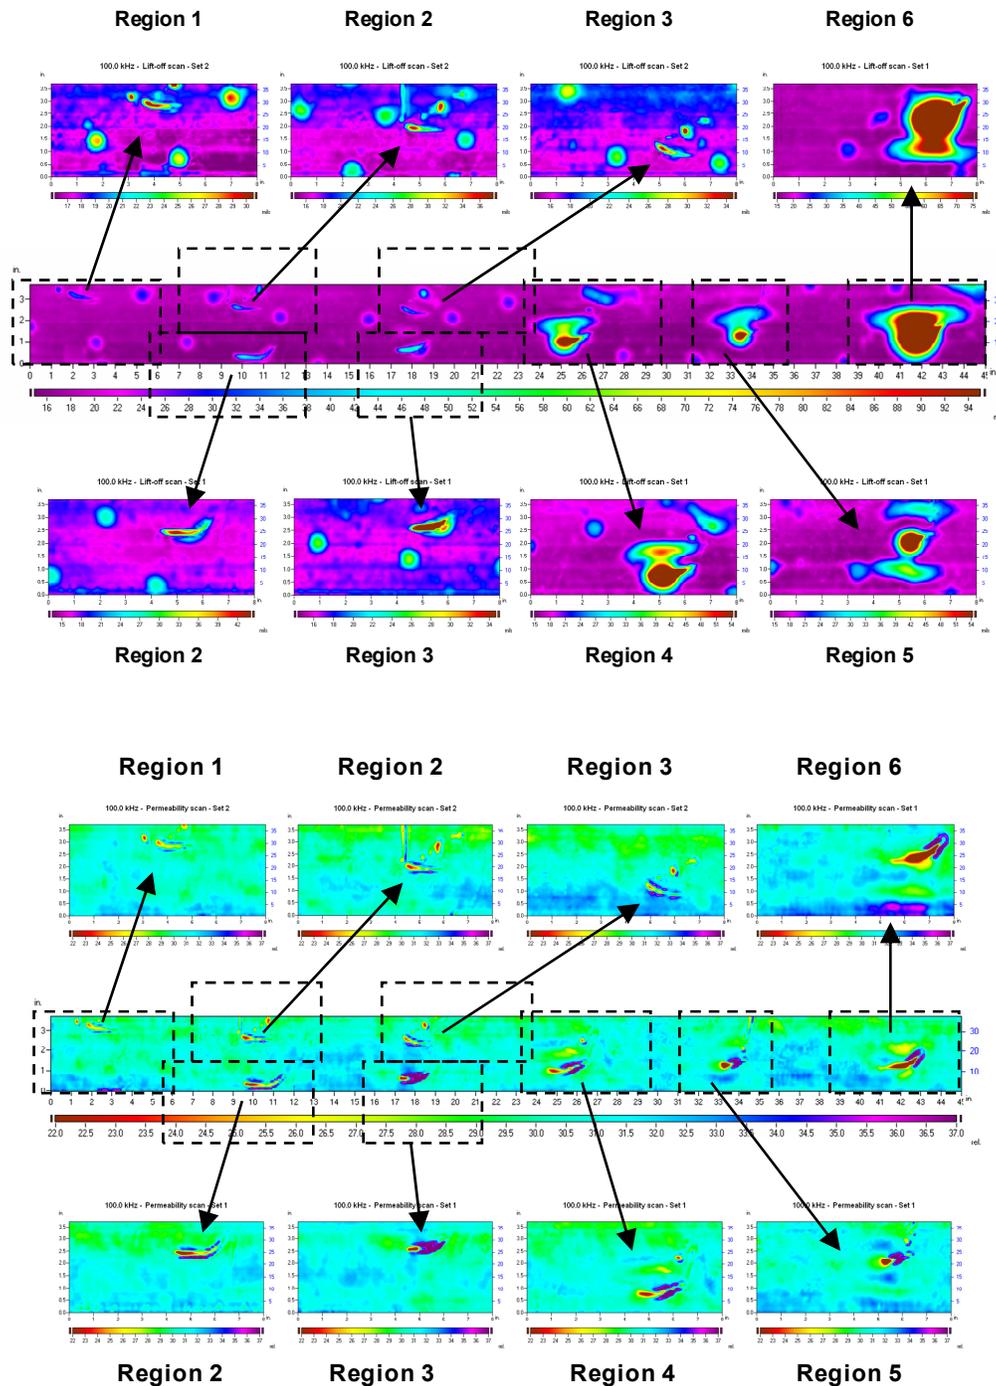
The FA24 sensor was also used to scan over each of the individual regions of mechanical damage. The expanded lift-off and permeability scan images are shown in Figure 40. It should be noted that a single scan was made with the FA24 sensor to obtain the expanded property images.

Figure 40. Complete axial scan images of Lift-off (top) and Permeability (bottom) with the FA24 sensor. The mechanical damage regions appear in both images, although the marker locations are only visible in the lift-off image. The mechanical damage Region 7 is not shown in the property images.

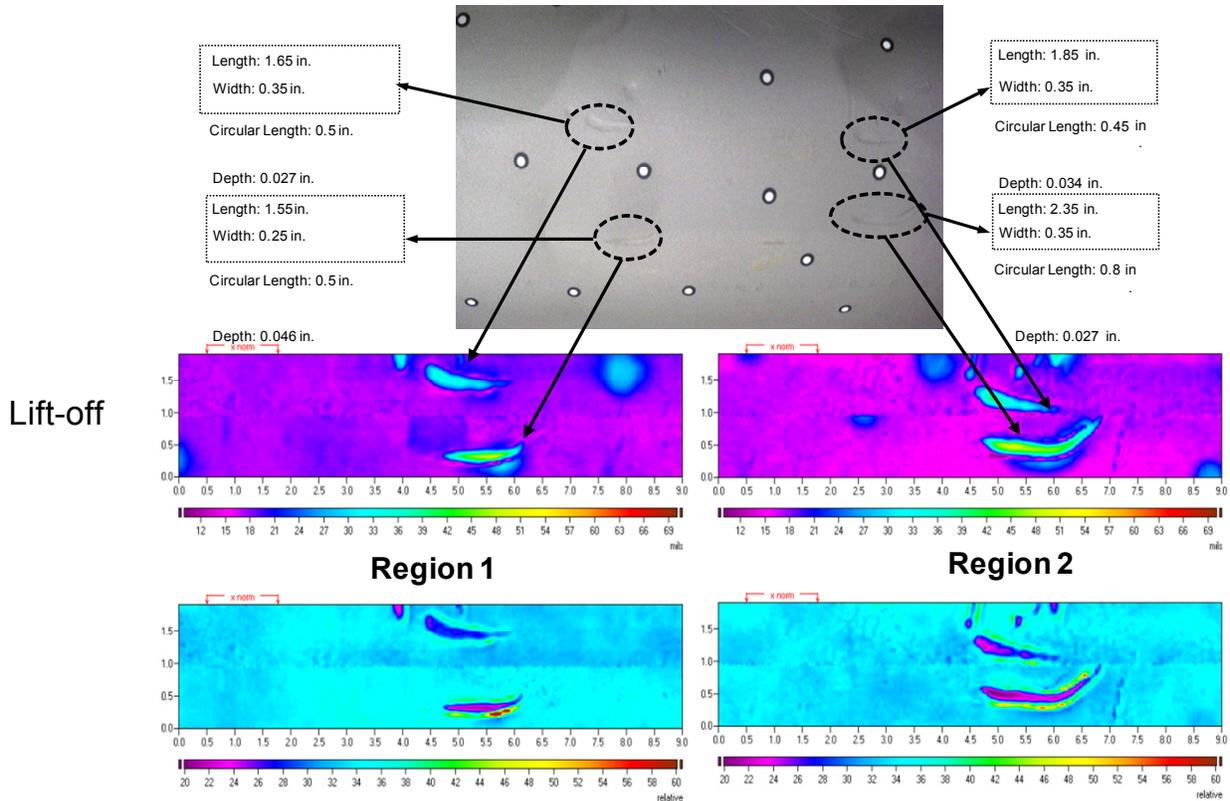
Figure 41. Mechanical damage Regions 1 and 2. Each of the locations contains two gouges. The lift-off images (top) show the marker locations, which are not visible on the permeability images (bottom).

Several measurements were then made on the individual mechanical damage regions of the 16-in. diameter pipeline section with the FA26 sensor. The FA26 sensor has the same drive-to-sense distance, but has higher spatial resolution given that its sense elements are 0.05-in., compared to 0.1-in. sense elements for the FA24 sensor. However the width of the scan path of the FA26 sensor is almost half that of the FA24 sensor and hence, two scans were made with the FA26 sensor with several channels of overlap to obtain the expanded property images. Figures 41 to 44 show close-up images of each of the mechanical damage regions as well as the corresponding property images taken with the FA26 sensor. The figures also provide a brief description of each of the regions. All photographs, as well as the data corresponding to size and location of the gouges are provided by Applus/RTD.

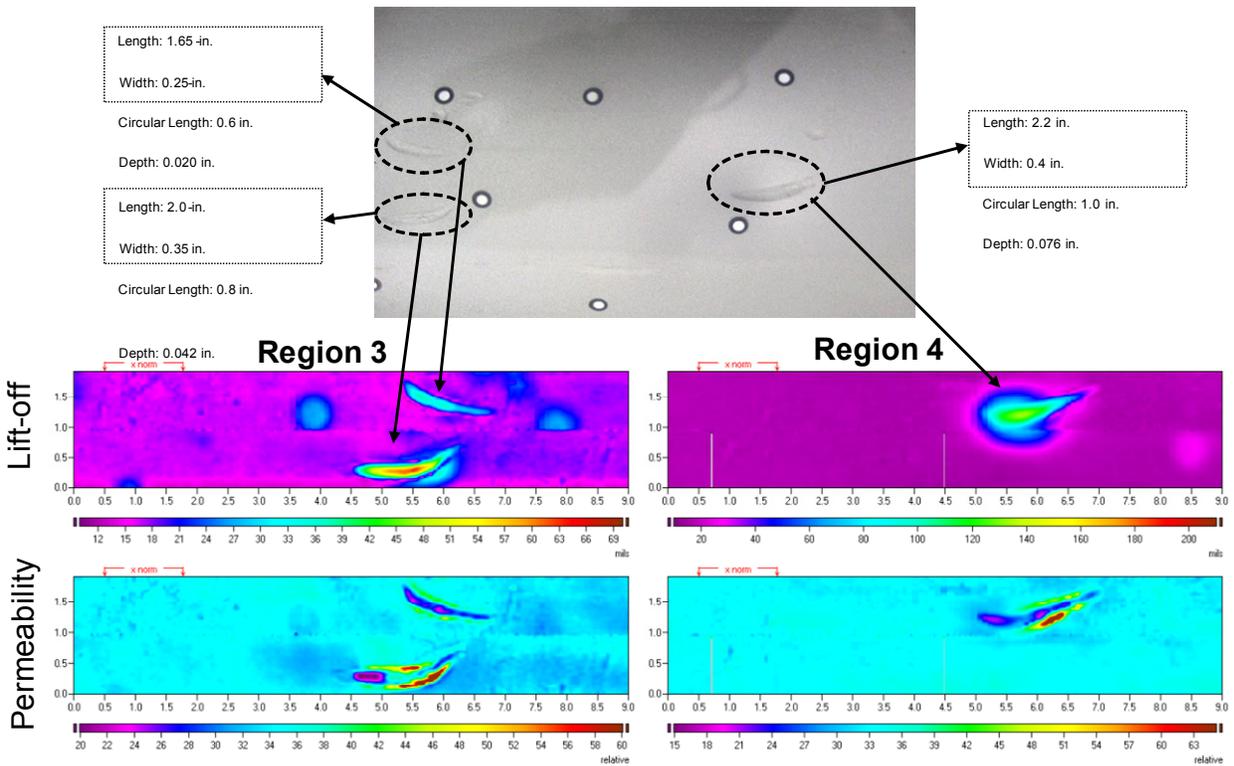
Figure 42. Mechanical damage Regions 1 and 2. Note that Region 3 contains two gouges whereas Region 4 only has one. The lift-off images (top) show the marker locations, which are not visible on the permeability images (bottom).

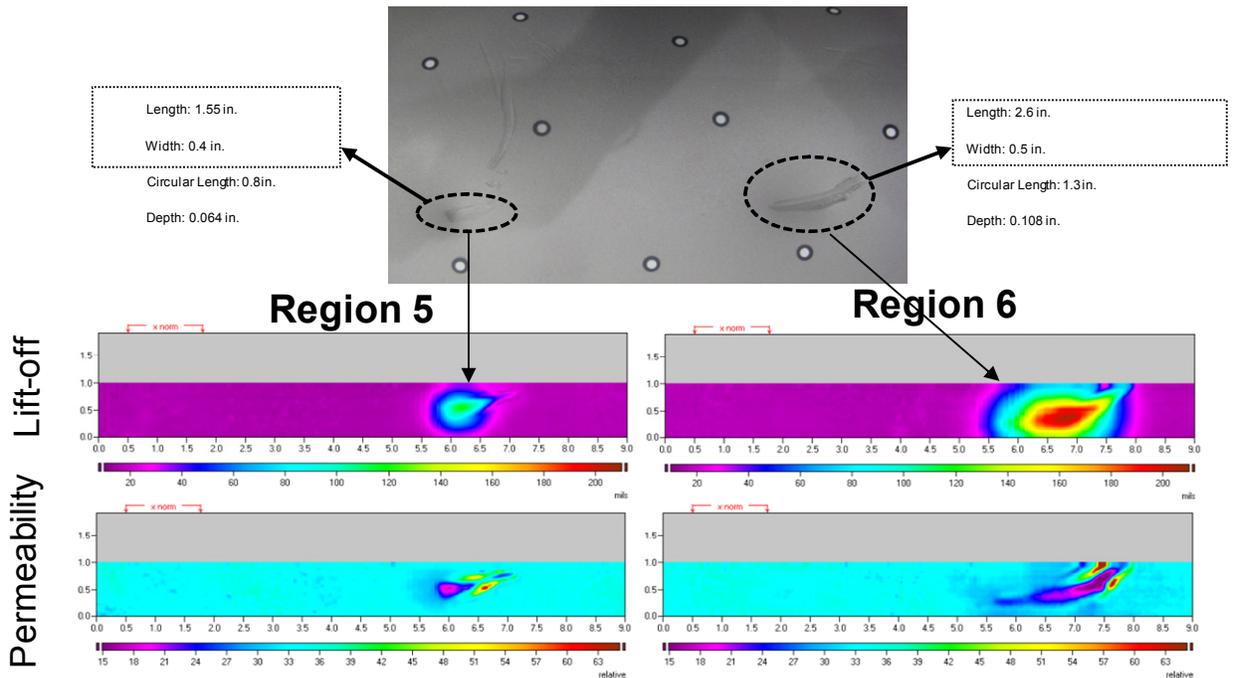
Figure 43. Mechanical damage Regions 5 and 6. Each of the regions only has one gouge.

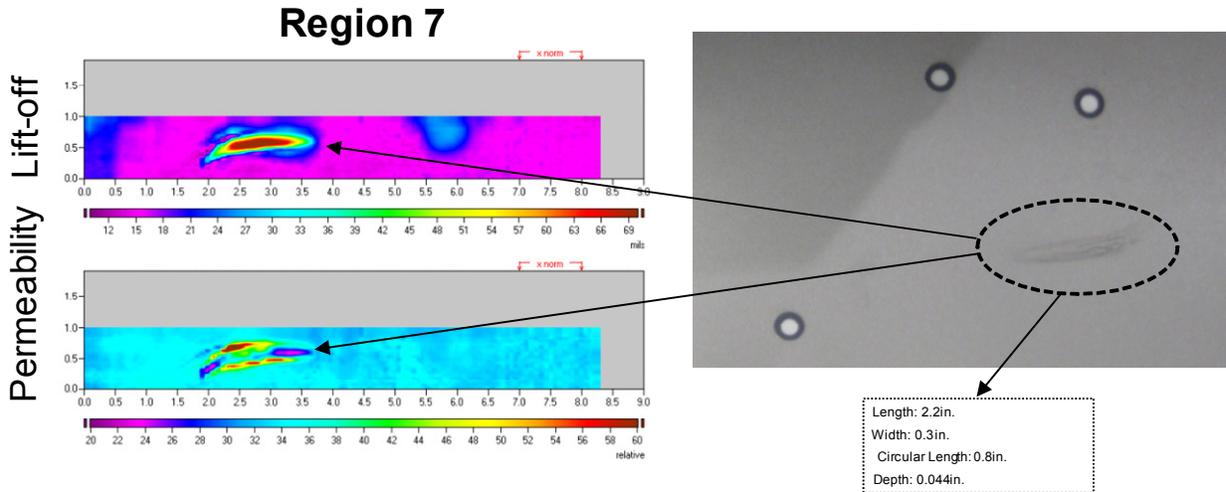
Figure 44. Mechanical damage Region 7. It should be noted that this particular scan with the FA26 sensor was made in the opposite direction (given its close proximity to the edge) from the other scans. Hence, the property images appear flipped compared to the actual photograph of the damage region.

Scans with the FA24 sensor, followed by the FA26 sensor scans illustrate a situation where a sensor with wider coverage can be used, possibly over a moderately thick insulation, followed by a closer inspection with a higher spatial resolution sensor after the coating is removed. The next stage in mechanical damage imaging might be to start quantifying some of the results to obtain a more accurate size and depth estimates. Also, it might be possible to scan the FA24 sensor over a 0.25-in. thick insulation and compare the results to the ones shown in this report. Also, circumferential scans performed with the FA26 sensor might provide more detailed information about the damage sites. We are in the process of modifying our existing fixture to better accommodate circumferential scanning in the near future.

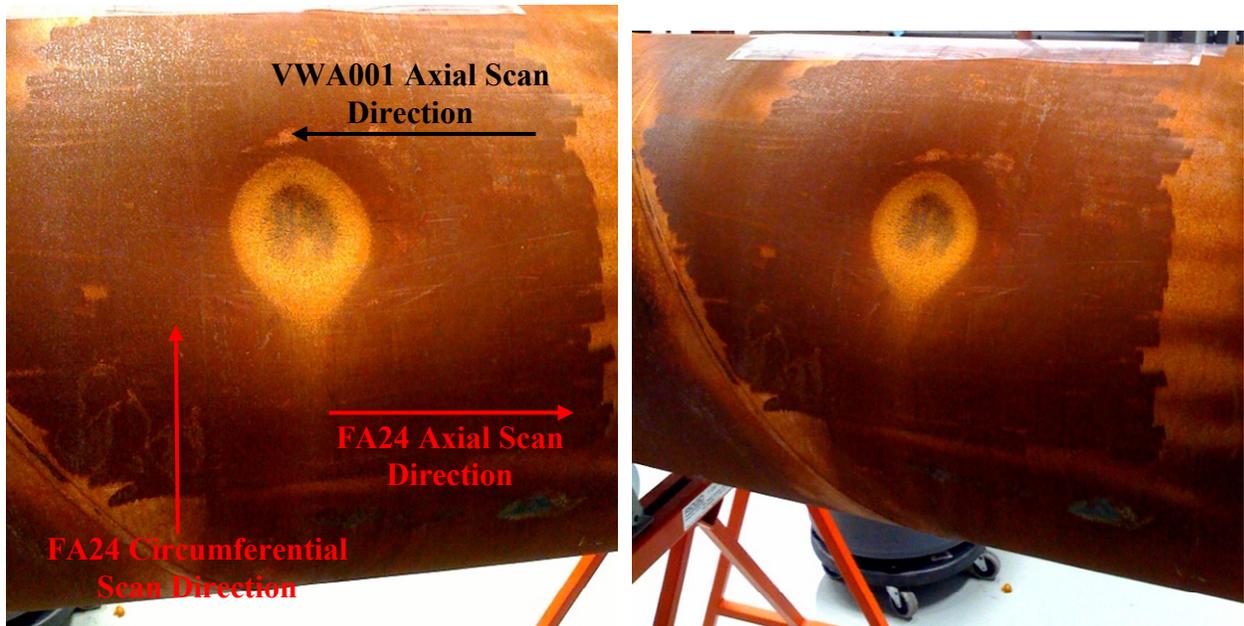
Several measurements were also performed on a 24-in. diameter pipeline section at RTD that included a large plain dent. Figure 45 shows the pipe section and the dent. The dent was at least 1-in. deep at the center and the pipe was deformed over an area several inches in diameter. One set of measurements was performed with the VWA001 sensor that has a 1-in. drive gap. The VWA001 sensor is a larger version of the MWM-Array and is being developed as part of a separate DOT PHMSA program titled “MWM-Array Detection and Characterization of Damage Through Coatings and Insulation.” Although the data taken with this sensor and a prototype scanning fixture are from this separate program, it is presented here to complement the data taken with the FA24 sensor. It also illustrates how the larger VWA001 sensor could be used to inspect for the location and initial characterization of mechanical damage through a coating and the subsequent inspection with an FA24 sensor without a coating (or with a very thin coating) can provide more detailed information about the damage. For this data, an air-shunt calibration was performed and the data was processed using permeability/lift-off measurement grids. A two-inch layer of foam was placed behind the sensor array and used to hold the array against the coated pipe surface.

Figure 45. 24-in. diameter pipe section with plain dent. The scan directions for the VWA001 and FA24 MWM-Arrays are indicated.

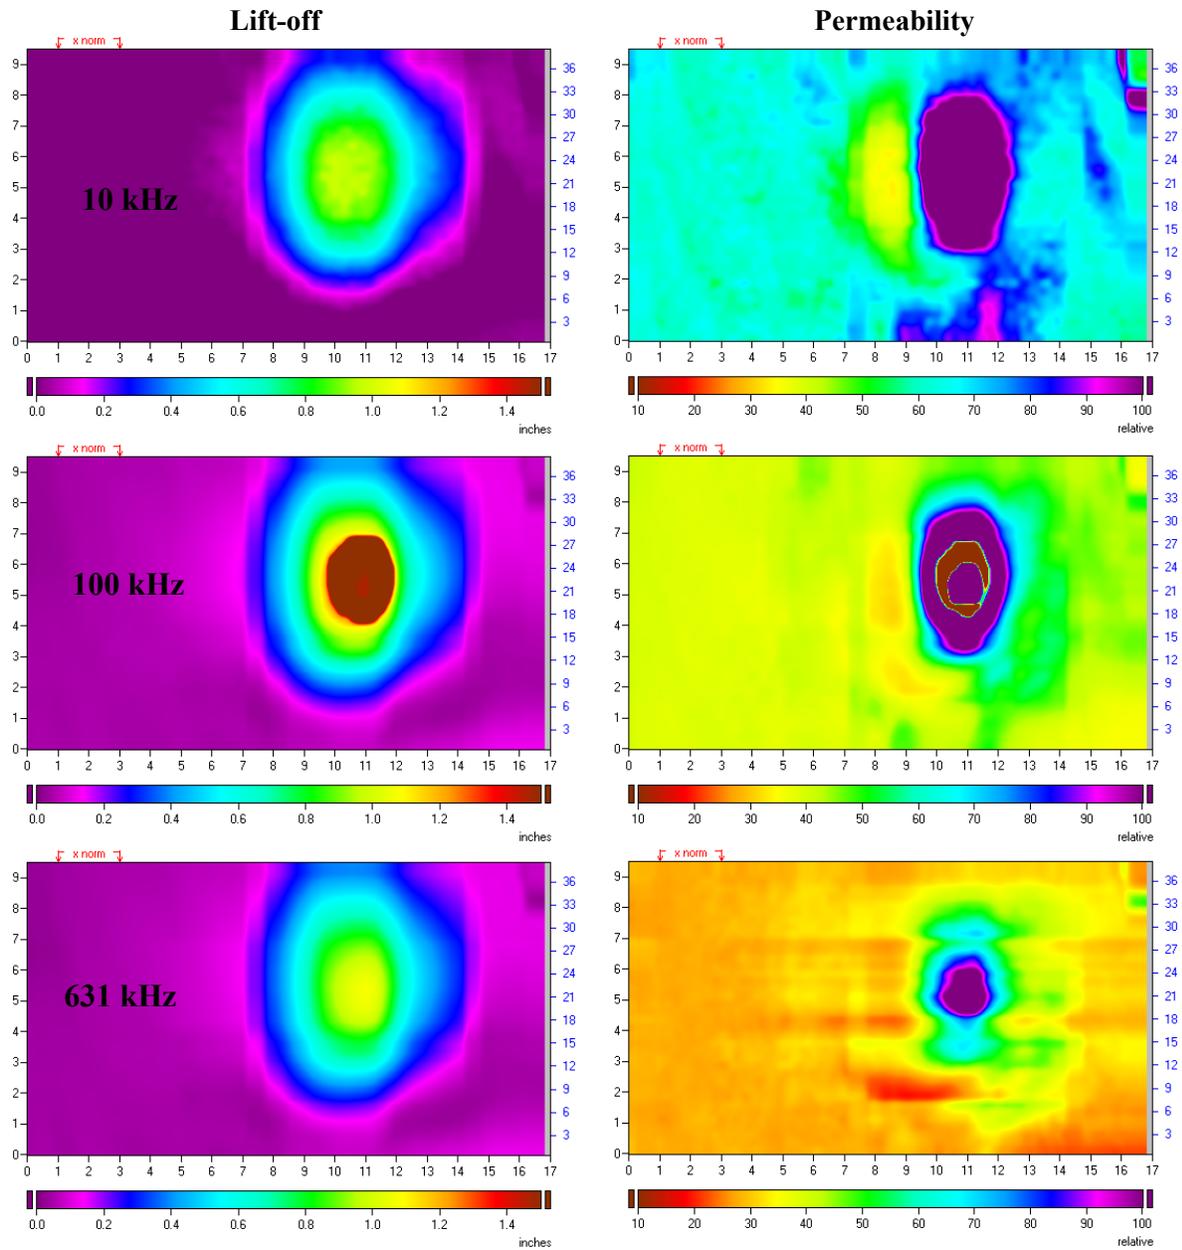
Figure 46 shows property images obtained with the VWA001 sensor through a 0.25 mm (0.010-in.) semi-rigid insulating sheet. Even though a drive-sense gap of 25.4 mm (1.0-in.) is relatively large for such a thin coating, the nominal coating thickness of approximately 0.25 mm (0.010-in.) was measured with the sensor. Similarly, Figure 47 shows property images obtained with the VWA001 sensor through a 12.7 mm (0.50-in.) semi-rigid insulating sheet of Neoprene rubber which covered the area far from the damage. The MWM array measured lift-off in this area of approximately 12.7 mm (0.5-in.), consistent with the nominal coating thickness. For both coatings, the region of mechanical damage appears as both an increase in the effective lift-off and increase in the relative permeability over a region that is several inches in diameter. The change in lift-off indicates that the depth of the damage is at least 25.4 mm (1.0-in.). This is not the true depth since the measurement grids assumed a planar material geometry and did not account for the geometry of the dent. However, based on other work, this depth is an underestimate of the actual depth of the damage. In the center of the flaw, the data no longer falls on the measurement grids and the property estimates are less reliable; this is most apparent in the 100 kHz data. On the left side of the mechanical damage there is a small decrease in the relative permeability that may be associated with residual stresses in the pipe wall. Thus, a larger wave length VWA sensor would be needed to map the lift-off at the center of this defect.

Figure 46. Effective property images obtained with a single pass of a VWA001 sensor with a 25.4 mm (1.0-in.) drive-sense gap and a 0.25 mm (0.010-in.) thick coating.

Figure 48 contains a plot of the effective lift-off for several channels with both coating thicknesses. Note that the channel number is indicated on the right side of each of the scan images in Figure 46 and Figure 47. Channels on the lower portion of the mechanical damage are plotted and show the gradual increase in lift-off associated with the damage. Channel numbers that passed over the center of the damage were not plotted since the data points over the center of the damage did not fall on the measurement grids and the property estimates are not robust. However, these plots show that the measurement procedure, with an air-calibration, correctly provides the nominal coating thickness and the shape of the plots of the mechanical damage are similar for both coating thicknesses. Note that in the future a larger wavelength sensor will be able to address measurements in the center region as well.
