Final Report

Department of Transportation Phase I SBIR Contract Number: DTRT57-09-C-10046

Digital Imaging of Pipeline Mechanical Damage and Residual Stress

David Jablonski, Ph.D., Principal Investigator
JENTEK Sensors, Inc.
110-1 Clematis Avenue
Waltham, MA 02453-7013
Tel: 781-642-9666
jentek@shore.net

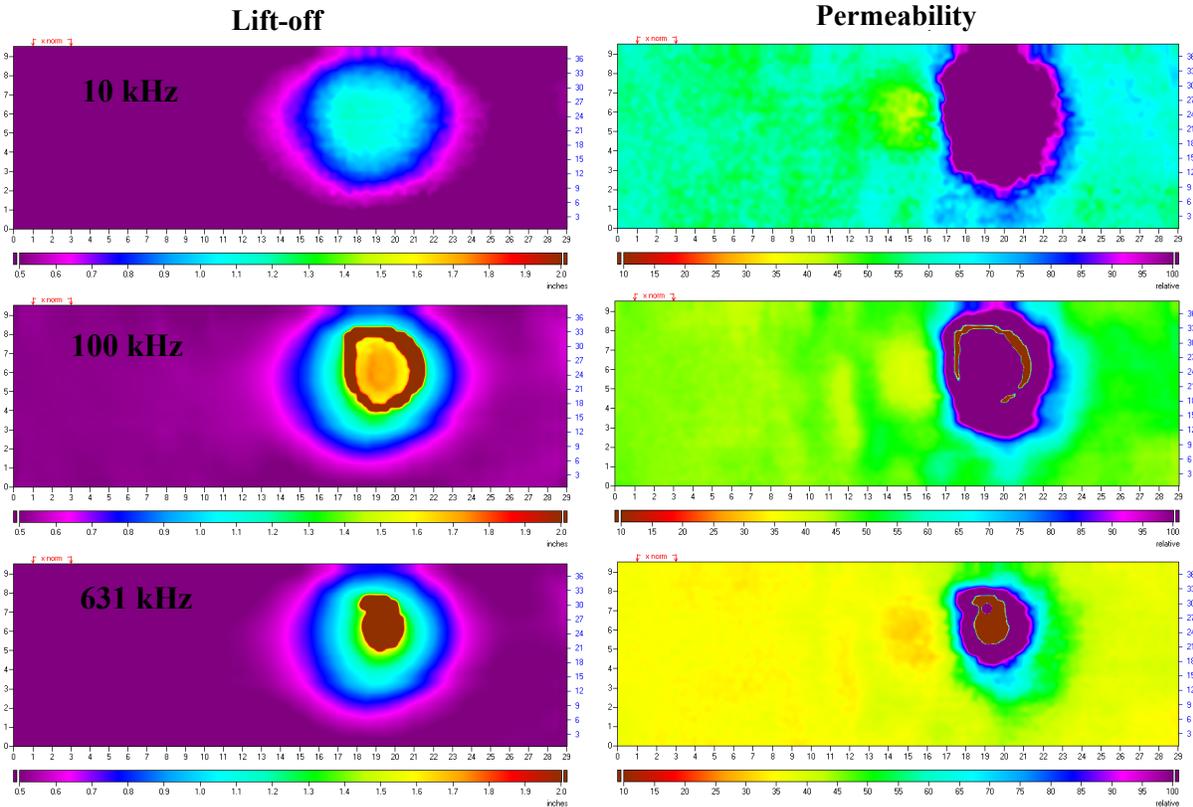
Figure 47. Effective property images obtained with a single pass of a VWA001 sensor with a 25.4 mm (1.0-in.) drive-sense gap and a 12.7 mm (0.50-in.) thick coating.

Figure 48 contains a plot of the effective lift-off for several channels with both coating thicknesses. Note that the channel number is indicated on the right side of each of the scan images in Figure 46 and Figure 47. Channels on the lower portion of the mechanical damage are plotted and show the gradual increase in lift-off associated with the damage. Channel numbers that passed over the center of the damage were not plotted since the data points over the center of the damage did not fall on the measurement grids and the property estimates are not robust. However, these plots show that the measurement procedure, with an air-calibration, correctly provides the nominal coating thickness and the shape of the plots of the mechanical damage are similar for both coating thicknesses. Note that in the future a larger wavelength sensor will be able to address measurements in the center region as well.

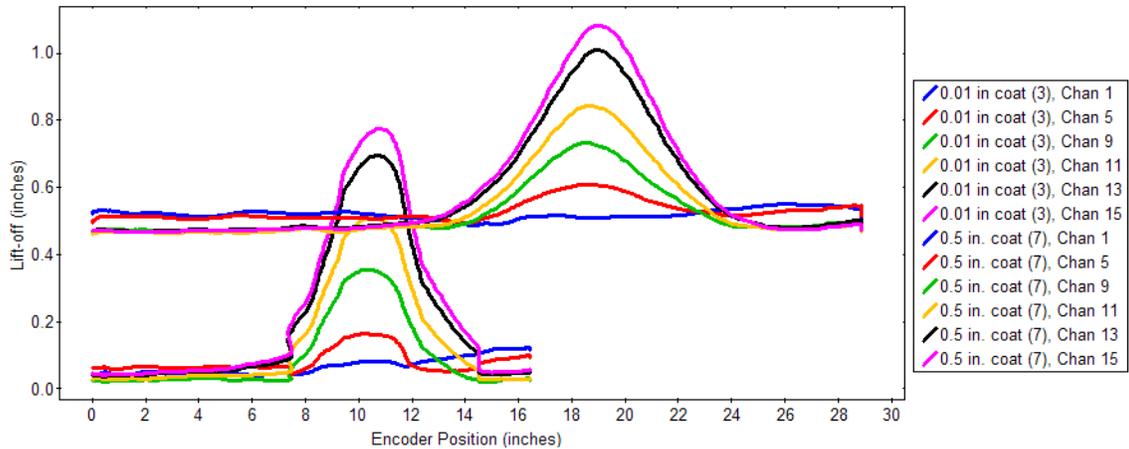
Figure 48. Effective lift-off plots for several channels for two coating thicknesses at 631 kHz.

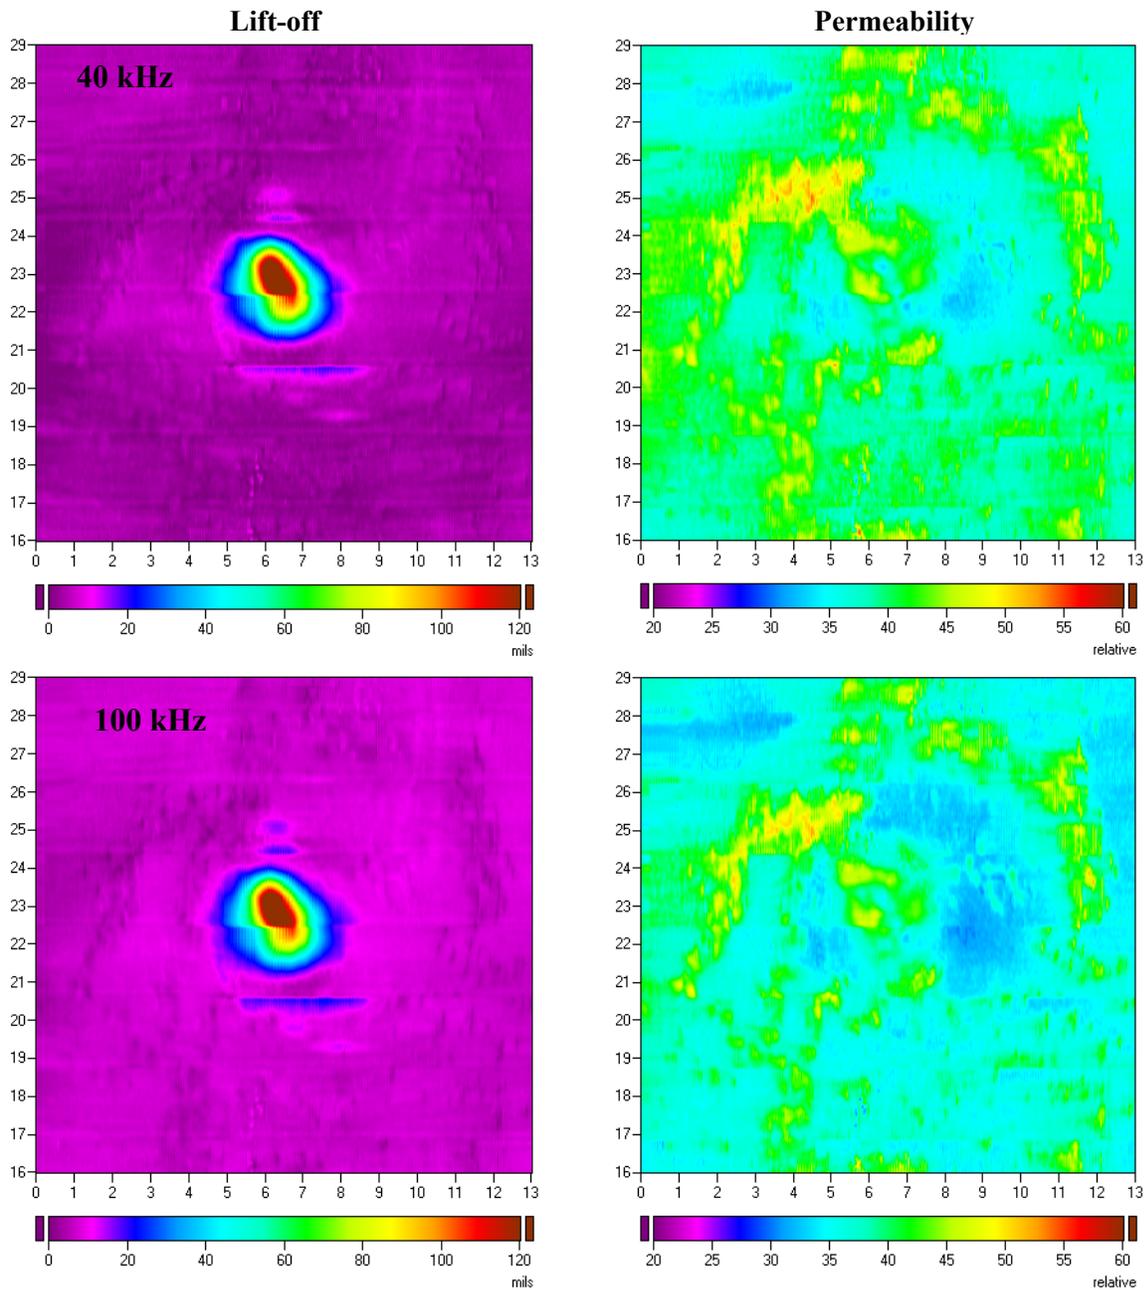
Figure 49 and Figure 50 show effective property images obtained for the axial FA24 sensor. For these scans, the sensor array was scanned in the opposite direction over the dent compared to the scans

performed with the VWA001 sensor. The effective lift-off is approximately constant at a low value of order 0.010-in. except in the vicinity of the central part of the dent. There appears to be some feature, such as surface roughness in the lift-off images, that is consistent with the observed surface finish on the pipe sample. The permeability images show a region of slightly elevated permeability values around the dent and low permeability values within the dent.

Figure 49. Effective property images obtained with eight (8) passes of an FA24 sensor over the plain dent on the 24-in. diameter pipe section. (Top) 40 kHz. (Bottom) 100 kHz.

Measurements were also performed with an FA24 sensor. For these measurements, Kapton tape was placed over the surface of the sensor to protect the sensor. A foam backing behind the sensor array allowed it to conform to the surface of the pipe wall. However, when the sensor array was mounted in the scanning cart, the edges of the cart hit the pipe and prevented the sensor array from conforming to the pipe wall. Consequently, the sensor array was removed from the cart and hand scanned over the surface. Assuming that the scan rate was constant, the measurement number corresponds to the position along the pipe surface. There was an overlap between scans of approximately one-half of the width of the sensor array for building the scan images.

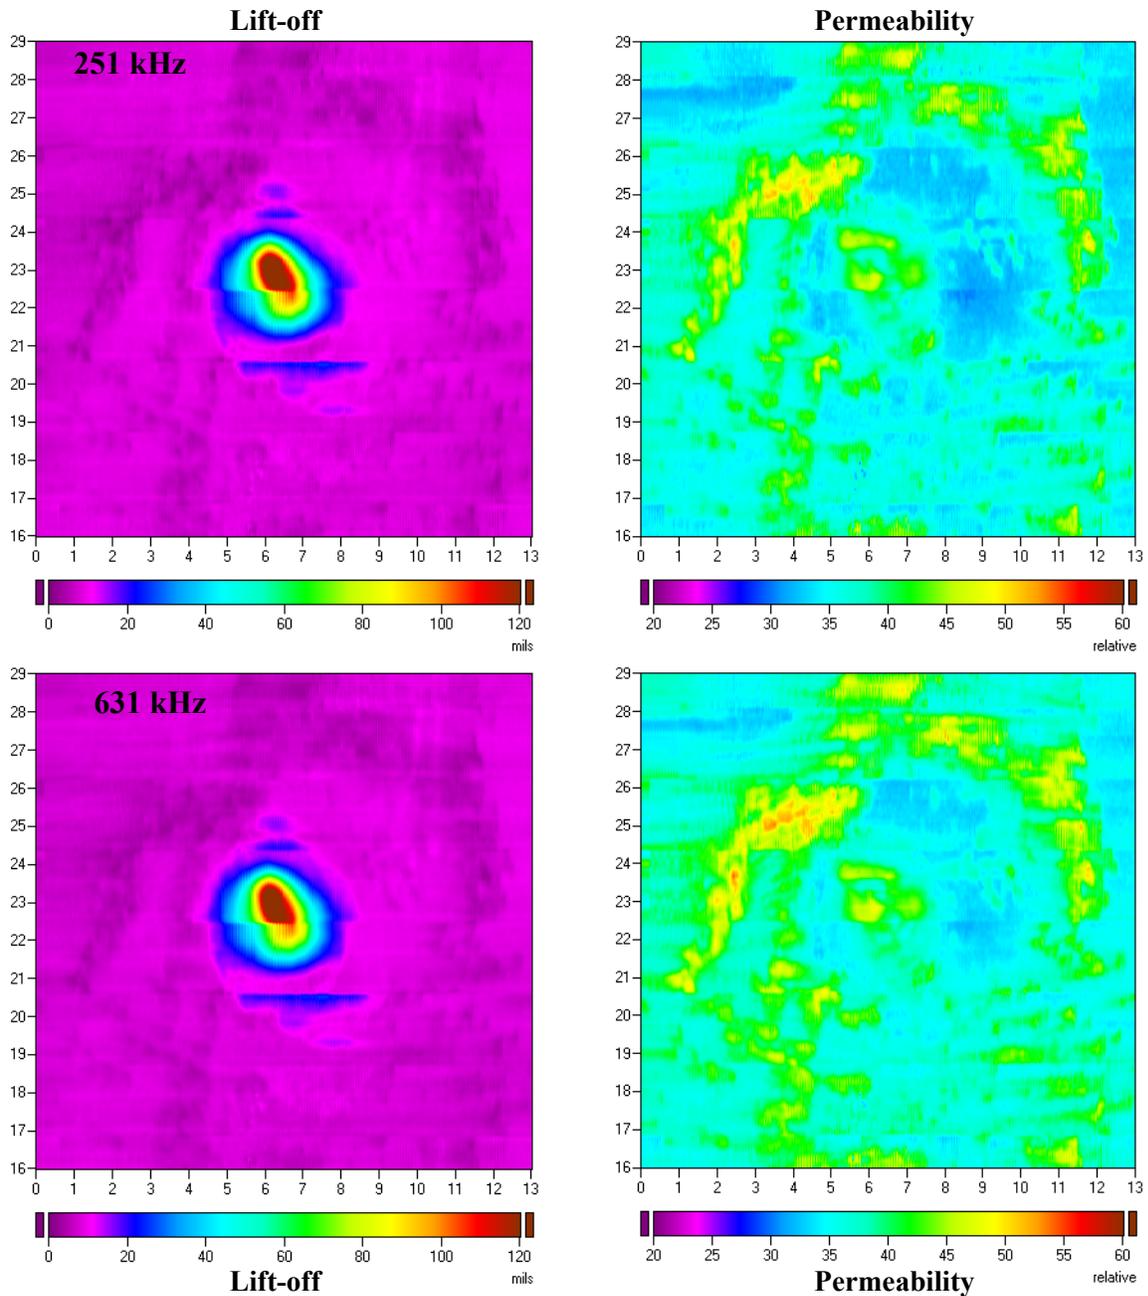
Figure 50. Effective property images obtained with eight (8) passes of an FA24 sensor over the plain dent on the 24-in. diameter pipe section. (Top) 251 kHz. (Bottom) 631 kHz.

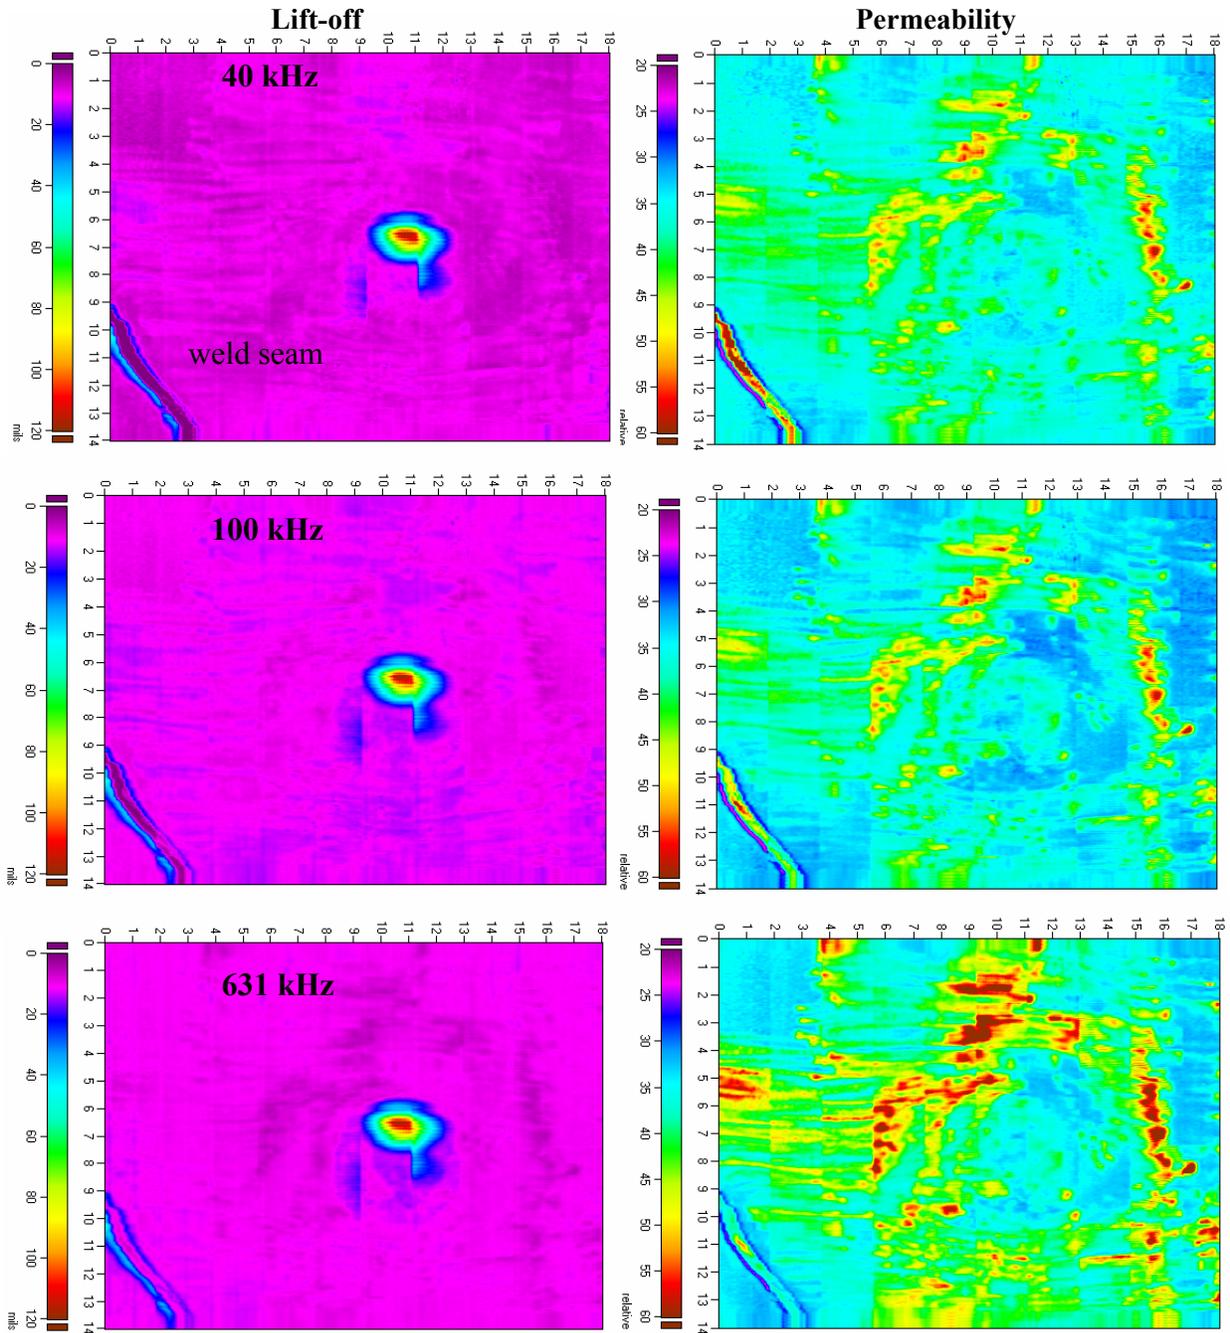
Another set of FA24 sensor measurements was obtained using circumferential scans. Again, the cart and position encoder were not useable and the manual-scans were assumed to be performed at a constant scan rate. Figure 51 shows the effective property images obtained for these scans. As with the axial scans, the effective lift-off is approximately constant except in the vicinity of the central part of the dent.

Figure 51. Effective property images obtained with several circumferential scan passes of an FA24 sensor over the plain dent on the 24-in. diameter pipe section. (Top) 40 kHz. (Top) 100 kHz. (Bottom) 631 kHz.

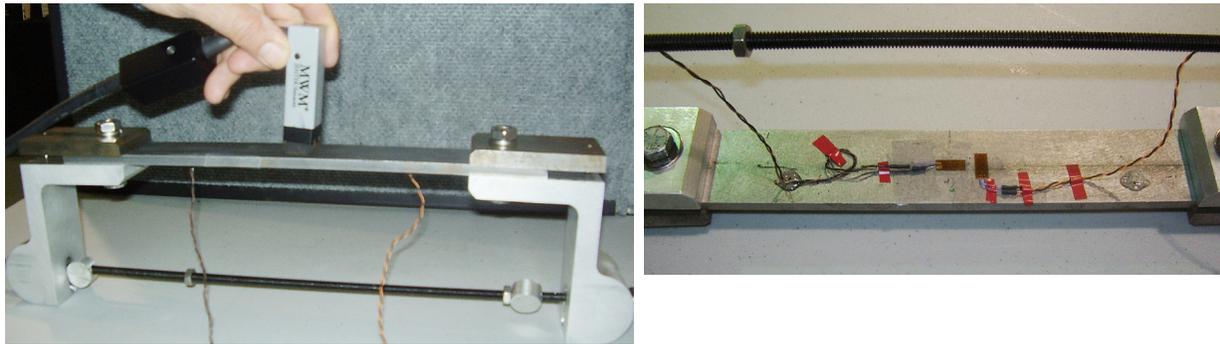
Bend specimens made from the ¼-inch thick plate material (4130 steel) that was used for the dent experiments (described previously) were placed in the bend fixture shown in Figure 52. Strain gages were mounted on one side of the specimen. The permeability was measured on the side opposite the strain gages using a single sensing element FS33 sensor (left). The strain was varied from 0 to 1200 μ -strain (approximately 35.5 ksi stress) in 200 μ -strain increments and then decreased back to zero at the same strain increment. The photo on the left of shows the permeability being measured on the tension side of the specimen. To measure the permeability on the compression side, the specimen was flipped and the permeability was measured on the bottom (compression) side of the specimens.

Figure 52. Photo of steel bend specimen showing MWM probe (left) measuring permeability and longitudinal and transverse strain gages (right) for measuring strain.

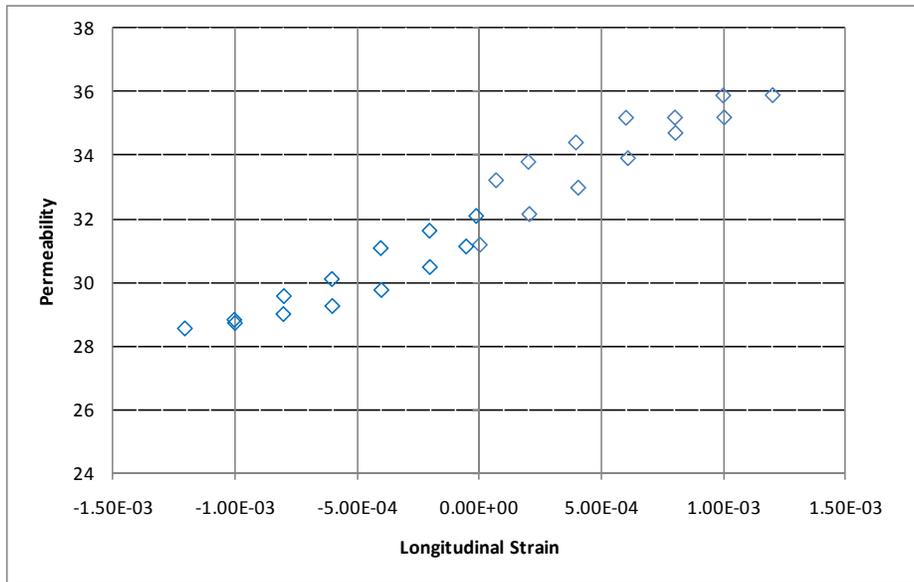
Figure 53 shows a plot of MWM measured permeability as a function of strain. The permeability increases with tension strain and decreases with compressive strain, as expected for low-alloy steels. The plot also shows there is hysteresis between the loading and unloading permeability measurements, which is expected.

Figure 53. Plot of permeability as a function of strain. Sensor was an FS33 and measurements are at 1 MHz.

The electro-magnetic properties of several steel plates were also measured for a variety of conditions. The measurements showed permeability increased with tensile strain and decreased with compressive strain. This was consistent with the permeability measurements made around mechanical damage sites such as dents. In the dented plates the center of the dent is in compression and the permeability was decreased from the baseline value. In the area adjacent to where the plates are supported during the denting process, the stress is tensile and the permeability is increased from the baseline value. We demonstrated that if these dented plates are annealed at a temperature of 650°C for 1-½ hours, the permeability approaches the values of the baseline un-dented specimen. However, there are still some geometric effects on the permeability values that are probably associated with the approach used to convert the sensor responses into effective properties. Future work could develop a procedure for compensating for these geometric effects on the permeability values.
