Composite Repair Technology and Its Application to Pipeline Integrity

Presentation to the PHMSA R&D Forum

Presentation by Dr. Chris Alexander (Stress Engineering Services, Inc.)

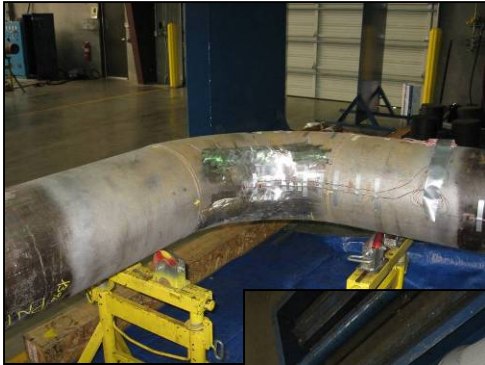
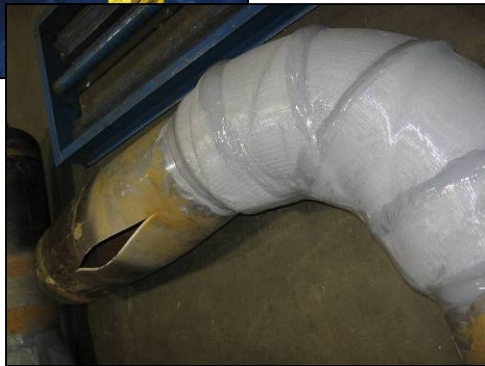
12-in STD Elbow (50% corrosion)

Results from Armor Plate Pipe Wrap test program involving 12.75-inch x 0.375-inch, Y52 elbow and tee pipe fittings with machined 50% corrosion –operating pressure is 1,778 psi

Unrepaired: 2,610 psi

Repaired: 4,625 psi

Failures in repaired fittings occurred outside repairs in base pipe.
(Composite thickness of 0.563 inches for both repairs)

Resulting design margin of 2.6+ for both repairs

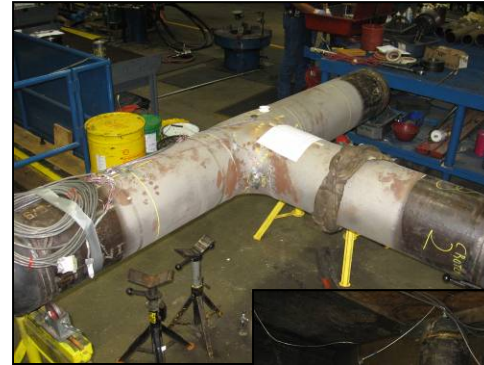
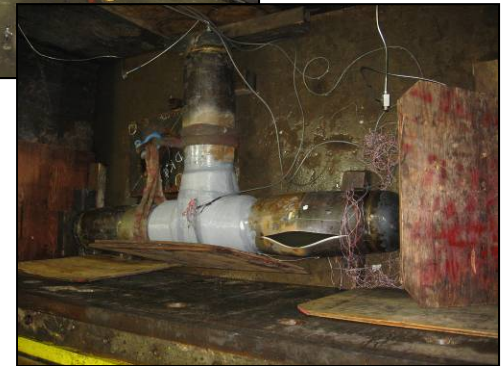
12-in STD Tee (50% corrosion)

Unrepaired: 3,059 psi

Repaired: 4,617 psi

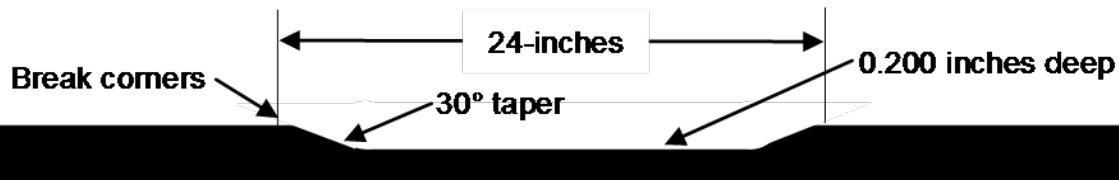
Testing Details

(Sample loading and defect configuration)

Simulated corrosion on outside surface of pipe (circumferential groove)

- Full-scale testing using 8.625-in x 0.406-in, Grade X46 pipe (representative D/t ratio for risers)
- Three test samples integrating 50% deep corrosion
 - 8-ft long Internal **pressure** sample (see NOTE)
 - 8-ft long Pressure and **tension**
 - 15-ft long Pressure, tension, and **bending**
- Strain gages installed in corroded areas on test samples beneath repairs
- In testing limit analysis methods used to capture the lower bound plastic collapse load

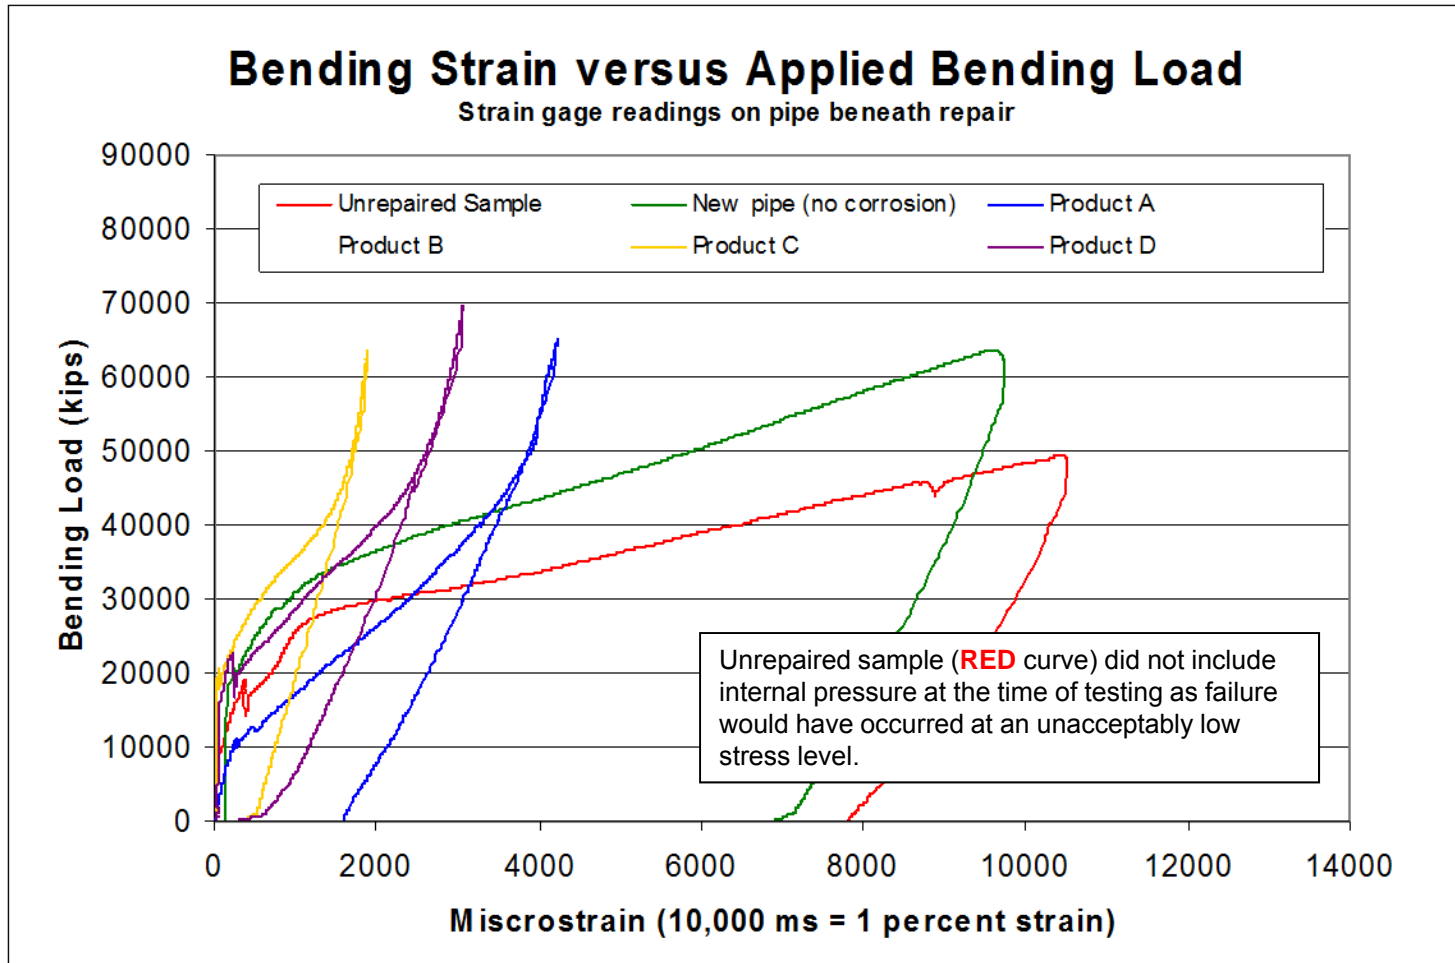
Test Results

(Bending load sample)

Testing loads included bending, tension (145 kips), and internal pressure (2880 psi)

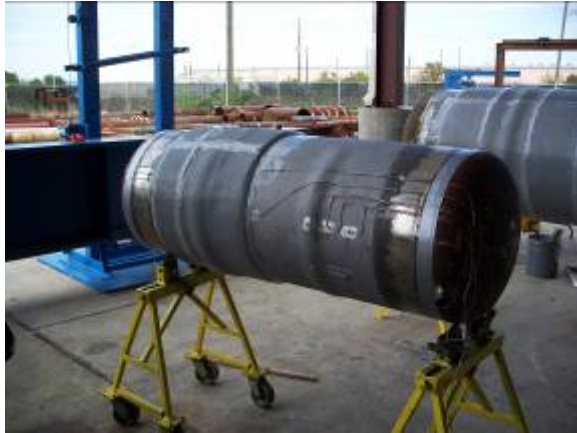
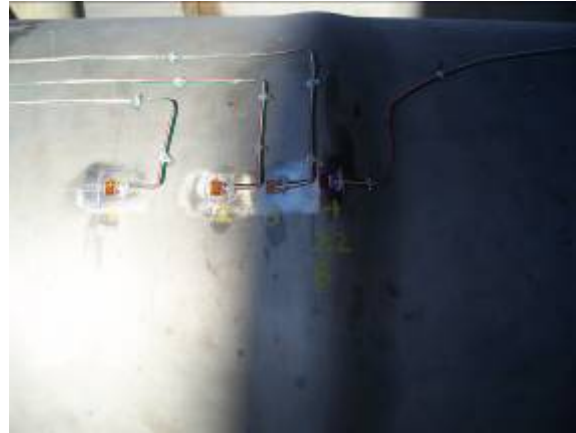
Wrinkle Bend Test Program (Photos from Test Set-up)

El Paso Wrinkle Bend Samples
(Samples EP22-1A and EP22-1B)

Sample	Condition	Peak of Wrinkle (Axial)		3 inches from Wrinkle (Axial)	
		De (me)	Dσ (ksi)	De (me)	Dσ (ksi)
EP22-1A (unrepaired)	Wrinkle in seam weld	1190	36	979	29
EP22-1B (repaired)	Wrinkle in seam weld	820	25	703	21
Percent reduction due to composite		31 percent		28 percent	
EP22-2A (unrepaired)		954	29	1096	33
EP22-2B (repaired)		757	23	868	26
Percent reduction due to composite		21 percent		21 percent	
EP30-1A (unrepaired)	40 percent corrosion	1960	59	1321	40
EP30-1B (repaired)	40 percent corrosion	1259	38	1213	36
Percent reduction due to composite		36 percent		8 percent
