CAAP Quarterly Report

Project Name: Selection and Development of Safer Polymer and Composite Pipeline Liners through Microstructural and Macroscopic Study of Materials and Designs

Contract Number: 693JK32250001CAAP

Reporting Period: Q6 (July 1 – Sep 30, 2024)

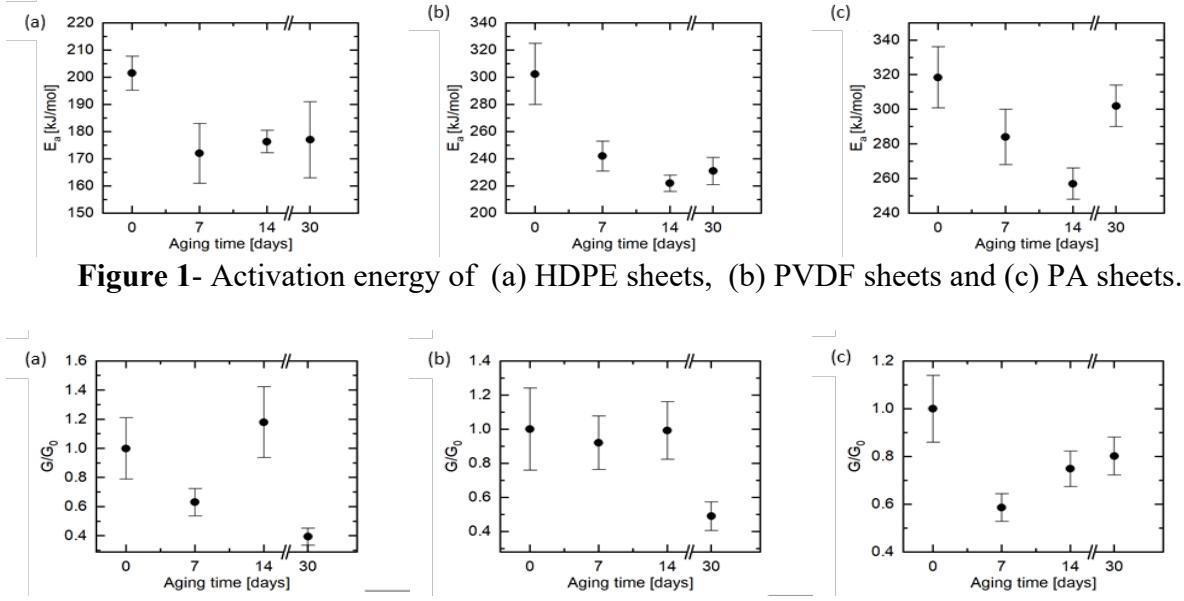
Figure 2 shows the elastic modulus of the aged samples. In contrast to activation energy, the modulus of the polymer samples fluctuated significantly. Therefore, using modulus changes may not be an appropriate method for tracking the property degradation of these polymer liners.

Figure 2- Elastic modulus (a) HDPE sheets, (b) PVDF sheets and (c) PA sheets.

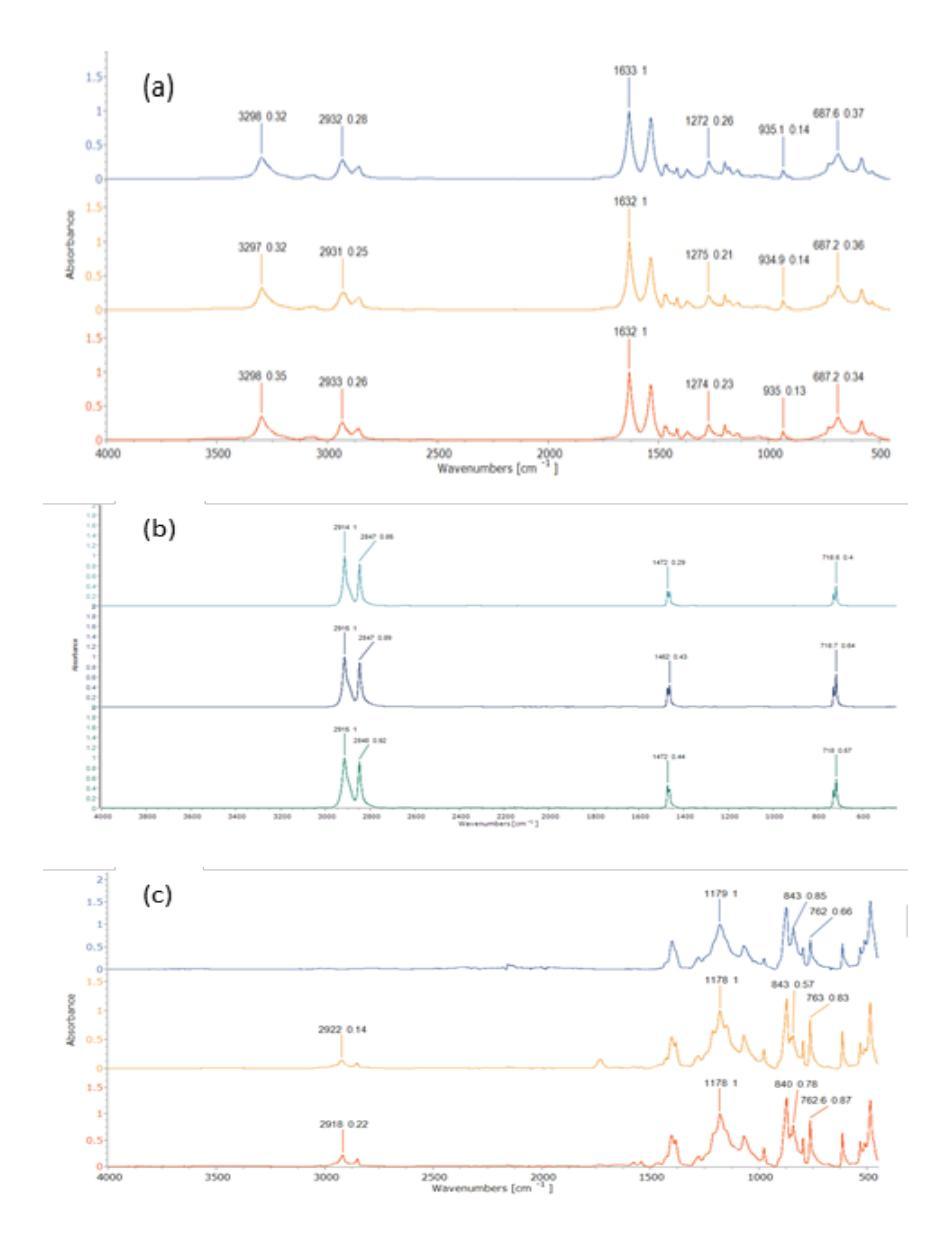
At Brown University, infrared spectroscopic analysis was conducted on Virgin, 1 Week and 2 Week Aged samples of PA, HDPE and PVDF, which can be seen in Figure 3. The polyamide used showed characteristic absorption peaks at 1632 cm⁻¹, 1535 cm⁻¹, and 1274 cm⁻¹ associated with the Amide I, Amide II, and Amide III bonds. The peaks seen at the other range of the spectrum at 3300, 3073, and 2933/2860 are associated with the Amide I, Amide B, and the C-H stretch. There are no notable changes in the intensities of the peaks, especially in the 2900-3000 region corresponding to the methane and ethane absorption bands if they were present in the sample. A similar peak profile is seen in HDPE with minimal changes in the 2915 and 2847 that correspond to the -CH stretch and the 1462 cm⁻¹ corresponding to the -CH scissor. In PVDF, we do see a significant change in several regions of the spectrum. The different spectrums were normalized to the 1178 peak, which corresponds to the CF₂ bond, acting as a constant. When normalized, there is a noticeable peak near 2920 cm⁻¹ that is only seen in the aged samples. This peak could correspond to the potential absorption of the hydrocarbons used in the aging process. Additionally, the peaks seen at 762 and 840 correspond to two distinct crystalline phases, specifically the alpha and beta, respectively, that show changes in intensity. The relative amounts of each phase were calculated from the intensity measurements and shown in Figure 4

Figure 3- FTIR of (a) PA, (b) HDPE and (c) PVDF. In each subfigure, top row- virgin, middle row- 1 week aged, bottom row- 2 week aged.

Previous testing showed changes in materials that were established by x-ray diffraction. This method is impractical in the field with XRD machines being bulky and immobile. If similar measurements can be made with an FTIR, which is a significantly more mobile tool, it is possible detect phase content changes that may be precursors to mechanical failure in the field.

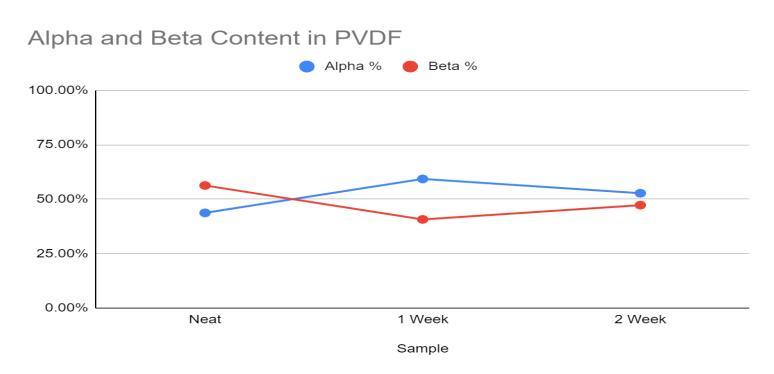
Figure 4- Alpha and Beta phase content of virgin and aged samples of PVDF.

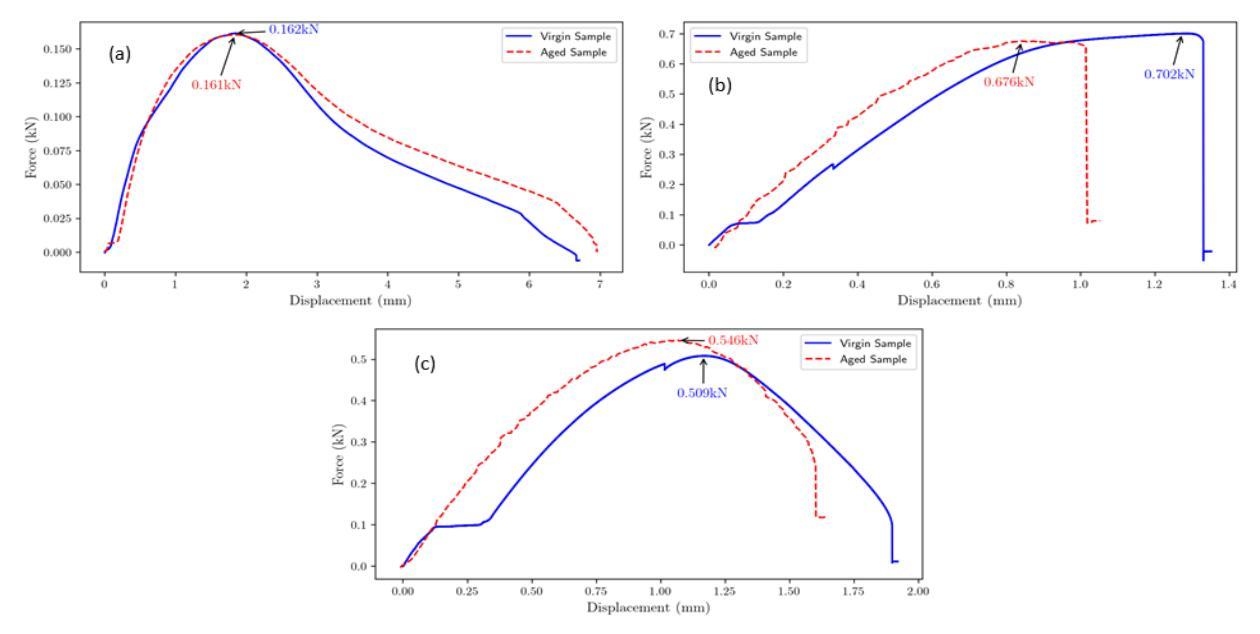
Figure 5- Force vs. Displacement curve for cracked virgin and 1 week aged (a) HDPE, (b) PA and (c) PVDF.

In Figure 5(a), for HDPE, we can observe that in the early stage of loading until the peak load, the force-displacement response of the virgin and the aged sample are very close. However, after the peak load, the virgin sample fails before the aged sample. In Figure 5(b), we can observe that in the early stage of loading, the aged sample shows a stiffer response than the virgin sample. The aged sample fails much before the virgin sample, with a peak load less than that sustained by the virgin PA sample. The sharp drop in force as the crack propagates indicates that the fracture is brittle in nature for both the virgin and aged samples. In Figure 5(c), we observe that the virgin PVDF sample experienced some slipping during the tensile test. Therefore, comparing these two curves might lead to wrong conclusions regarding the difference in strength or the peak load sustained by the virgin and the aged sample. Hence, we need to repeat this set of experiments. However, the drop in the force follows the same trend in both the virgin and aged samples.

Tension tests on cracked aged (aging condition: NG1-90C-243 psi-14 days) HDPE, PA and PVDF samples were also performed at Brown University. The uniaxial tension tests were conducted at a constant strain rate of 0.0005s⁻¹. The microstructural differences of the fractured surfaces were investigated under a Scanning Electron Microscope (SEM). The results are compared with virgin samples obtained in the last quarter.

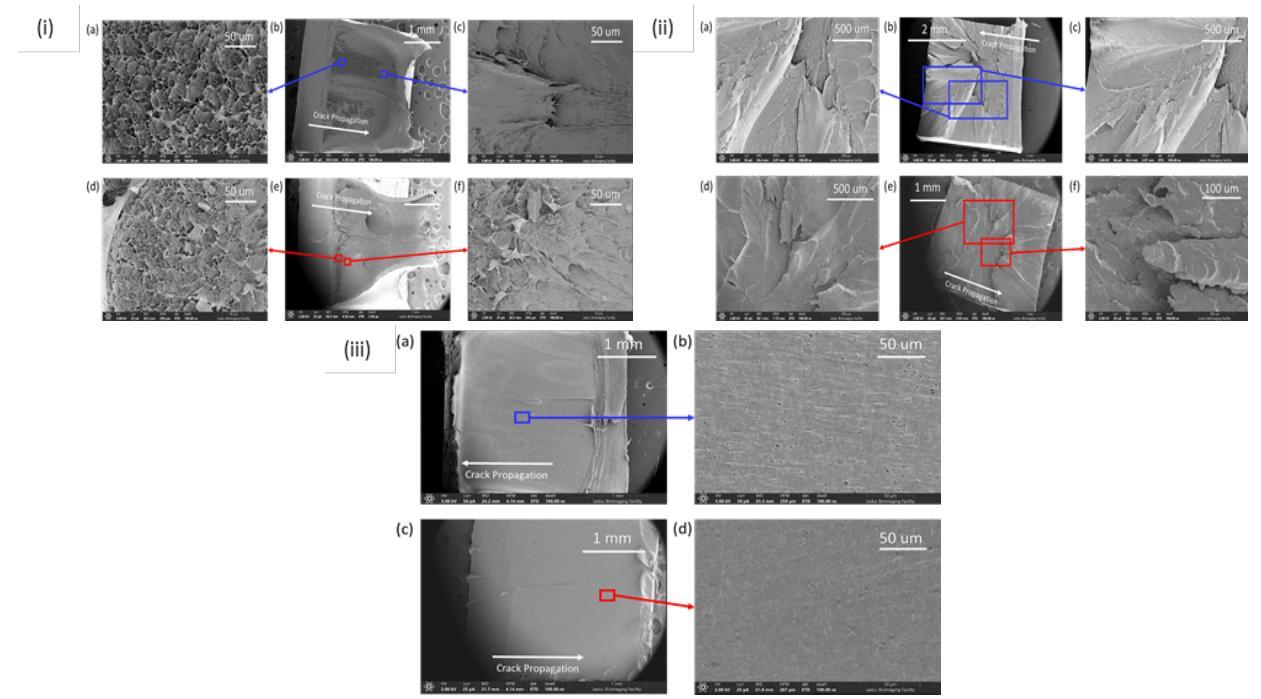
In Figure 6(i), we present the fracture morphology of the cracked virgin HDPE sample (1st row) and aged sample (2nd row). In Figures 6(i)(a) and 9(i)(d), we can observe that the surface near the initial crack tip is characterized by short fibrils and voids. Such short fibrils, accompanied by voids, characterize a craze-like failure. Crazing is often associated with brittle-like failure. Figures 6(i)(c) and 6(i)(f) show that as the crack progresses, the fibrils get stretched out, resulting in a final ligament. This is an indication of a brittle to ductile transition as the crack propagates. In Figure 6(i)(e), it can be seen that the craze-crack mechanism quickly transitions to a shear-yielding mechanism characterized by the dimple pattern, which indicates ductile failure. We can distinguish that the crazing mechanism of failure is more dominant in the virgin sample than in the aged sample. Hence, this results in the early failure of the virgin sample compared to the aged sample.

In Figure 6(ii), we present the fracture morphology of the cracked virgin PA sample (1st row) and aged sample (2nd row). Qualitatively, we don't see any distinct difference in the features of the fracture surface. In Figure 6(iii), we present the fracture morphology of the cracked virgin PVDF sample (1st row) and aged sample (2nd row). We don't observe a significant macroscopic difference in the morphology of the virgin and aged PVDF samples.

Figure 6: SEM images of the fracture surface of (i) HDPE - virgin (1st row), aged (2nd row), (ii) PA - virgin (1st row), aged (2nd row) and (iii) PVDF- virgin (1st row), aged (2nd row)
