FINAL PROJECT SUMMARY REPORT

Midé Technology Corporation
200 Boston Avenue
Suite 1000
Medford, MA 02155 | 2. <u>DOT SBIR PROGRAM</u>
2003 PHASE I | 3. <u>DOT CONTRACT NUMBER</u>
DTRSS7-04-C-10016 |

-
5. PROJECT TITLE
PIEZO STRUCTURAL ACOUSTIC PIPELINE LEAK DETECTION SYSTEM

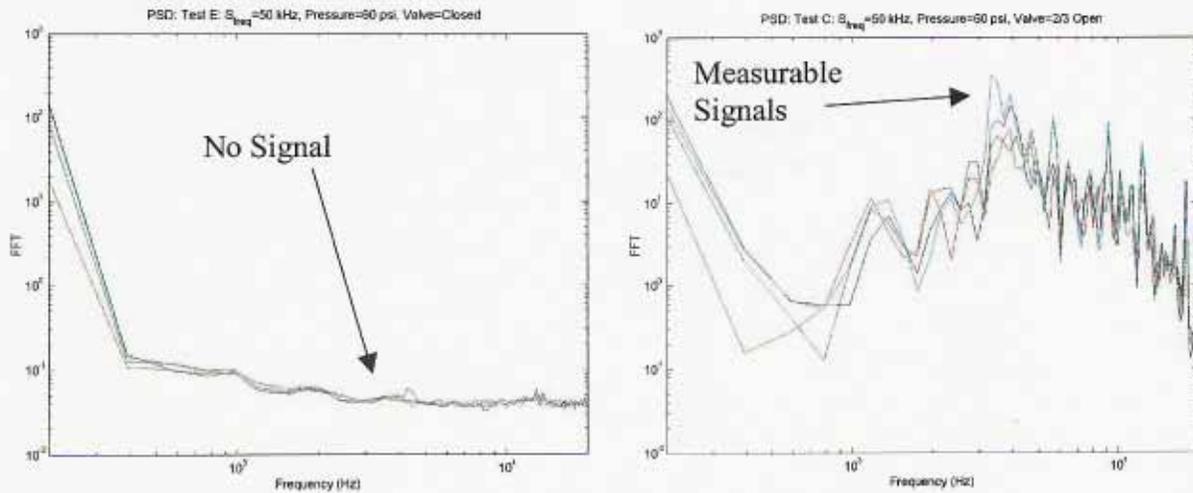
This figure illustrates the difference in Midé's PowerAct™ sensor' output when there is no leak in the pipe(left) and when a leak is present (right)

- Data was captured from a desktop signal-conditioning device. (Section 2.3.3)
- FFT analysis on the captured data illustrated that the location and intensity of the leak can be observed while employing the sensors. The figures below illustrate the frequencies that are picked up by the sensors when there is no leak (left) and when a ball valve is 2/3 open with 60 psi of air in the pipe. (Section 2.3.3).

- Results indicate that the location and magnitude of the leak can be determined by integrating the energy output from the sensors at specific frequencies. (Section 2.3.3)
- An FEA model of the test setup was constructed. (Section 2.3.4)
- The FEA model was validated with the experimental results. (Section 2.3.4)
- The FEA model indicates that the pipe's higher natural frequencies are only marginally affected by boundary conditions. It easily follows that experimental results in air (above ground) may reasonably approximate system performance below ground. (Section 2.3.4)

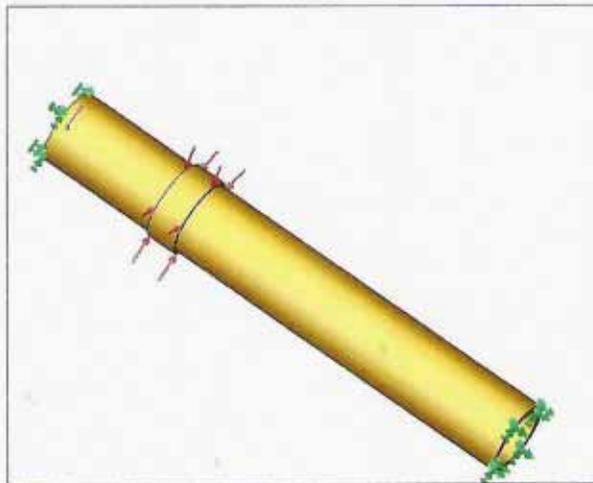
Figure 1: Model for initial pipe modal investigation.

A FEA frequency analysis was performed for a simple pipe being subjected to a radial pressure (Figure 1). Since the primary purpose of the exercise is to visualize the vibration modes that may be seen in a pipe, no dimensions or material properties will be given. The pipe is fixed at the ends, and the pressure is applied at some distance along the pipe. The first thirty modes are shown in Appendix A. Shown in Figure 2, is a typical result. Appendix A shows all thirty modes. As will be evident by the figures, there are many pairs of matching vibration modes. The modes, shown in increasing order, ranged from 1.5 to 12 kHz. As soon as a characteristic pipe is defined, this analysis will be performed again to match pipe dimensions and material properties with the resonant pipe frequencies.

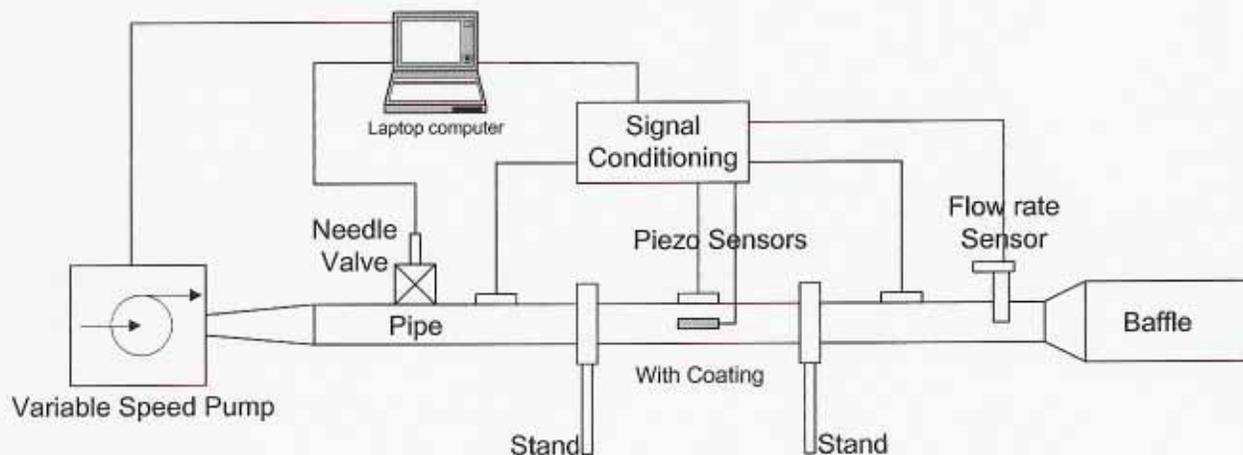
Figure 3: Concept for the desktop demonstrator.

A test and desktop demonstration concept was presented to the technical monitor for approval. The concept is shown in Figure 3. The system consists of the following:

- Variable Speed Pump
- Pipe
- Baffle for noise control
- Needle Valve
- Flow Rate Sensor
- Supports
- Piezoelectric Sensors
- Signal Conditioning Unit
- Laptop Computer with AD/DA capability

The laptop computer will control the speed of the pump and the opening of the needle valve. These two variables will determine the rate of the leak. The piezoelectric elements will sense the leak, their output voltage determined by the intensity of the leak and their proximity to it. These signals, as well as a flow rate sensor signal, will be conditioned and transmitted to the laptop for visual display. The operator will be able to change the speed and the size of the orifice from the laptop and immediately see the effect on the sensors.

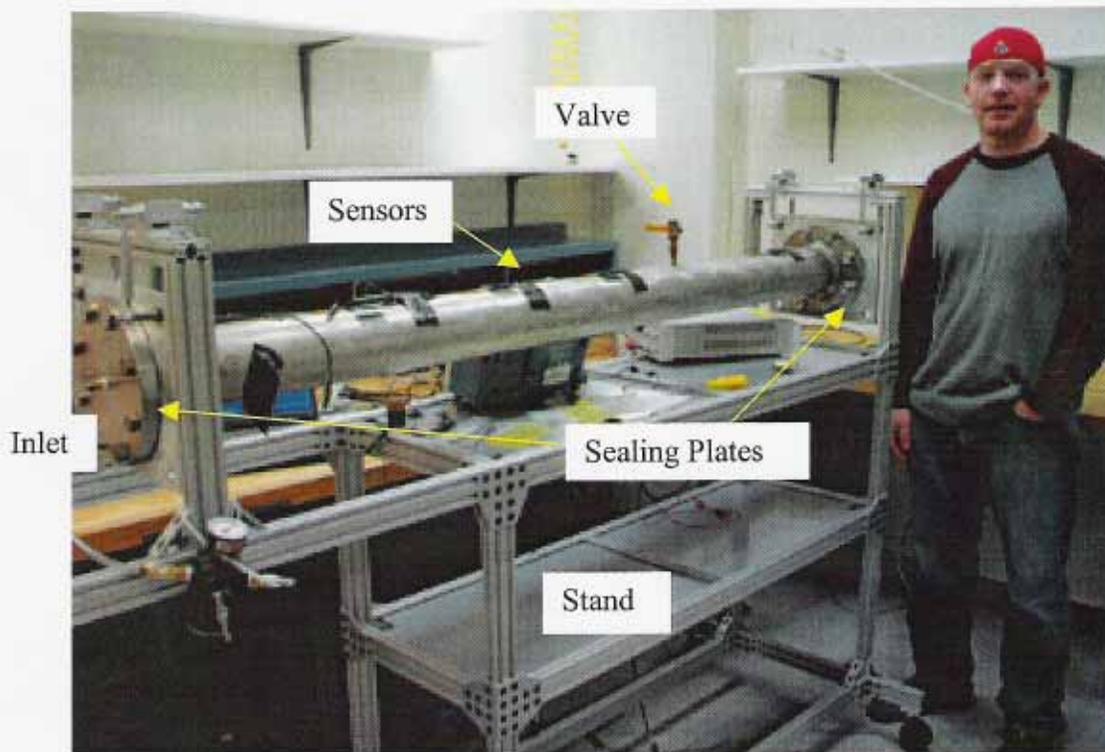
Figure 4: The test pipe section. The inlet tube connects the pipe to the regulated air while the sealing plates ensure that the outlet valve produces the only leak. The location of the sensors and the portable stand is also shown.

Figure 4 shows the laboratory test pipe section. The test setup consists of a 6' stainless steel pipe section of 4" ID. The pipe was sealed on both ends with sealing plates. One of the sealing plates has an inlet for air. A hole was drilled and taped and a valve placed 2 ft from the other sealing plate.

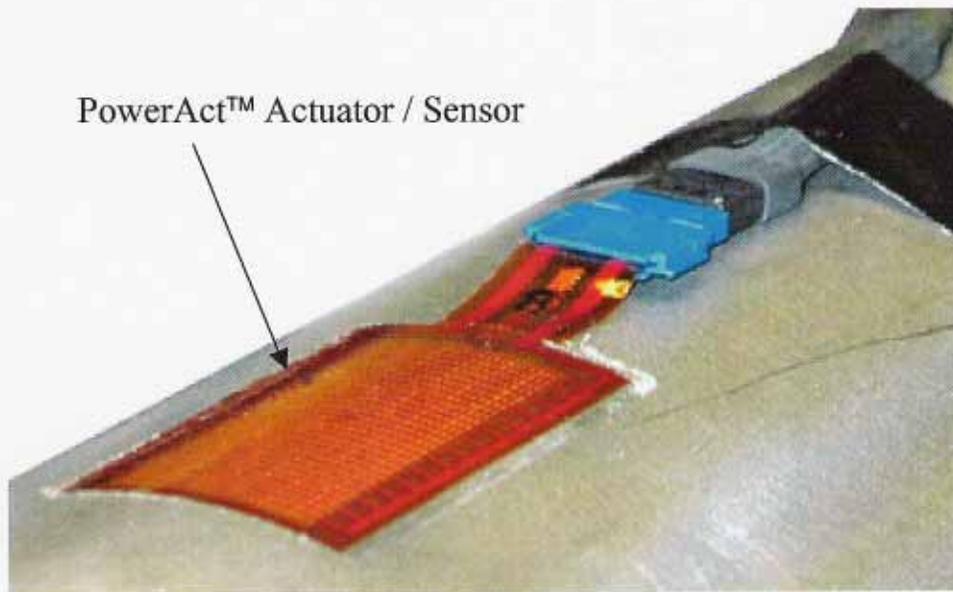
Four PowerAct™ actuators / sensors were vacuum bonded, equally spaced from the outlet. Figure 5 shows the PowerAct conforming to the pipe radius. Also shown in the Figure is the connection from the PowerAct

connector to a BNC cable. These BNC cables transfer the signal from the PowerAct to the sensing electronics.

Figure 5: Close-up of PowerAct™ Actuator / Sensor as bonded on to the test pipe section.

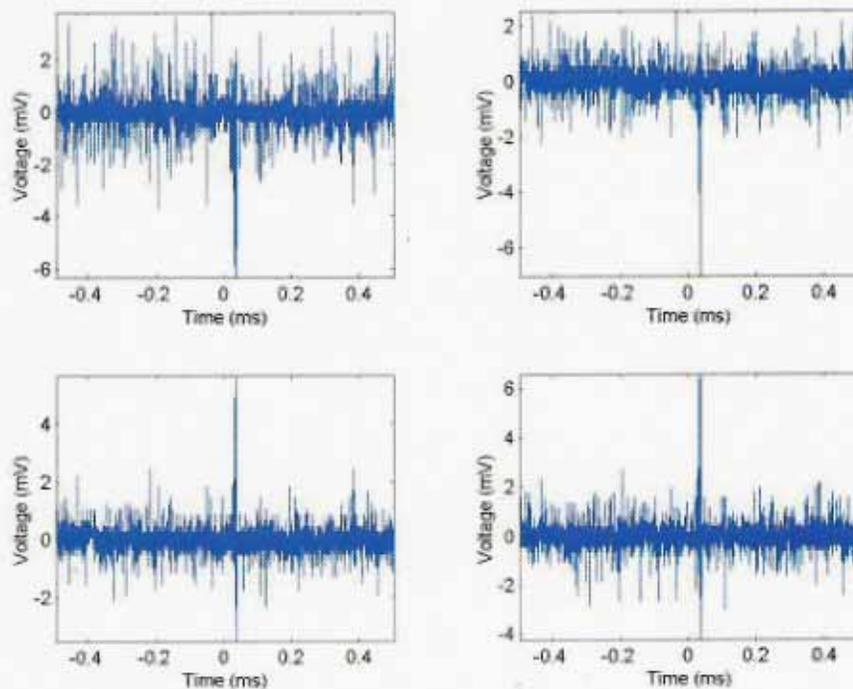
These tests were conducted in order to determine how the sensor's output correlated with various degrees of leakage. A manual needle valve was placed between PowerAct™ 3 and 4 and used to change the flow rate from the pressurized pipe. The sensor response to these events was recorded as before. The pipe was pressurized to 90 psi and three readings were taken: valve fully closed, half open and fully open. The results of these three tests are depicted in Figure 10 to Figure 12.

Figure 10: Data traces from the PowerAct™ sensors with 90 psi pressure and the pipe completely sealed. Traces are from left to right top to bottom, from sensor numbers 1,2,3,4.

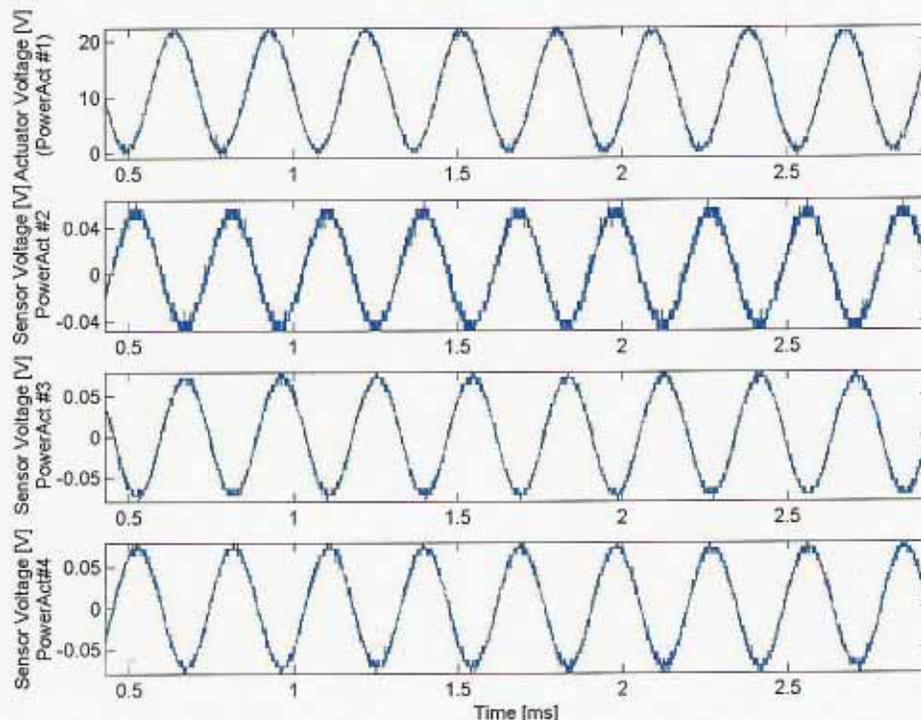
These tests aimed at proving feasibility of transferring data down the pipe, actuator to sensor, one to the next. Please note the dual functionality of the PowerAct™: sensing and actuation, is a significant cost saving tactic. The tests were performed by actuating the left (#1) PowerAct™ and measuring the response of the other PowerAct™s. The result of this test is shown in Figure 13

Figure 13: Result of the data transfer test. The trace on top is the input signal to the actuator, PowerAct™ #1. The following traces are the measured response from the other piezo actuators, used as sensors. All the Sensors produce the same signal amplitude, but with a phase shift.

The input signal is 10V p-p and the responses around 50 – 60 mV. It is interesting to note how “clean” the signal is. There is another high frequency mode on top of the approximately 3.5 kHz signal. This high frequency noise can be filtered with little effort and should not pose a problem for the data transfer.

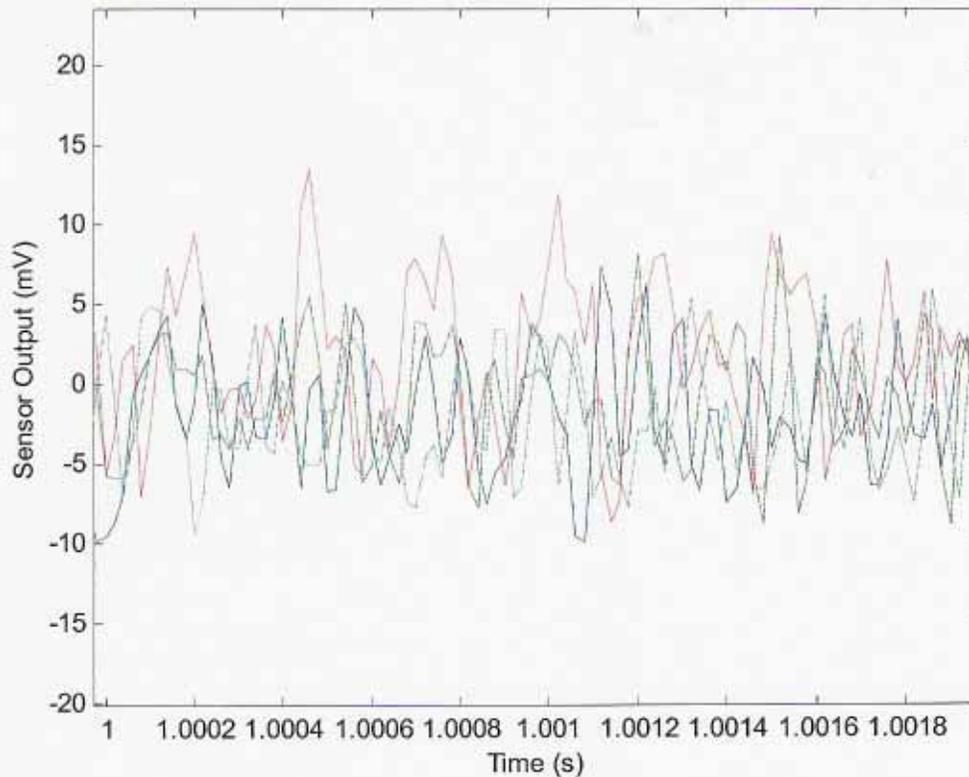
A sample of the raw data traces collected by the LabView™ program had is shown in Figure 14. The leaking air exits multiple frequencies at different amplitudes in the pipe. The logical next step in the data collecting process was to convert these time domain traces into frequency domain traces by means of an FFT algorithm.

Figure 14: Sample of a LabView™ data trace for one of the tests. Sensor 1 = blue, Sensor 2 = green, Sensor 3 = red, Sensor 4 = cyan.

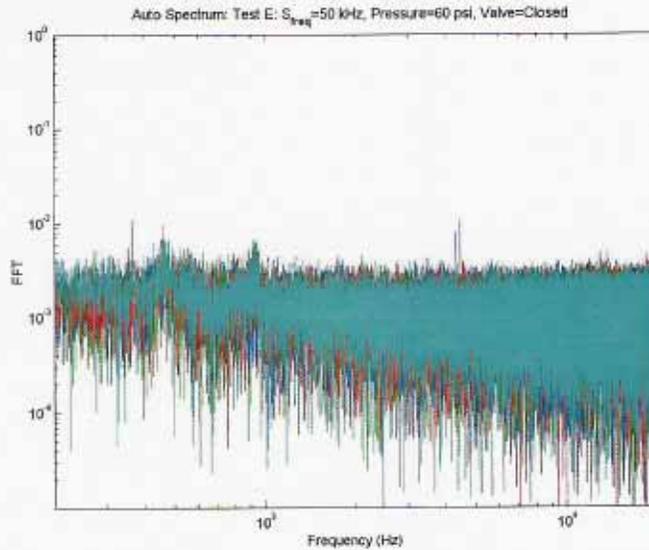
Figure 15: FFT (Auto Spectrum) of the sensor outputs when the pipe is at 60 psi and the valve is completely shut.

Figure 16: Power Spectral Density of the sensors when the pipe is at 60psi and the valve is completely shut.

When we compare Figure 16, when the valve is shut, with Figure 18, when the valve is a third open, it is clear that energy is produced in the sensors by the leak. Not only are there multiple resonant frequencies, but also the amplitude of the signal had risen by two orders of magnitude. If we compare Figure 18 with Figure 20, we see the same resonant frequencies and that the magnitude of the sensor output has increased. This clearly illustrates the ability of the PowerAct™ sensors to detect the leak and its magnitude.

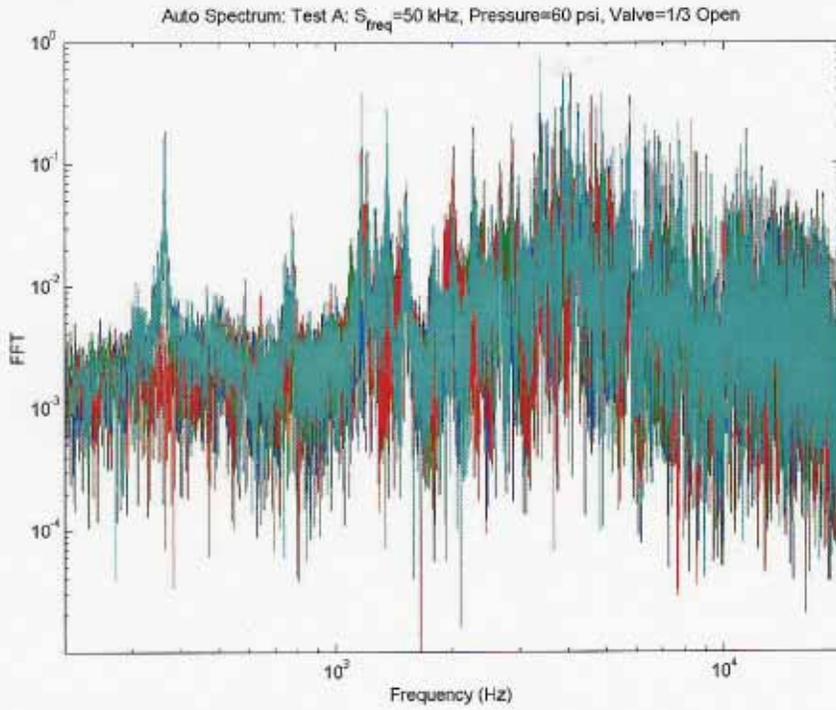
Figure 17: FFT (Auto Spectrum) of the sensor outputs when the pipe is at 60 psi and the valve is 1/3 open.

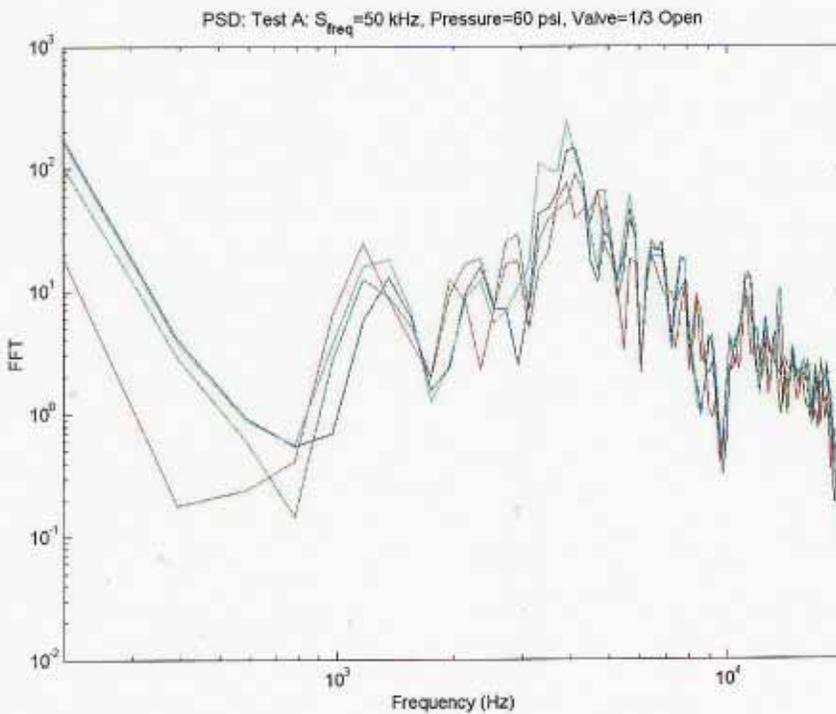
Figure 18: Power Spectral Density of the sensors when the pipe is at 60psi and the valve is 1/3 open.

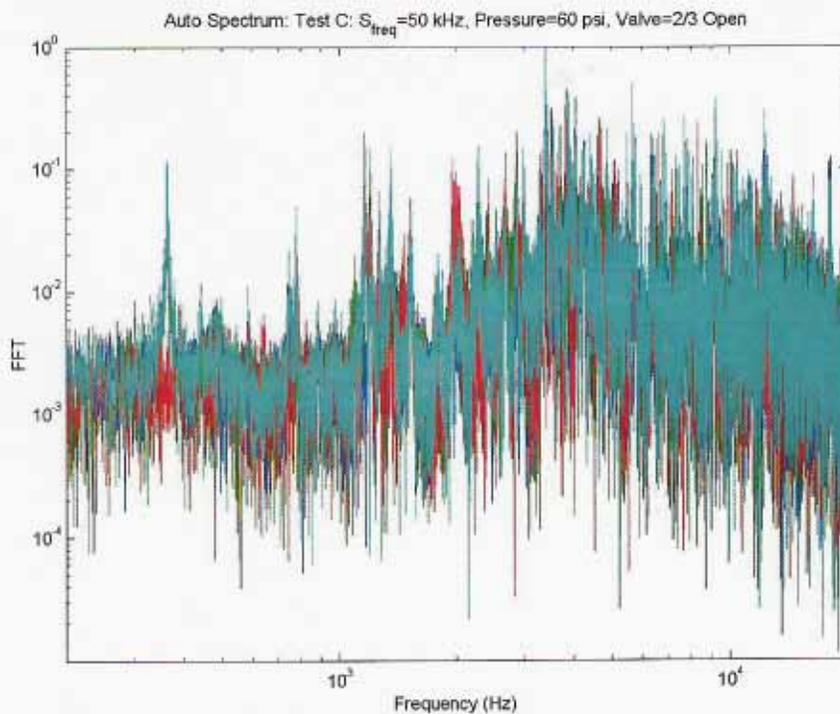
Figure 19: FFT (Auto Spectrum) of the sensor outputs when the pipe is at 60 psi and the valve is 2/3 open.

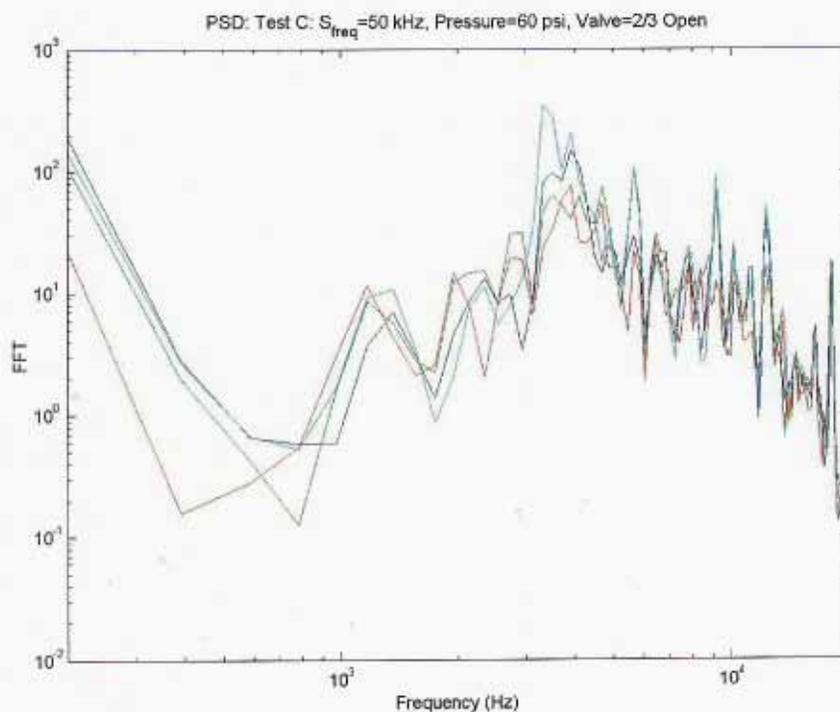
Figure 20: Power Spectral Density of the sensors when the pipe is at 60psi and the valve is 2/3 open.

It is interesting to compare Figure 29 with Figure 20. As stated earlier, the dominant resonant frequencies of the test setup was determined to be at 362 Hz, 757 Hz, 1168 Hz and 4 kHz. These frequencies also clearly show up in Figure 29. It is thus concluded that the FEA analysis is a close approximation of the real test setup and that the model can be used for design purposes.

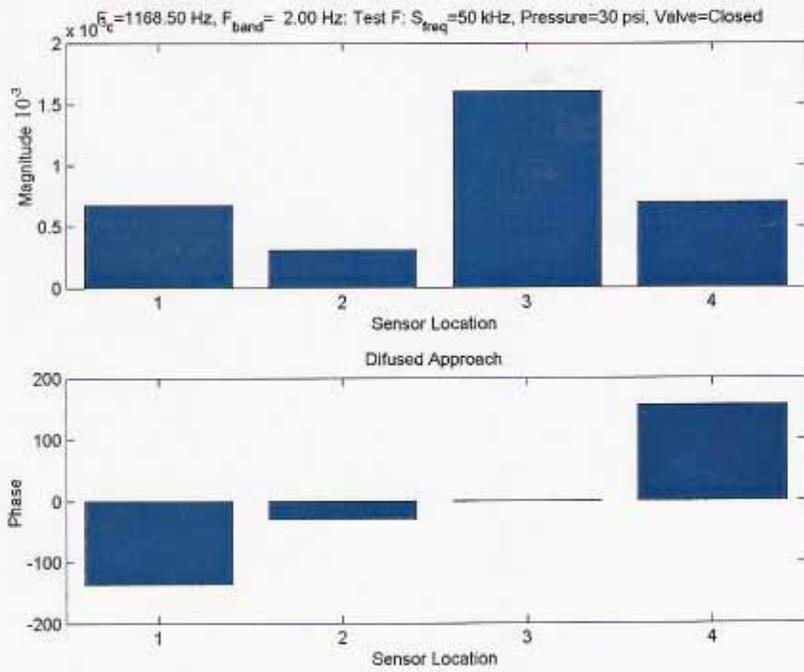
Figure 21: Integrated signal magnitude (top) and phase shift with respect to sensor 3 (bottom) at 1.168 kHz for pipe pressure at 30 psi and valve closed.

For the case where there is no leak, the amplitudes are below .002 (Figure 21), about an order of magnitude lower than any one of the leak tests (Figure 22 and Figure 23.) In all these tests, the maximum amplitude was near Sensor 3. In most cases the next strongest output is from Sensor 4, indicating the leak is between these two sensors.

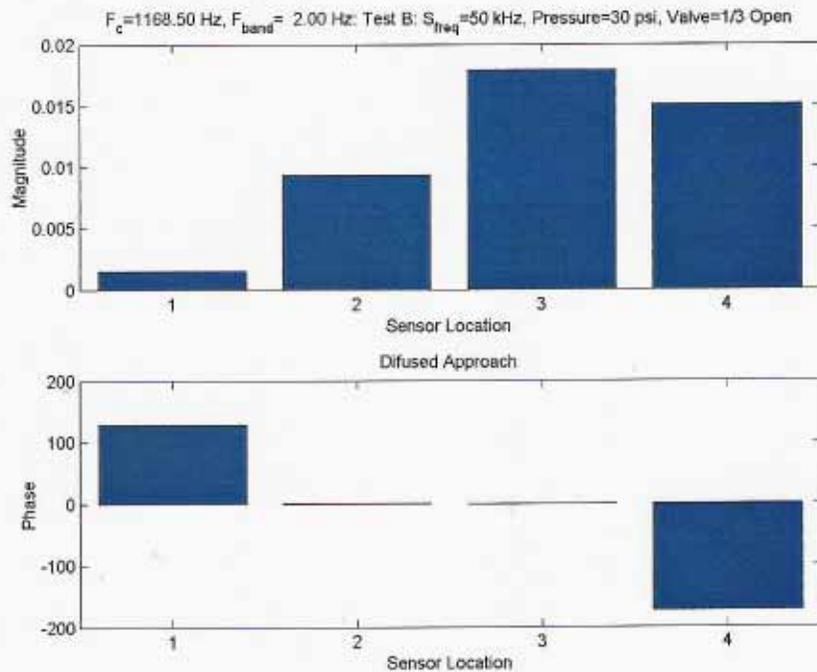
Figure 22: Integrated signal magnitude (top) and phase shift with respect to sensor 3 (bottom) at 1.168 kHz for pipe pressure at 30 psi and valve 1/3 open.

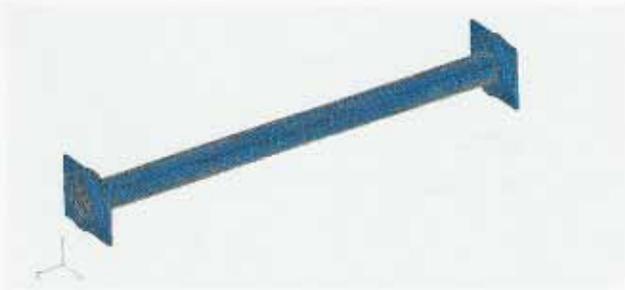
An FEA model was created in NASTRAN and is shown in Figure 27. The model consists of 2874 nodes and 2892 quadrilateral plate elements. This model in the free-free end condition is used to compare and corroborate test results.

Figure 27: FEA model of the test article as created in NASTRAN. The model consists of 2874 nodes and 2892 quadrilateral plate elements.

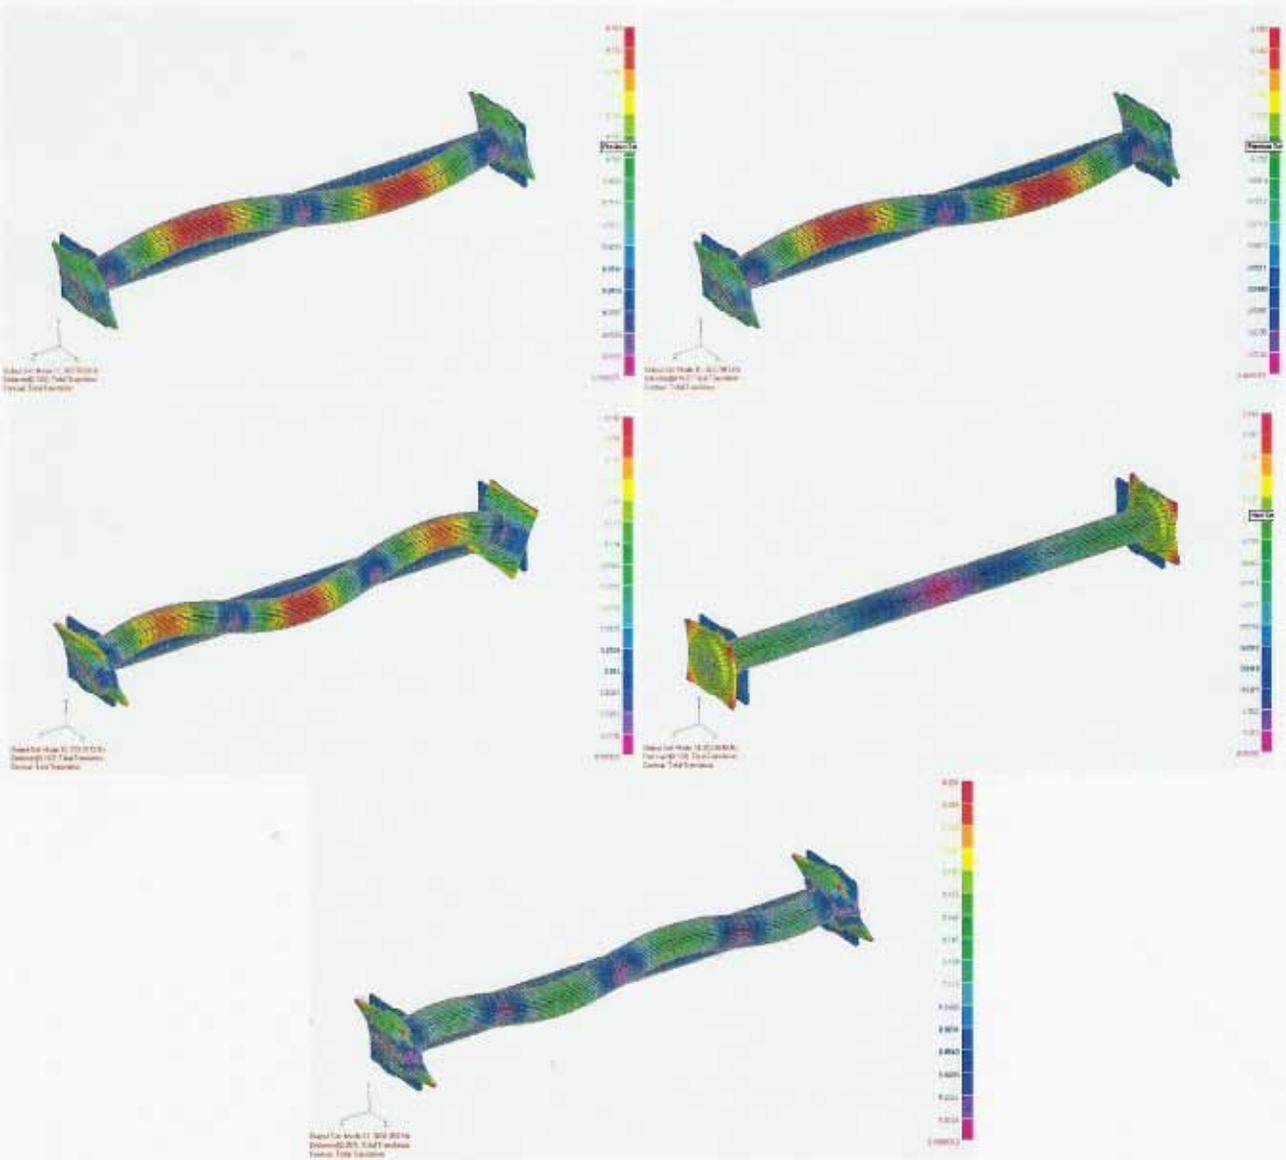
Some of the modal results are shown in Figure 28. It is interesting to note that both string and radial vibrations contribute to the modes present in the pipe. Further analysis and modeling will be performed in the follow on contract. One of the tasks will be to instrument a pipe that is currently being used and compare the actual results with the predicted results of these models.

Figure 28: Results of the free-free FEA analysis. The modes from left to right, top to bottom are 359.5 Hz, 362.8 Hz, 708.3 Hz, 812 Hz and 1,091 Hz.

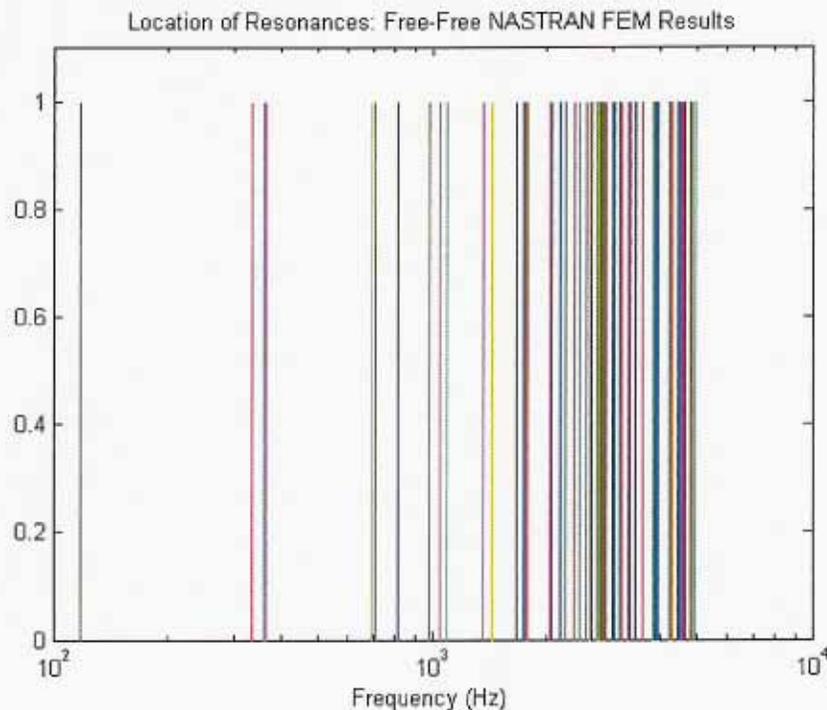
Figure 29: FEA results of free-free modal calculation. Note the number of resonances at the 4 kHz range.

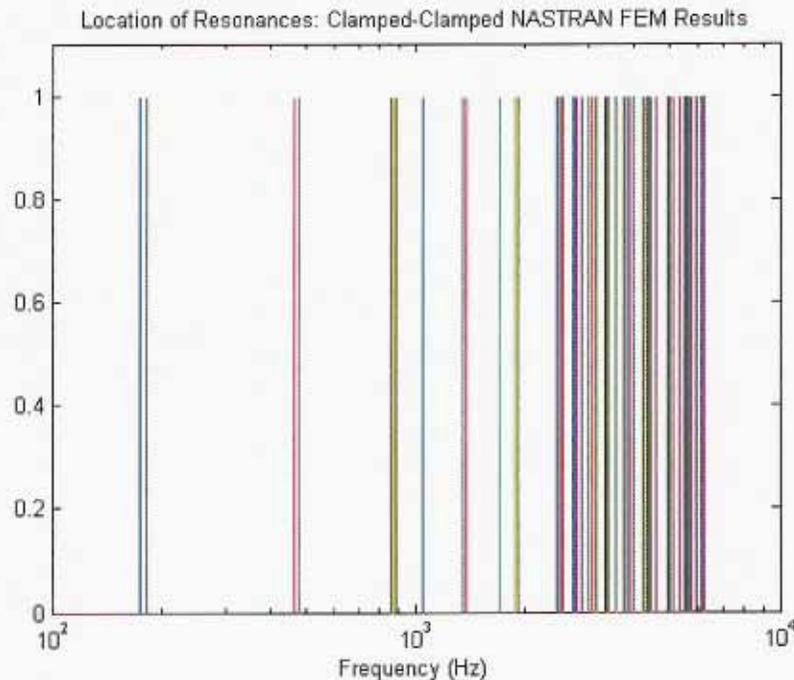
Figure 30: FEA results of clamped-clamped modal calculation. Note the similarities of the high frequency nodes to the free-free calculation in Figure 29.

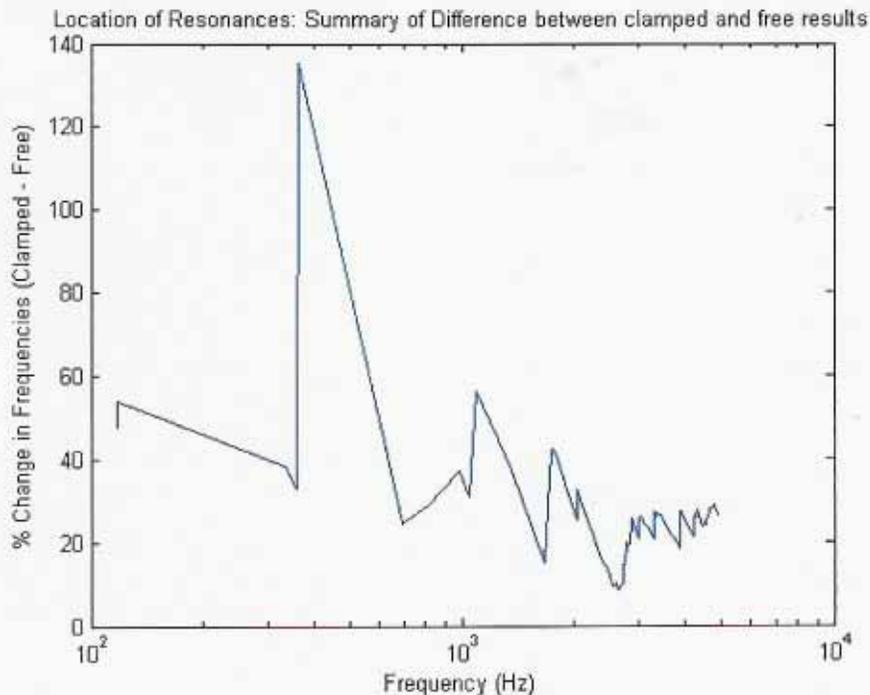
Figure 31: Percentage change in frequencies between the free-free and clamped-clamped conditions as calculated by the FEA model.

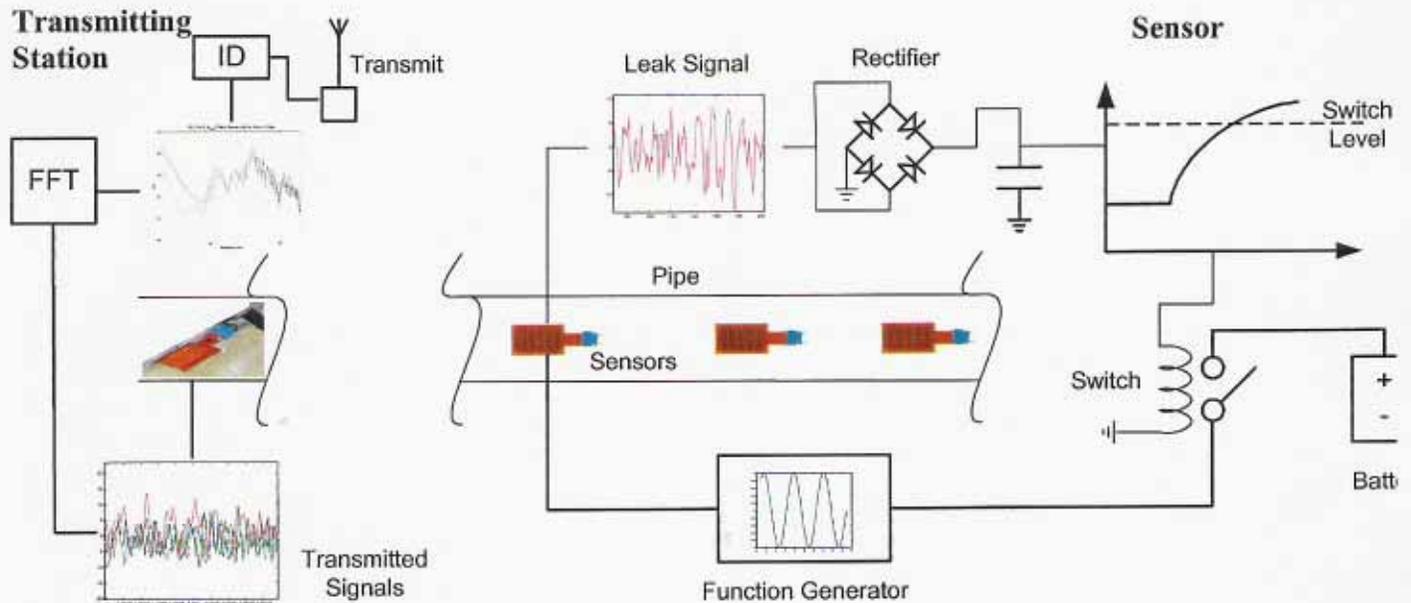
Based on the work performed and the results obtained, a high-level system design for the communications protocol can be done. This system consists of two major parts, the sensor and the transmitting station as shown in Figure 32.

Figure 32: Communications system design. The sensors pick up the leak signal that is rectified to give an increasing DC signal. Once the DC signal is higher than the switch's power on level, the switch closes. A battery provides power to a function generator that powers the PowerAct™ to start acoustic data transfer. At the transmitting stations, the acoustic signals are picked up, analyzed and identified. This data is then transmitted through RF (above ground) to the monitoring stations that alert the relevant personnel.

The detection is done via a PowerAct™ sensor that is permanently mounted on the pipe. These sensors are spaced about 100m apart. When a leak appears, the PowerAct™ generates a voltage over its poles as was shown in Section 2.3.2.2. The voltage is rectified and turned into a direct current signal, without using any power. The voltage over the capacitor continues to build up, until it reaches the switch level. This is the voltage required by the switch to engage.

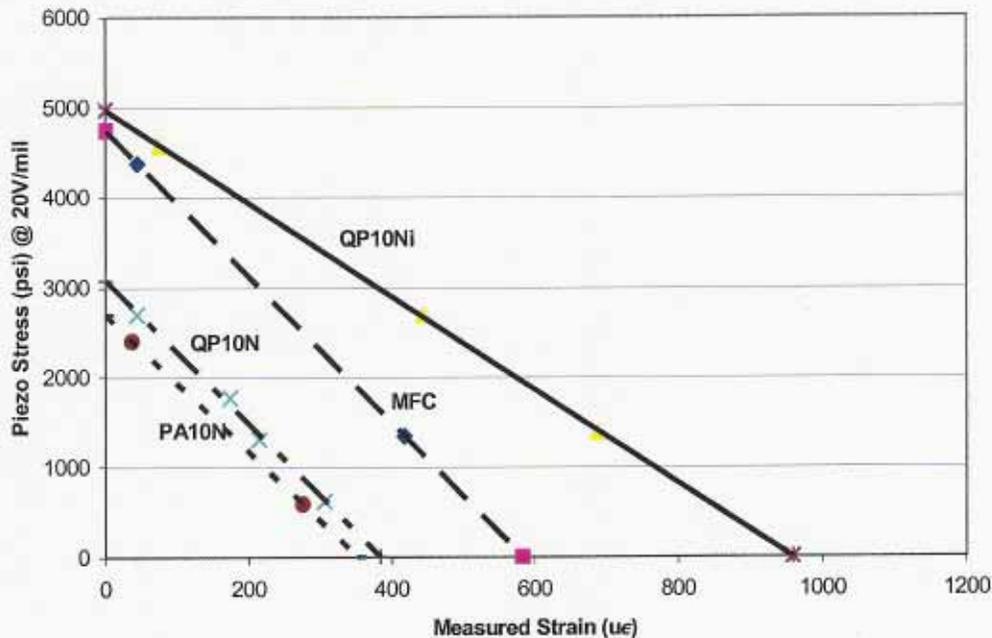
These actuators were compared on the basis of stress and strain produced at a specific field density. The field density of 20 V/mil represent the maximum amount that will ensure high fatigue performance under high stress and strain conditions such as those expected on a pipeline. Figure 34 shows the result of the comparison. Midé's QP10Ni actuator produces the largest amount of stress and strain for a given field density.

Figure 34: Piezo stress versus measured strain for 20V/mil field.

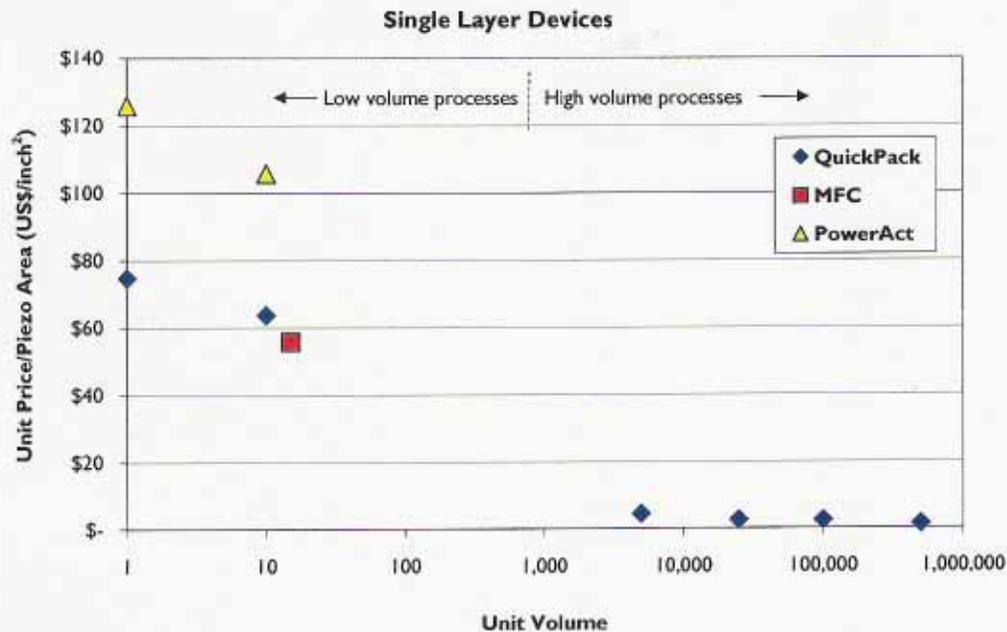
Figure 35 shows the available pricing data on the various technologies. The low-volume (up to 15 units) data points represent the average published “catalog” prices, on a per-unit-area basis. The QP10Ni is included in the QuickPack average, but none of the many 2-layer QuickPack catalog products are included in that average. By the argument above, the fact that the MFC is slightly less expensive than the QuickPack® does not reflect an inherent cost advantage of the MFC technology.

Figure 35: Pricing data for commercially available packaged strain actuators.

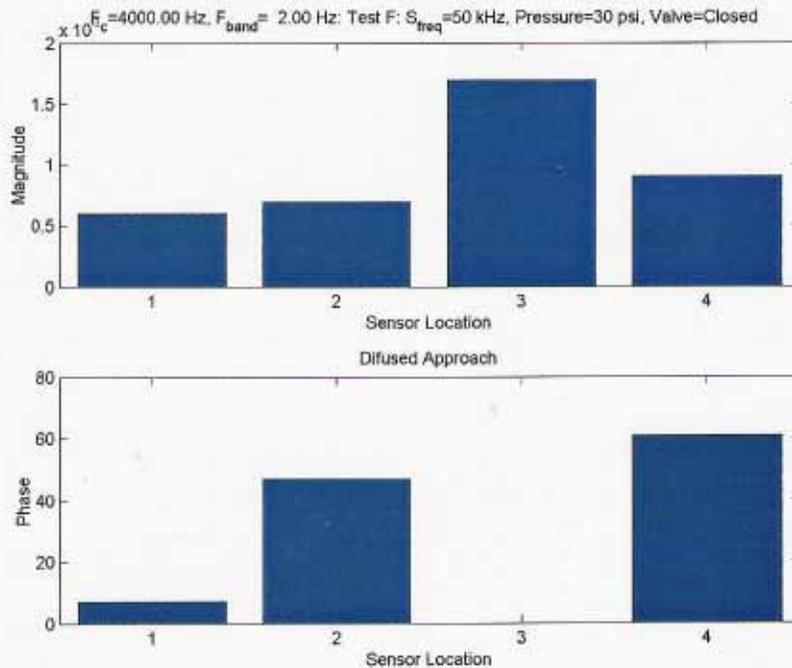
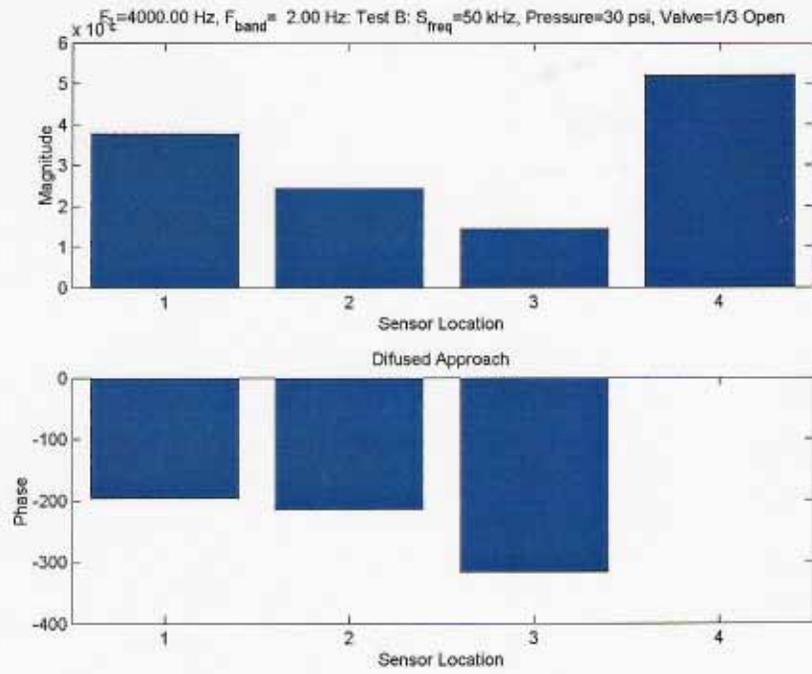
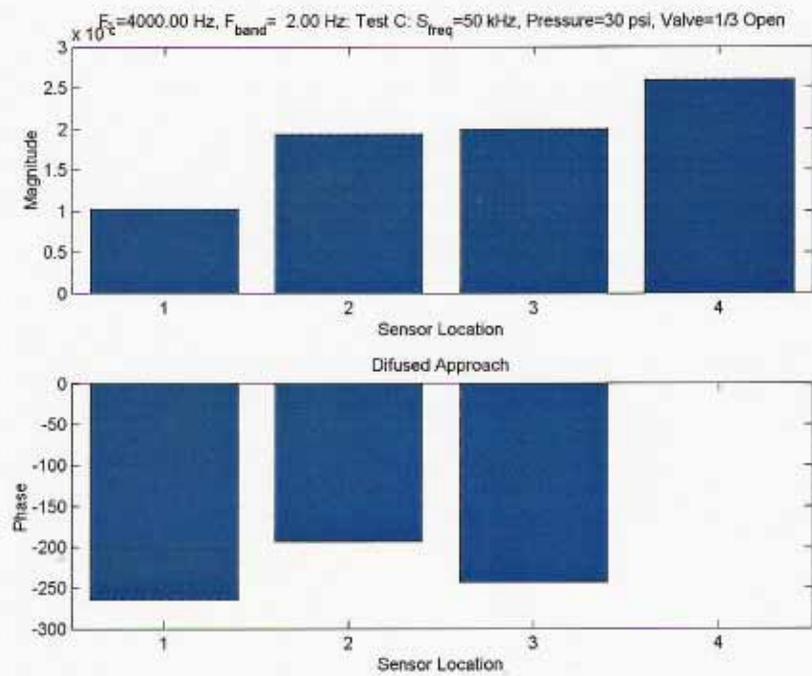
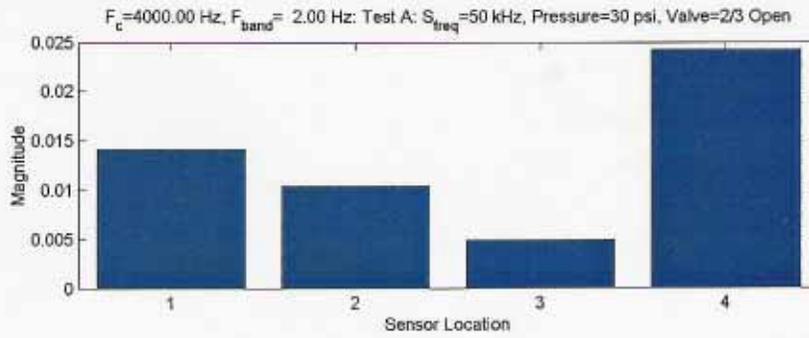
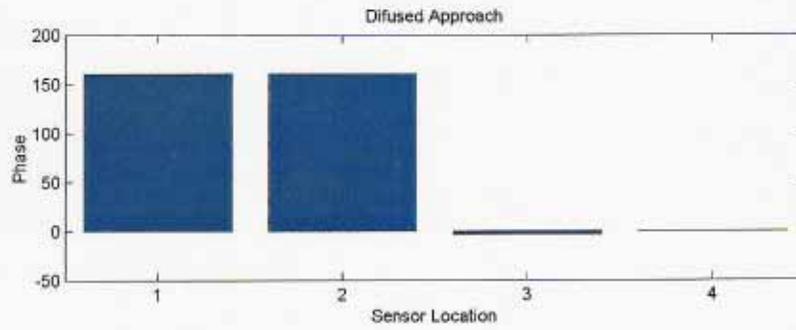
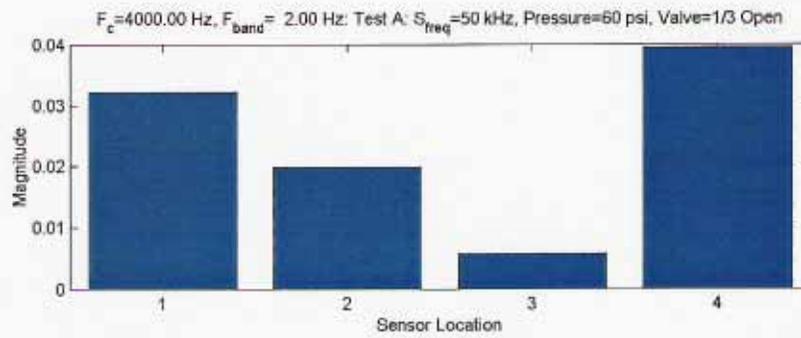
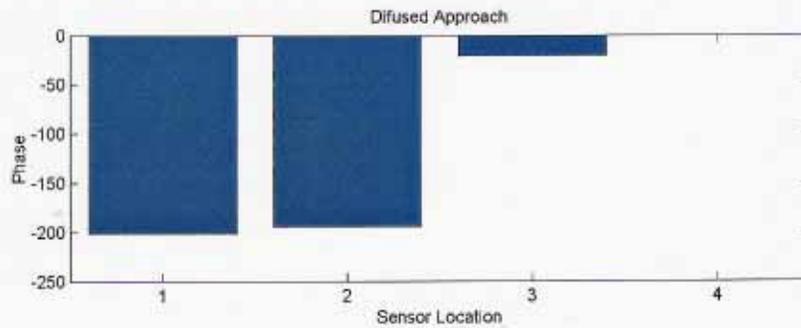
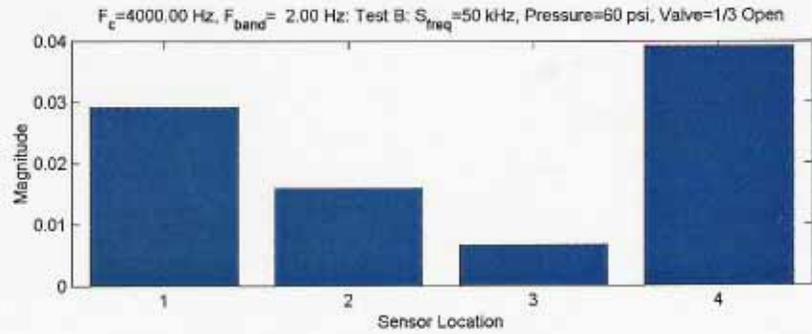
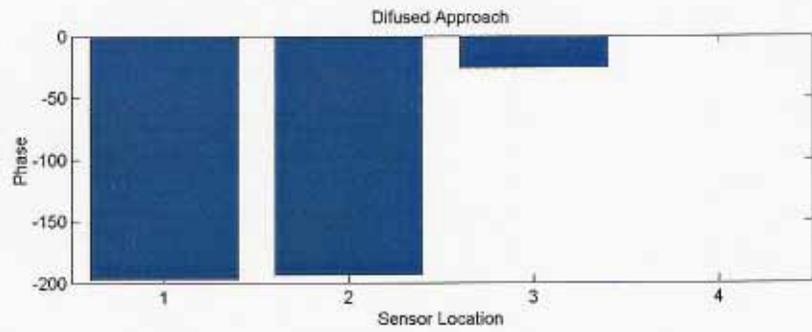
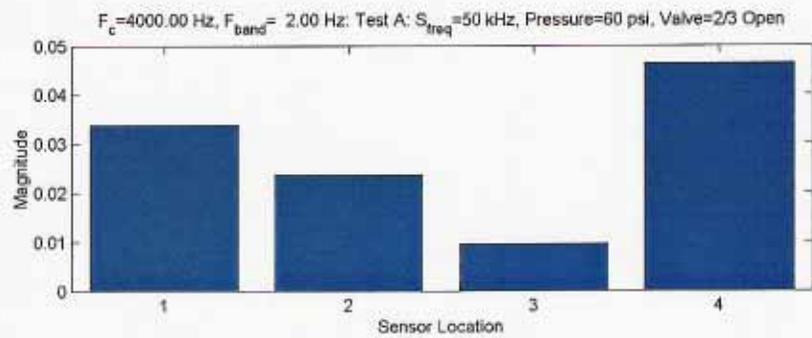
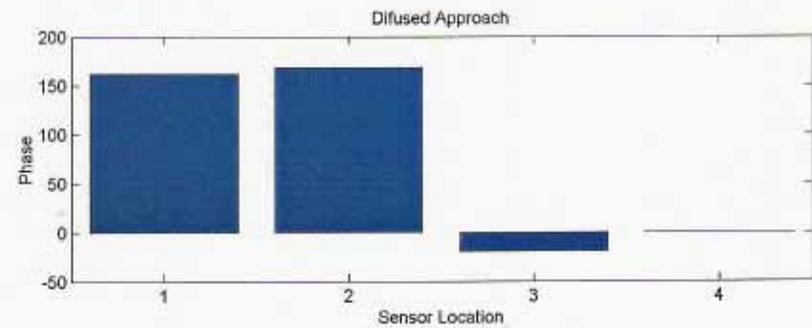
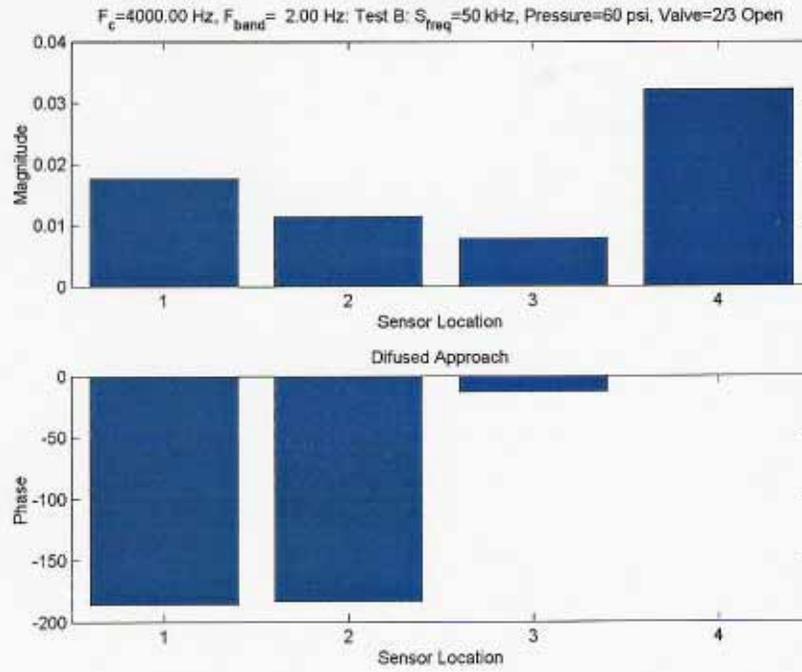
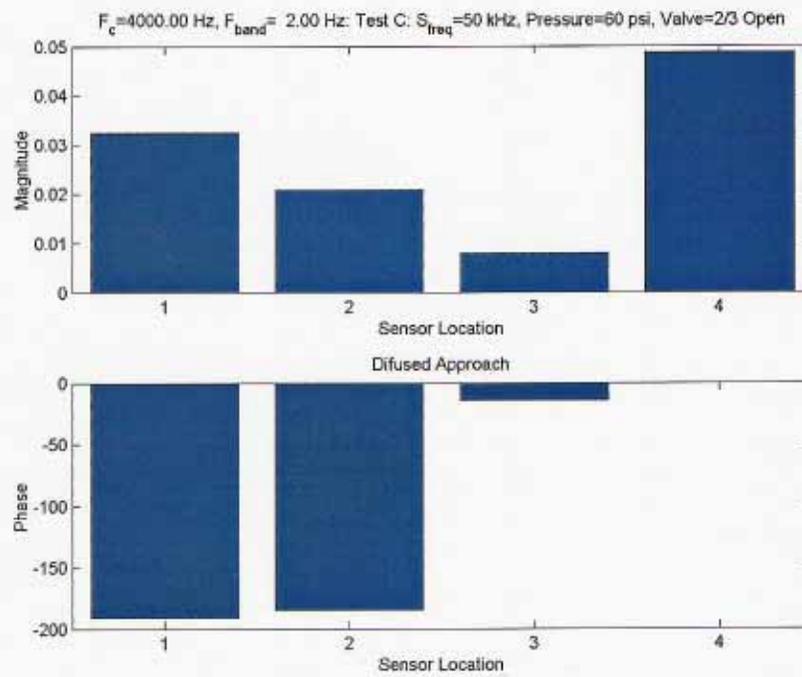
3.2.2.2. Sensor Signal Amplitudes and Phasing at 4000 Hz

At 4 kHz the maximum amplitude was near Sensor 4. The phase results are more difficult to interpret and this work is in progress.
