# CAAP Quarterly Report

Date of Report: *Dec. 31<sup>th</sup>, 2019*

Project Title: *Development of New Multifunctional Composite Coatings for Preventing and Mitigating Internal Pipeline Corrosion*

Prepared by: *North Dakota State University*

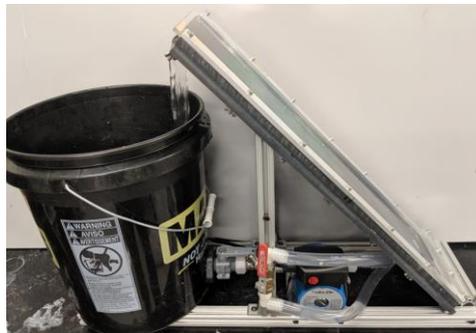
Figure 1. Setup for long-term durability tests

To further investigate the corrosion resistance performance of the coatings under dynamic liquid flow, illustrated in Fig. 1, the flow test was continued, and the exposure duration was increased up to 1000 hours.

As expected, the neat epoxy has the weakest corrosion under the liquid flow condition, and severe coating degradation was observed when the exposure time elapsed, which both the impedance and phase angle were decreased in Bode plots.

Improved corrosion resistance was observed in the specimen that reinforced by nanofillers. In the first 500 hours, no significant reduction was observed in the impedance curve, indicating the coating behaved as an intact layer to prevent the corrosion attacks. However, the phase angle was slightly decreased when the exposure time elapsed, indicating the coating degradation was initiated after the exposure.
