FINAL REPORT

GTI Project Number 20754

Validation for Flaw Acceptance of Mechanical Damage to Low-Stress Natural Gas Pipelines

U. S. Department of Transportation
Pipeline and Hazardous Materials Safety Administration
Office of Pipeline Safety
DOT Project No.: 257
Contract Number: DTPH56-08-T-000023

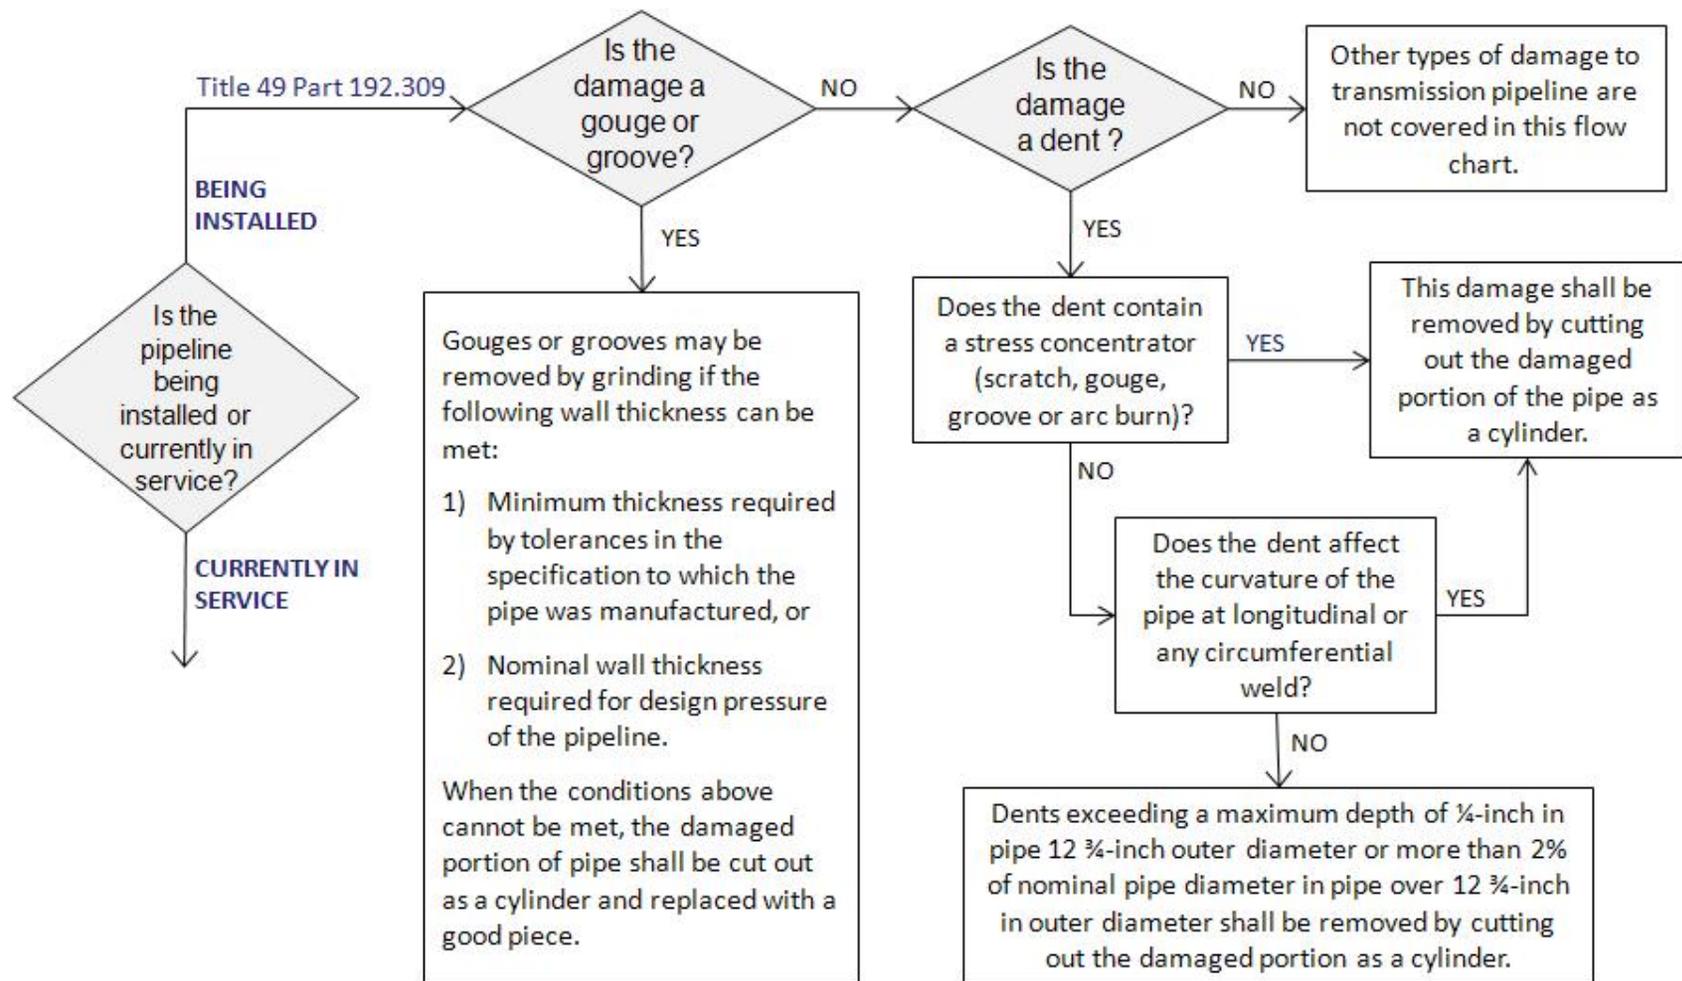
Figure 1 - Construction Requirements of damaged pipes in 49 CFR Part 192-Subpart G

- CFR 49 Part 192-Subpart G: In this Subpart, Section 192.309 addresses the repair requirements for damaged pipe sections during construction. Figure 1 shows a flow chart of the requirements under this section.
- CFR 49 Part 192-Subpart M: Section 192.713 in this Subpart provides the maintenance requirements for non-leaking defects on steel pipelines. Figure 2 shows a flow chart of the repair options under this section.
- CFR 49 Part 192-Subpart O: In this Subpart, Section 192.903 addresses transmission pipelines which are subjected to the integrity assessment requirements in High Consequence Areas (HCA). The code assigns scheduling requirements for the repair of the damaged pipes according to the level of damage.

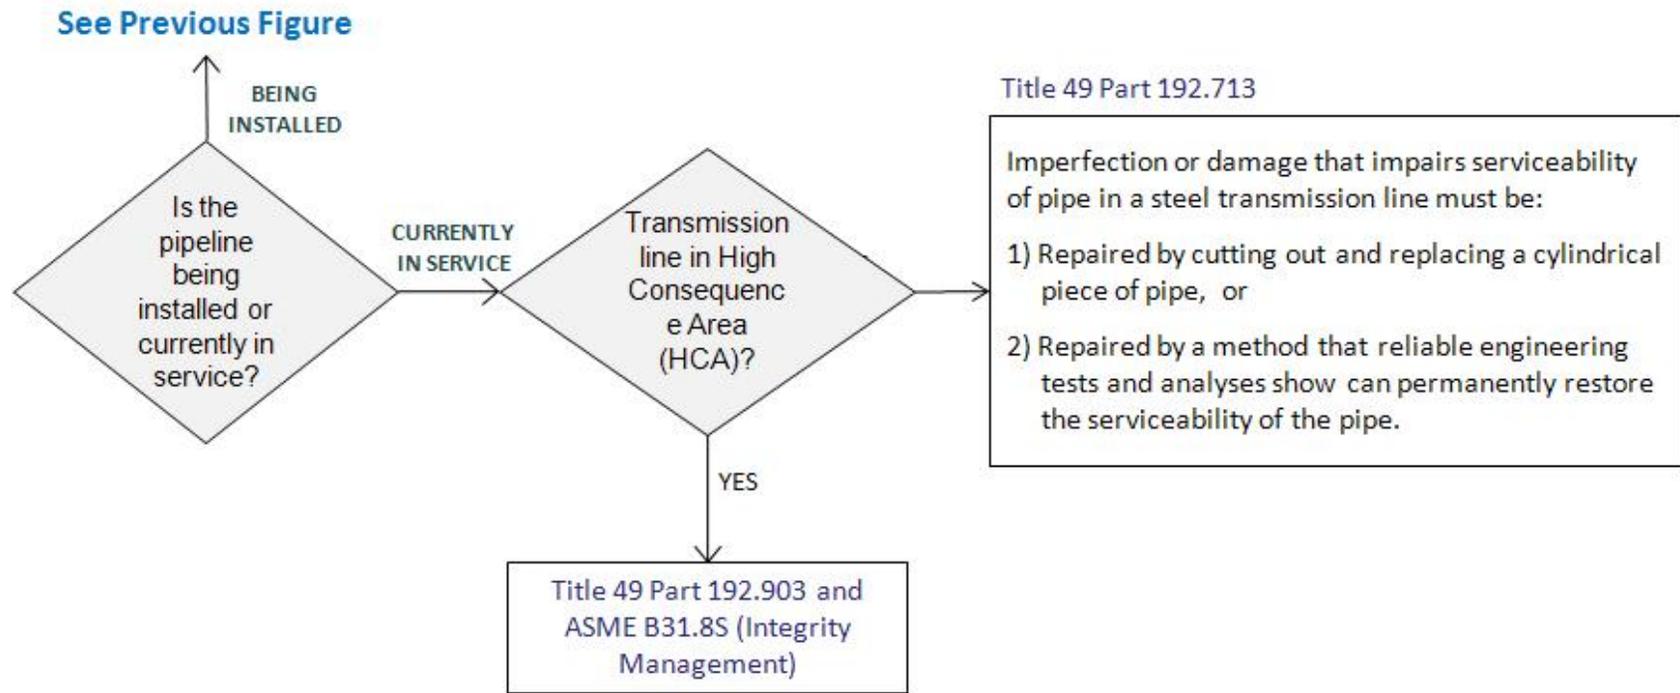
Figure 2 - Repair requirements of damaged pipes in 49 CFR Part 192-Subpart M

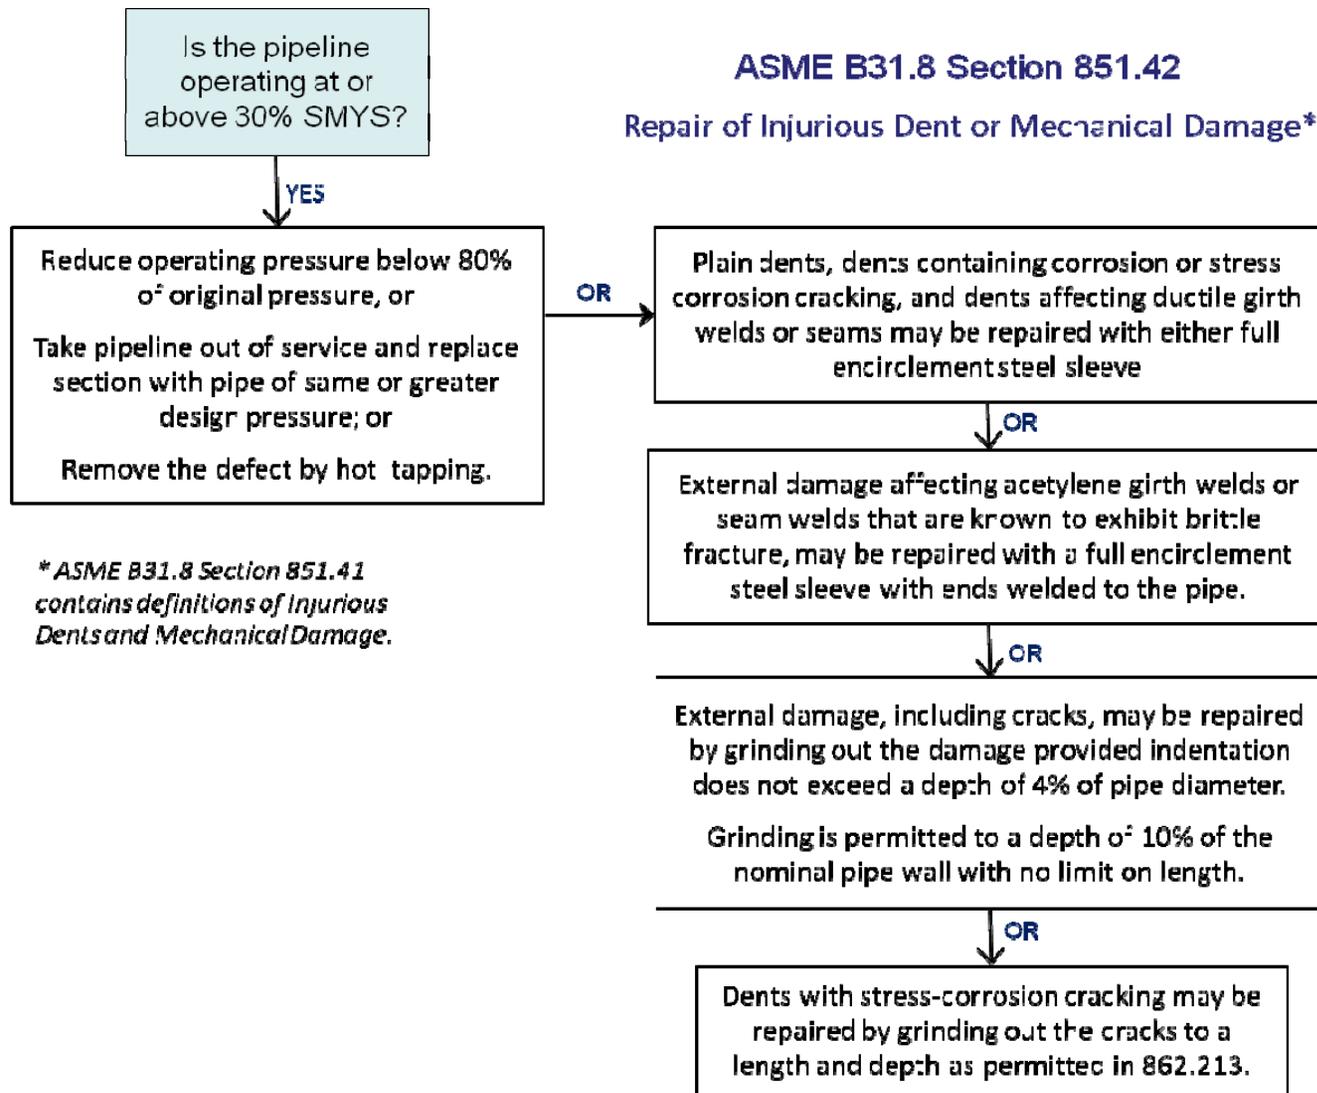
Figure 3 - Repair requirements of damaged pipes in ASME B31.8

The ASME B31.8 standard (1) also provides various repair options to injurious dents and mechanical damages to pipelines as shown in Figure 3.

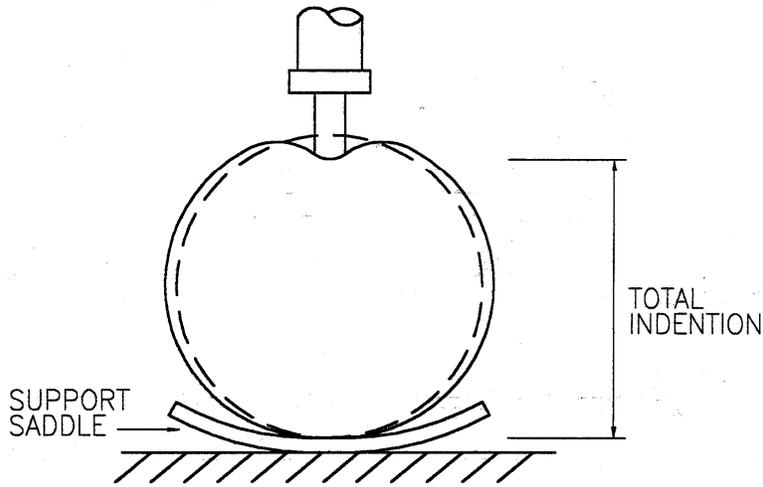
Figure 4 - Typical indentation process associated with methods 1 and 3

This type of damage application does not account for the stiffening effect of internal pressure and the method is not a valid representation of actual mechanical damage in a pressurized pipeline. However, this type of test simulates what might happen if a pipeline is damaged when depressurized, as for example, during its initial construction.

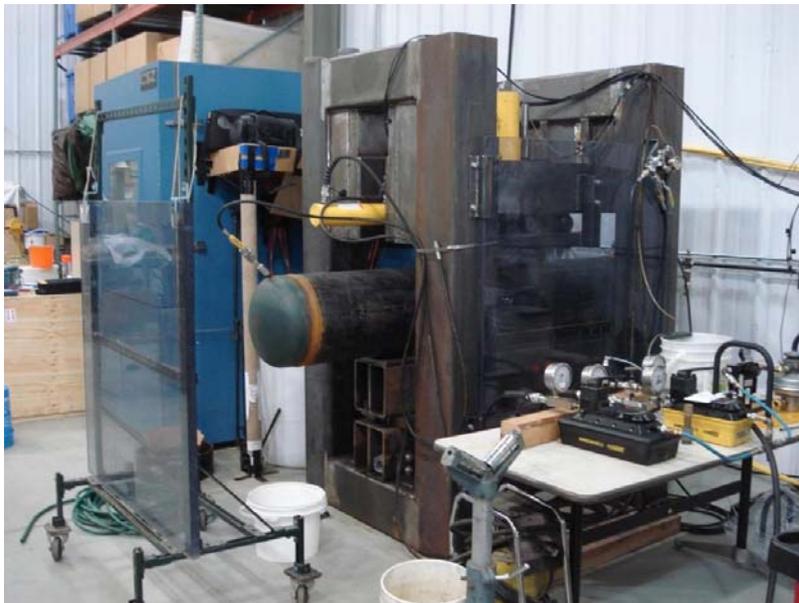
Figure 6 - The large-scale dent-gouge machine with a 16-inch diameter pipe

In order to accommodate a wide range of pipe sizes and pressures in the testing program, a large-scale loading frame and hydraulic system were manufactured. The hydraulic system is capable of applying dents and gouges to pressurized pipes of sizes up to 22 inches in diameter. Figure 6 shows a view of the large mechanical-damage loading equipment.

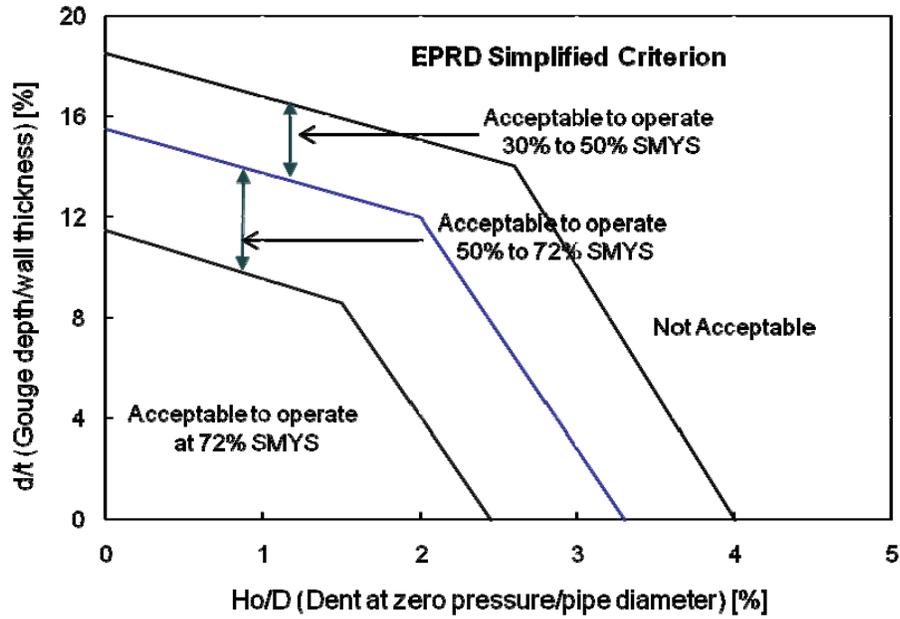
Figure 7 - The EPRG simplified model criterion

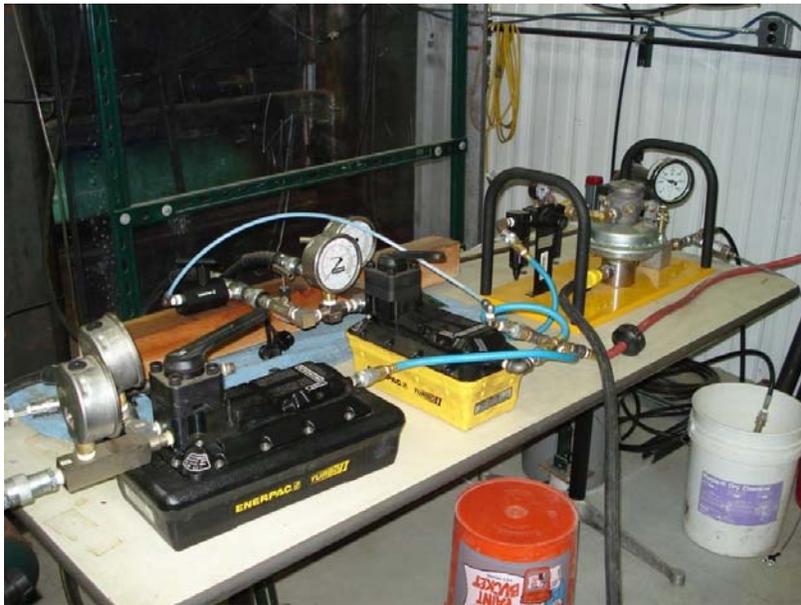
Figure 8 - The hydraulic loading system for dent-gouge applications

The dent-gouge loading machine was used to apply the hydrostatic pressure at 40% SMYS during indentation. Figure 8 - The hydraulic loading system for dent-gouge applications

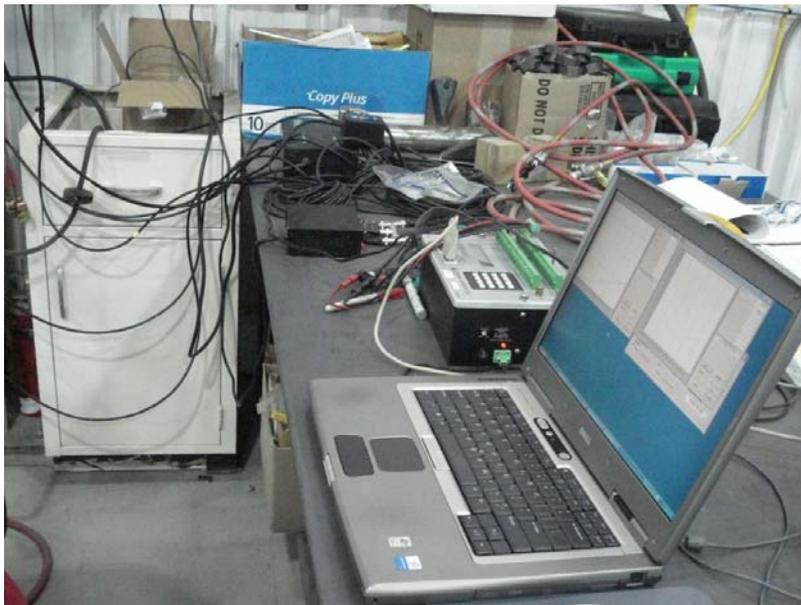
Figure 9 - Data monitoring of pipe deformation during damage application

The data logger system (Figure 9) was used to monitor the pipe hydrostatic pressure, dent depth, and length during the application of the mechanical damage and in burst tests. This process allowed the application of accurate and consistent mechanical damages on all the pipe specimens.

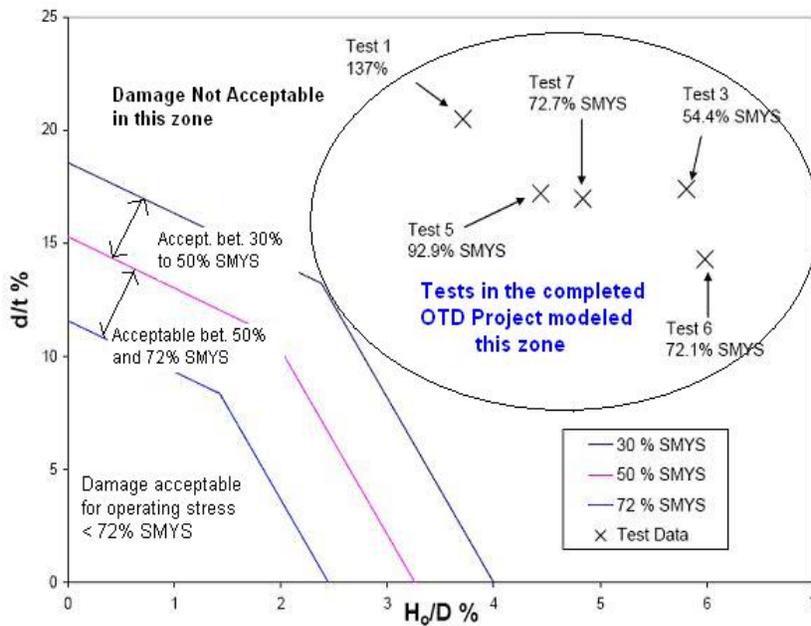
Figure 10 - Results of the earlier OTD study to verify EPRG Simplified Model

The results of the testing program are used to validate the EPRG Simplified Model. Earlier experiments at GTI evaluated the mechanical damages on 8-inch diameter pipes with depth to thickness (D/t) ratios from 26 to 42 (3). The results of these tests are plotted on the model diagram in Figure 10. As shown in the figure, the earlier tests were performed at high values of dents and gouges on relatively rigid pipe samples; thus resulting in very conservative failures with respect to model predictions.

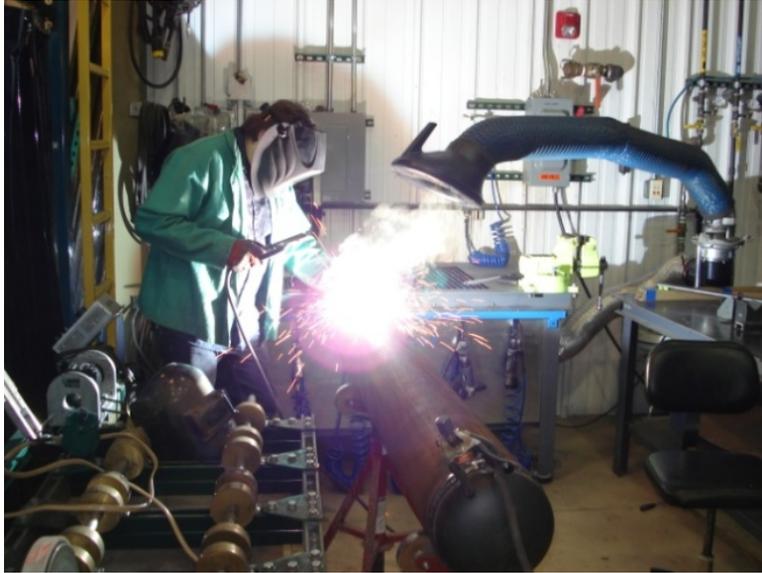
Figure 11 - Welding of pipe caps in preparation of the pipe test sample

In order to reduce the end effect of the welded caps on the location of the applied damage, the pipe sample had a minimum length of 4.5 times the pipe diameter. A sample length of 6.25 ft was used for both the 8-inch and 16-inch diameter pipes in the testing program. Figure 12 shows a schematic of the pipe test specimen.

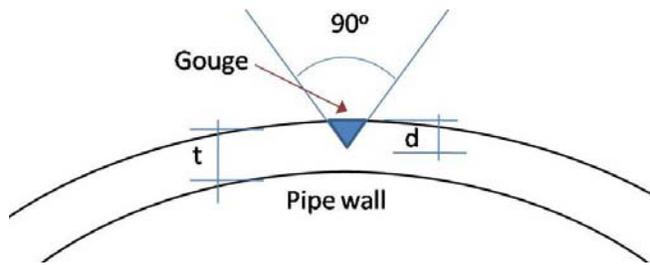
Figure 13 - Shape of the applied gouge on the pipe specimen

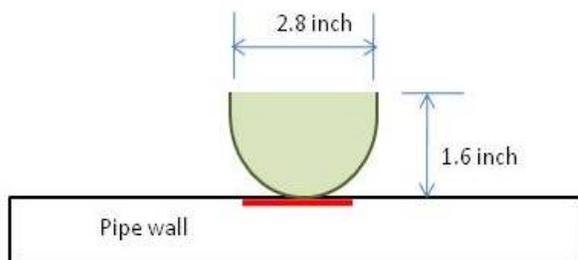
Figure 15 - Schematic of the rounded disc for dent application

A pressure release tank is connected to the pipe during this process to accommodate the volume of water displaced from the pipe during pipe denting. The vertical pipe displacement is monitored using a data acquisition system.

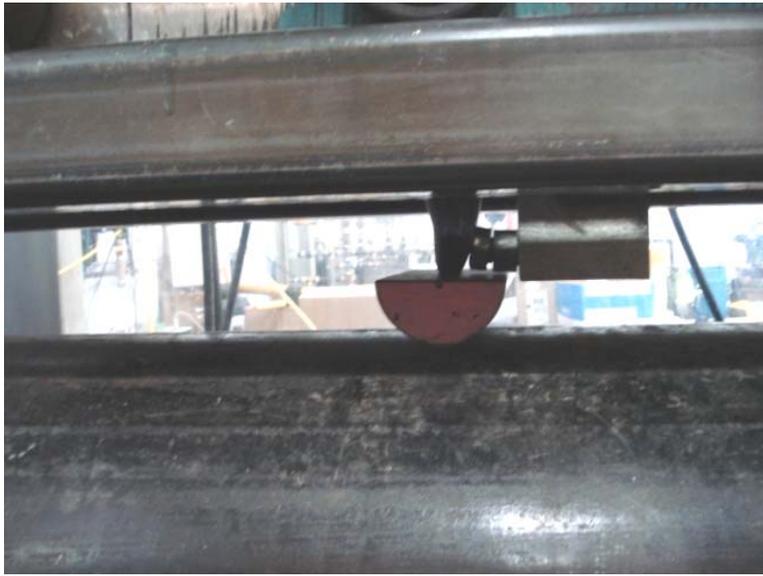
Figure 16 - Application of longitudinal dent along the pipe specimen

The lengths of the gouges and dents were 12 inches in all the pipe specimens. Table 17 shows that the length of gouge is greater than $6\sqrt{Dt}$ for the samples in the testing program. As such, the defect can be considered to be representative of a “long” defect and the results would be similar to longer defects.

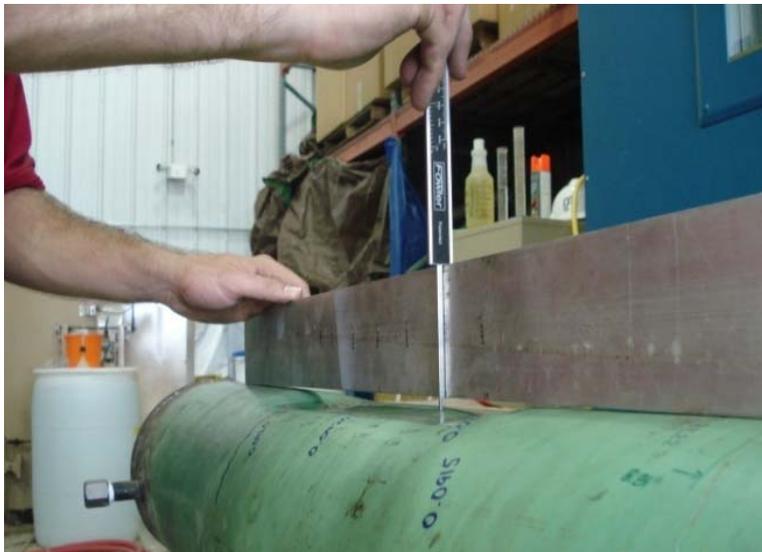
Figure 17 - Measurement of dent at zero pressure (H_0)

After denting, pipe pressure was released to 0 psig and the dent depth was measured using a straight edge and a depth gauge Figure 17. The dent depth after the indenting tool has been withdrawn and the pipe has been depressurized is defined as H_0 as shown in Figure 18.

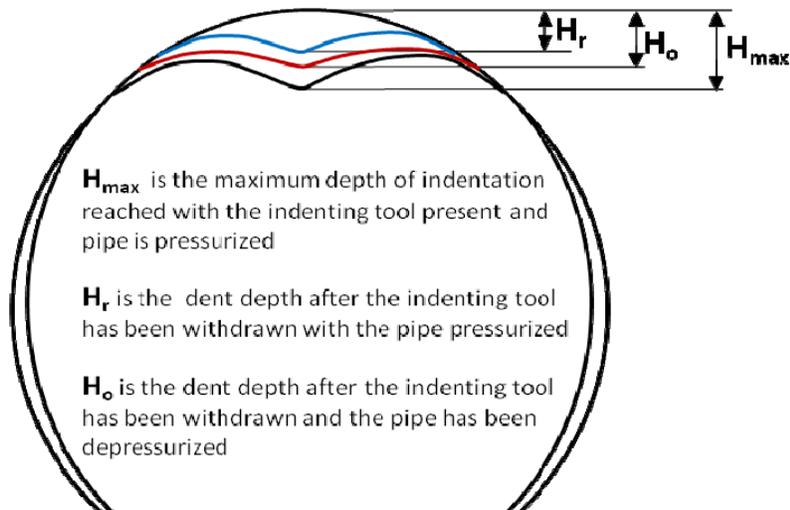
Figure 18 - Measurements of dents in the pipe during and after loading

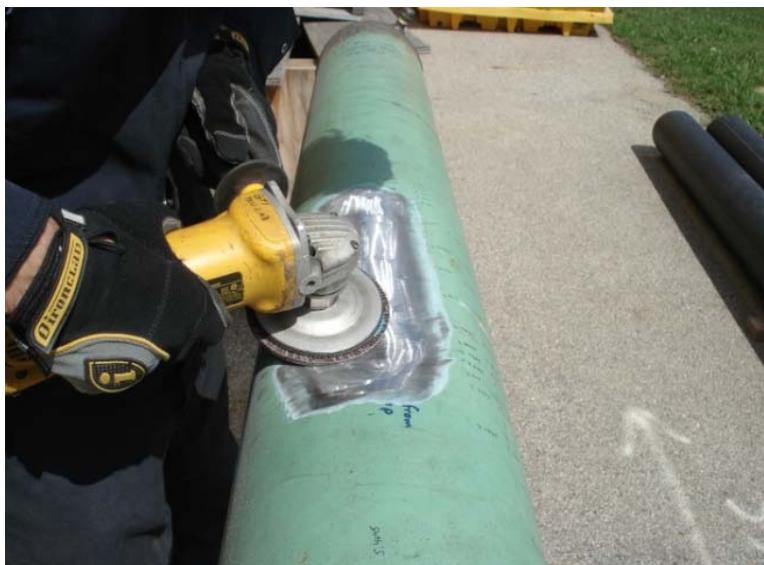
Figure 19 - Grinding the pipe surface for the inspection of cracks

After the completion of damage application, pipe samples were investigated to check if the gouge-dent procedure causes the development of surface cracks. The procedure consisted of grinding the surface to remove pipe coating from the dented area (Figure 19) and inspecting the surface using magnetic particle test equipment (Figure 20). The pipe wall thickness was measured using an ultrasonic thickness gauge.

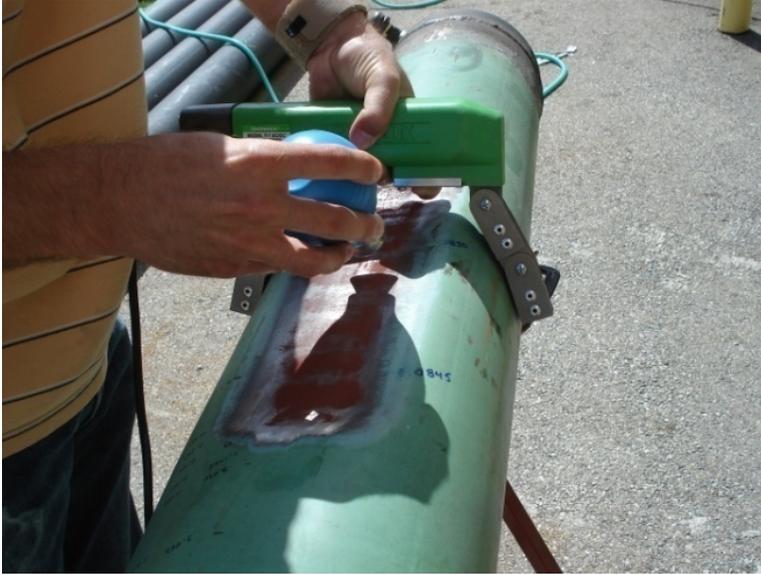
Figure 20 - Inspection of cracks using magnetic particle device

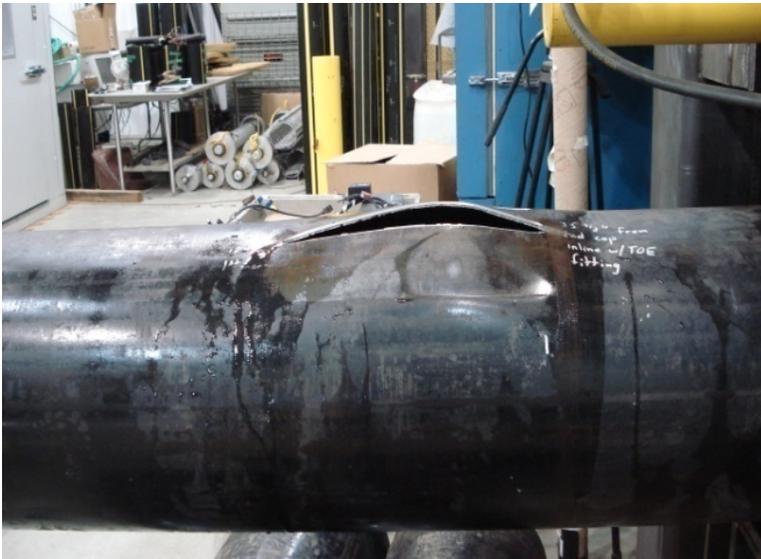
Figure 21 - View of pipe at the completion of the burst test

Hydrostatic pressure was then applied to the pipe incrementally until pipe failure. Figure 21 shows a view of a 16-inch pipe sample after a burst test showing the burst failure at the dent and gouge location.

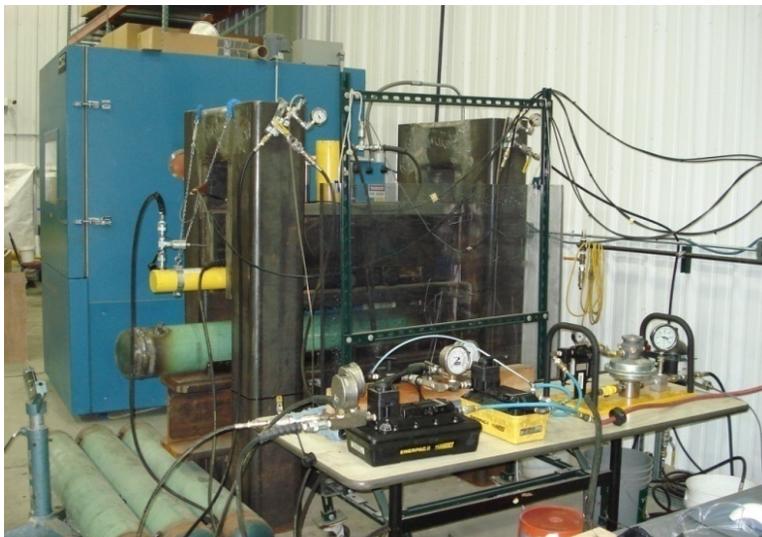
Figure 22 - View of the Large-scale dent-gouge machine

Hydrostatic pressure tests were performed on pipes with various dents and gouges. Figure 22 shows the testing of an 8-inch pipe in the dent-gouge loading machine. Several test sets were performed to evaluate the failures of pipes under various testing parameters. The test sets are shown in Table 18. The details of the tests performed in each set are presented in this Chapter and the results are also summarized in Appendix A. Test Set A evaluated failure of pressurized pipes with different stiffness (i.e., pipe diameter/wall thickness) ratios. Set B evaluated pipe failures due to only gouges or dents. Test Set C had pipes dented at pressure 20% SMYS, and were tested to reach failure at 40% SMYS. Set D evaluated pipe failures with various gouge shapes. Set E simulated dents and gouges from a backhoe tooth applied to the pressurized pipes, and Set F was performed on grade X60 pipes.

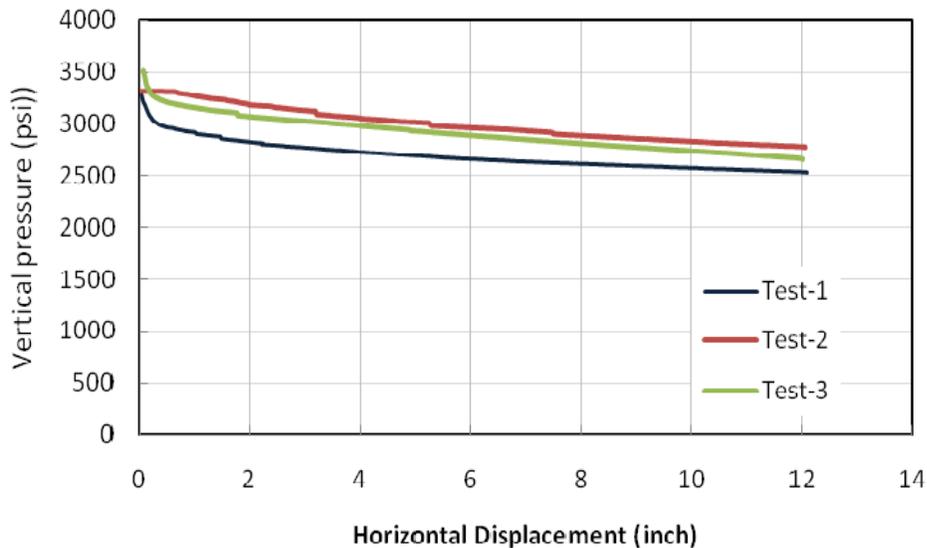
Figure 23 - Applied pressure and horizontal displacement during denting

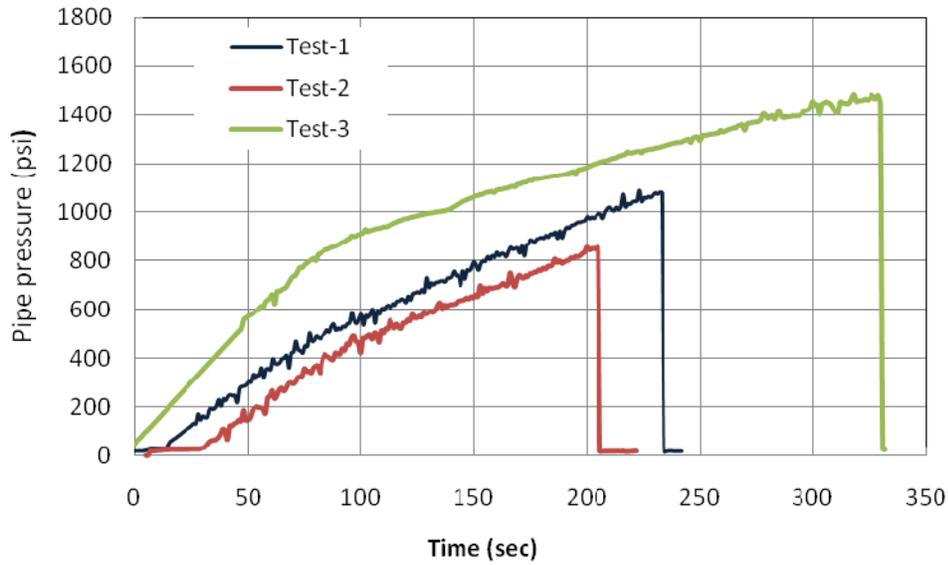
Figure 24 - Pipe pressure during burst tests of the 16-inch pipes in Set-A

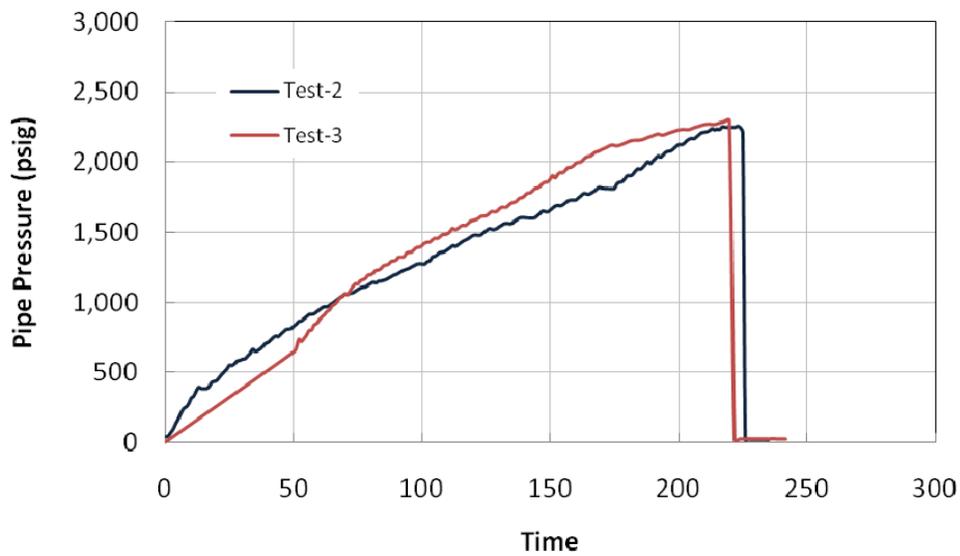
Figure 25 - Pipe pressure during burst tests of the 8-inch pipes in Set-A

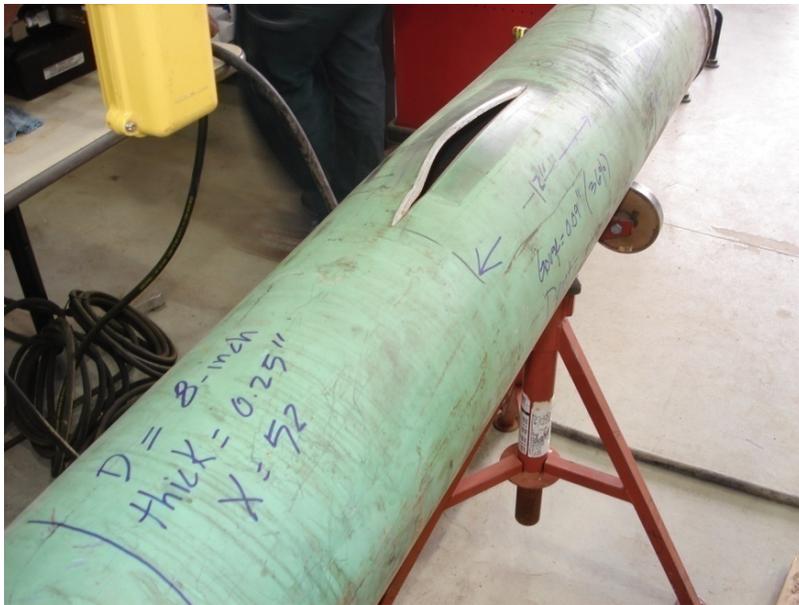
Figure 26 - View of the 8-inch pipe after burst test

Figure 26 and Figure 27 show pipe samples after the completion of the hydrostatic burst tests for the 8-inch and the 16-inch pipes, respectively.

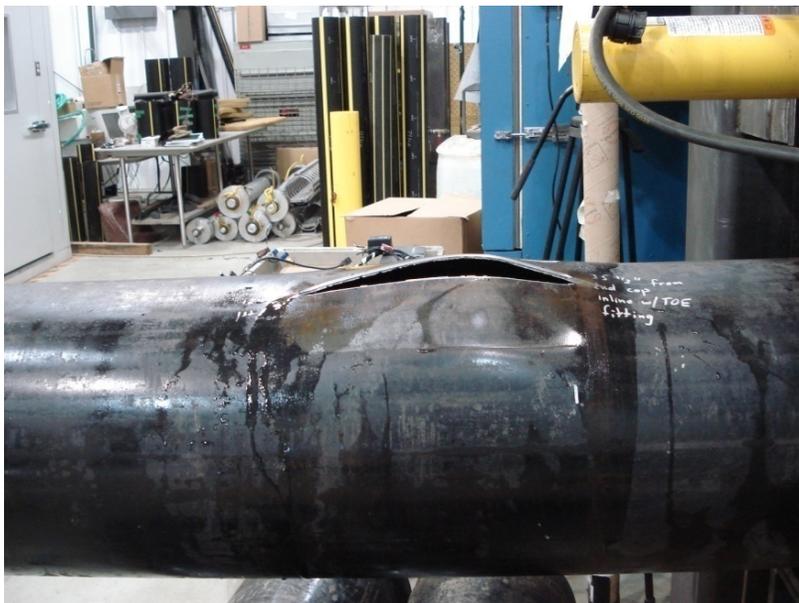
Figure 27 - View of the 16-inch pipe after burst test

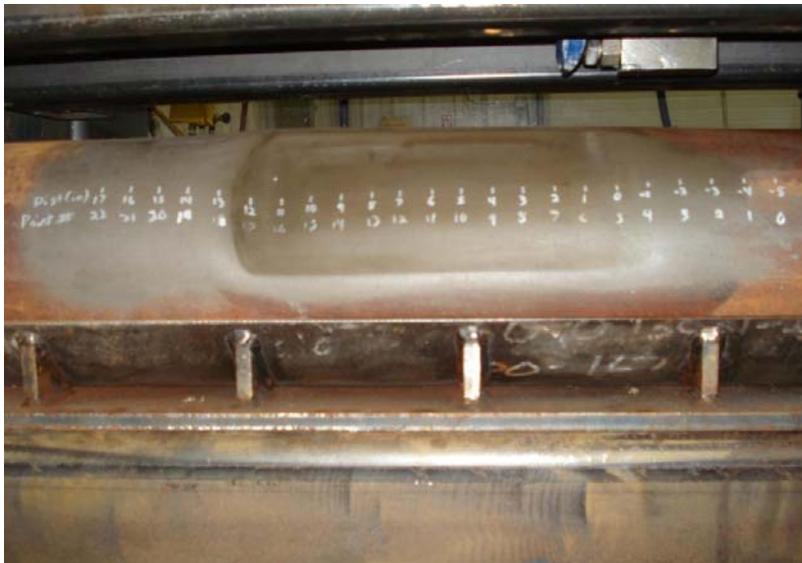
Figure 28 - Indentation of the 8-inch pipe in Set-B

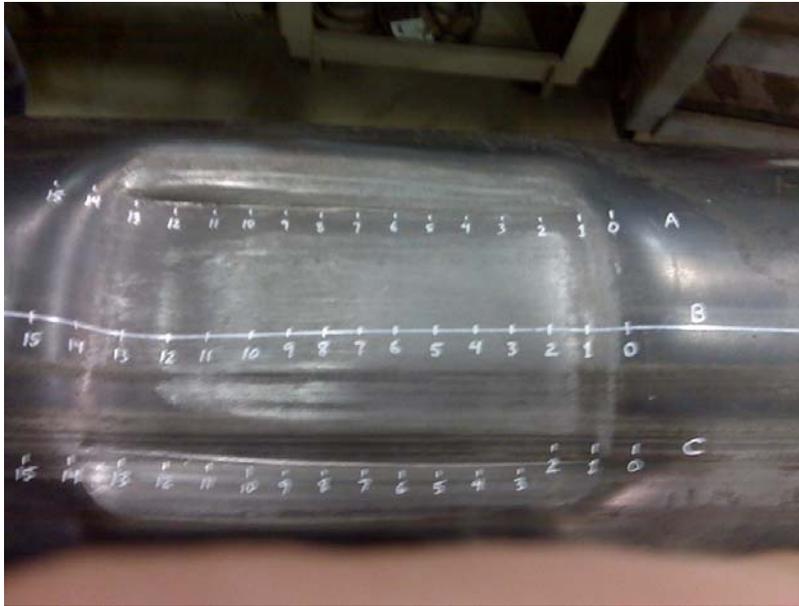
Figure 29 - Indentation of the 16-inch pipe in Set-B

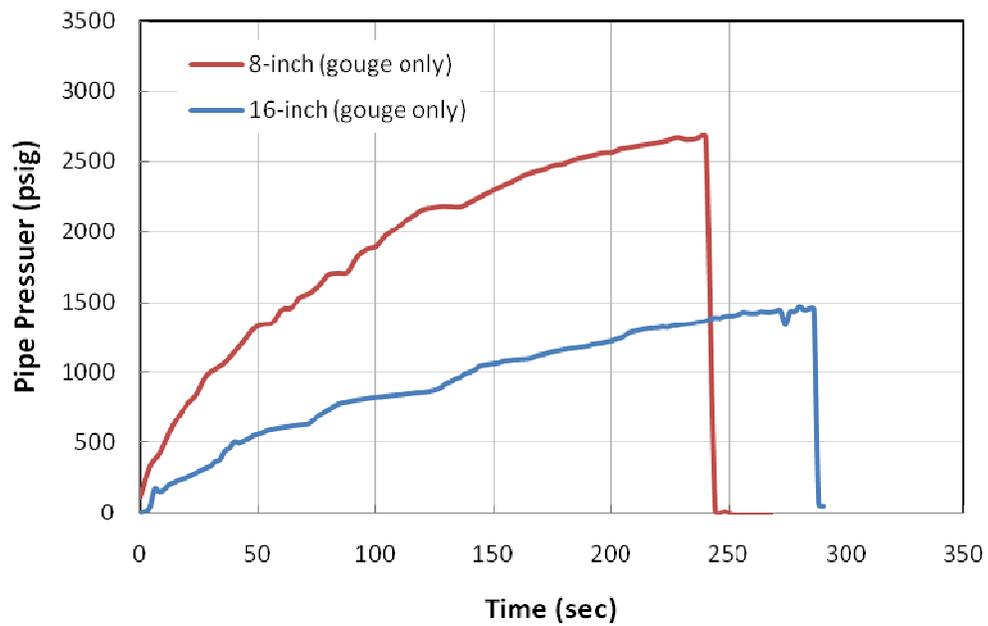
Figure 30 - Pressure tests on the gouged pipes in Set-B

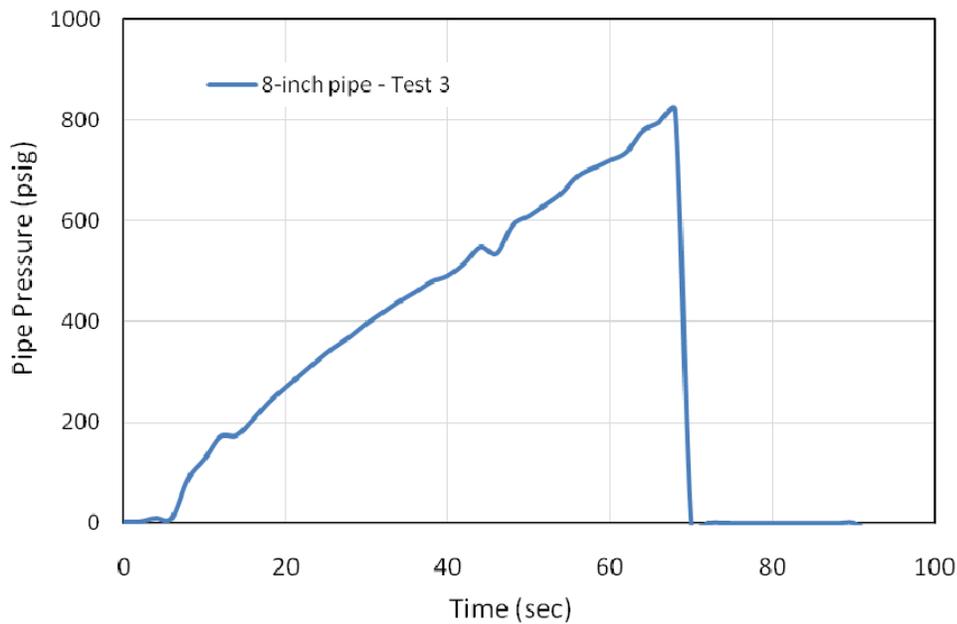
Figure 31 - Pressure tests No. 3 on the 8-inch pipe in Set-C

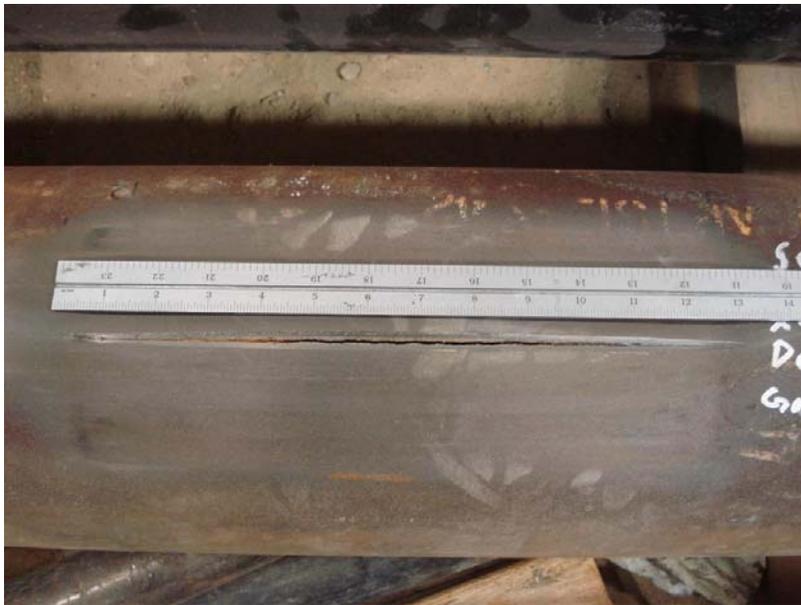
Figure 32 - View of the Test-3 8-inch pipe after Testing

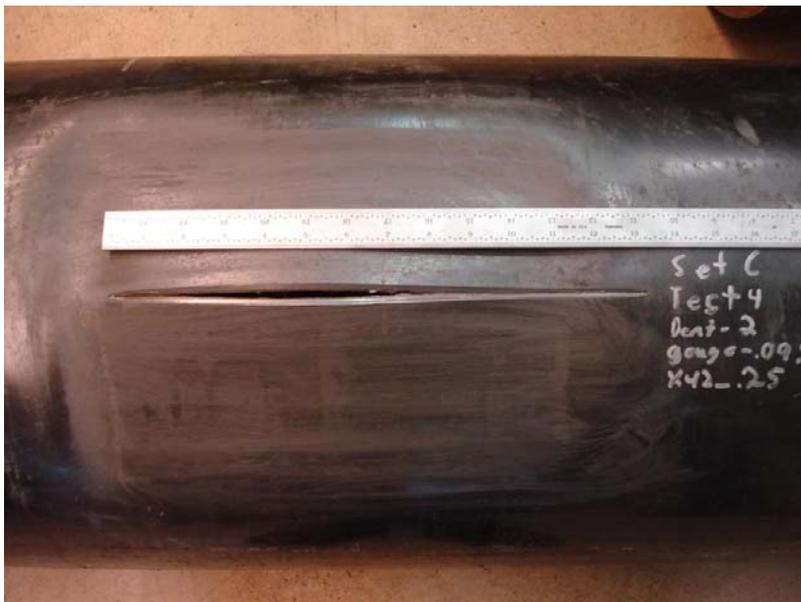
Figure 33 - View of the Test-4 16-inch pipe after testing

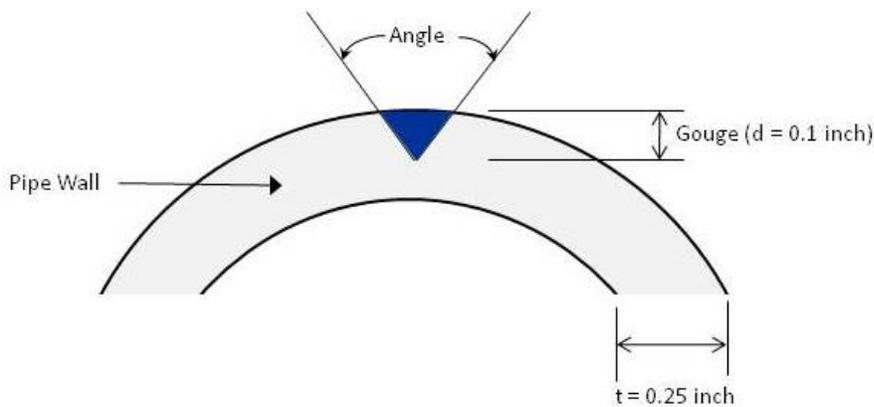
Figure 34 - Testing parameters for test Set-D

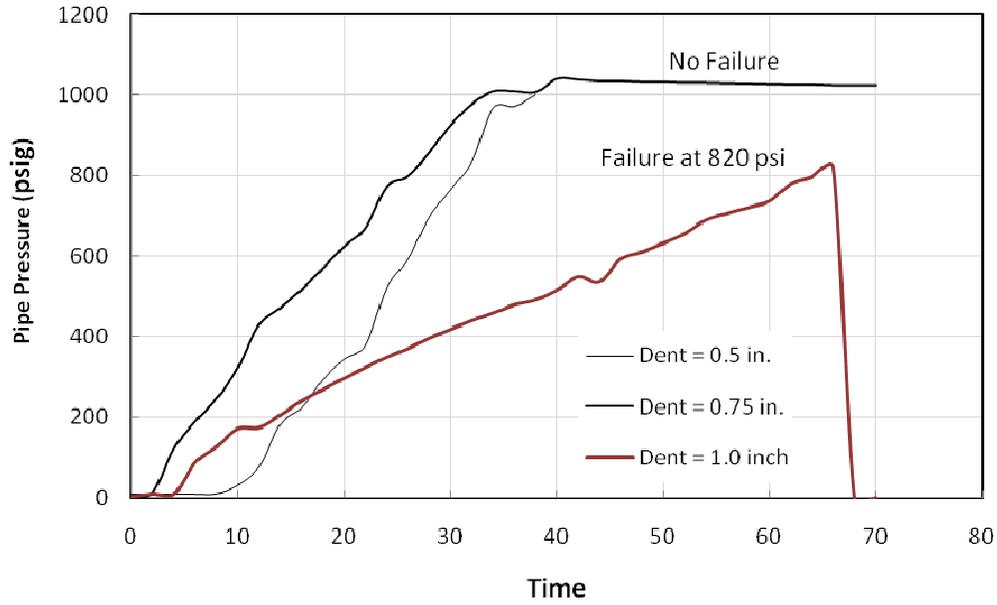
Figure 35 - Results of Test 1 with 90° gouge and various dents

Several dents were applied to the pipe in each test. At each indentation level, the pipe was pressurized to 40% SMYS. If the pipe did not fail, higher indentation was the applied until the pipe failed at or below 40% SMYS. The results of these tests at various indentation levels are shown in Figure 35 to Figure 38.

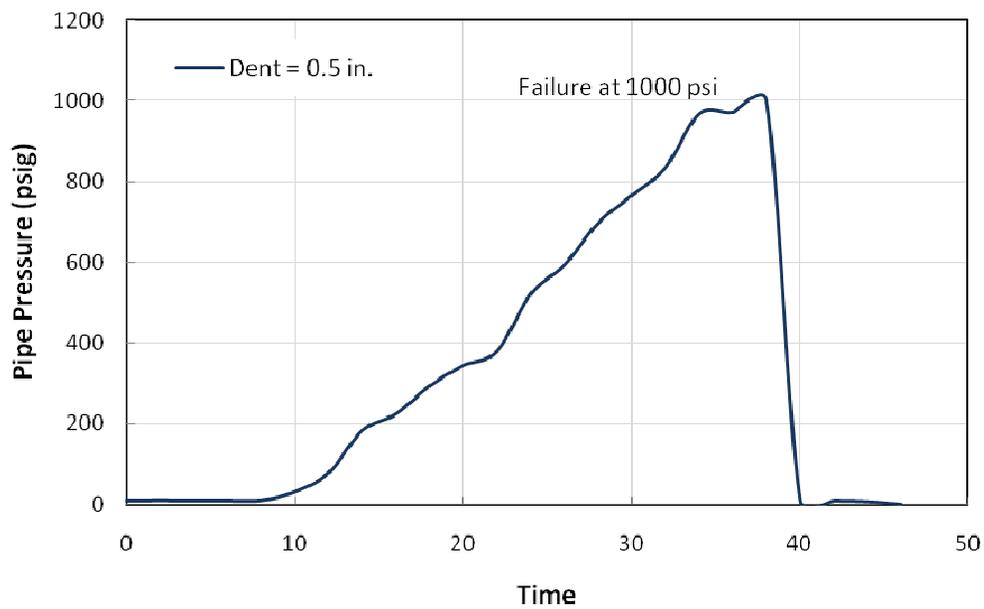
Figure 36 - Results of Test 2 with 45° gouge angle

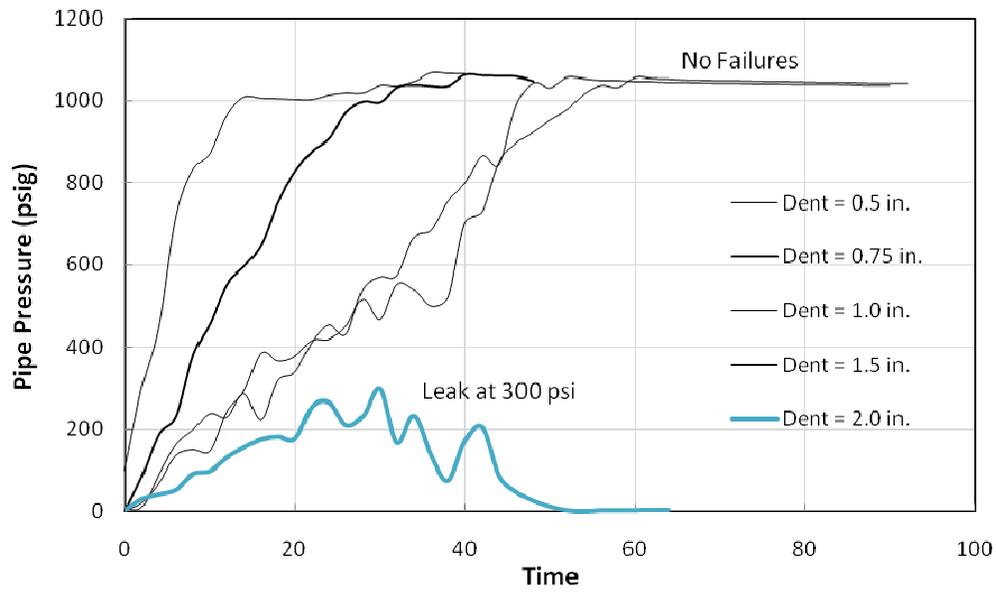
Figure 37 - Results of Test 3 with rounded gouge and various dents

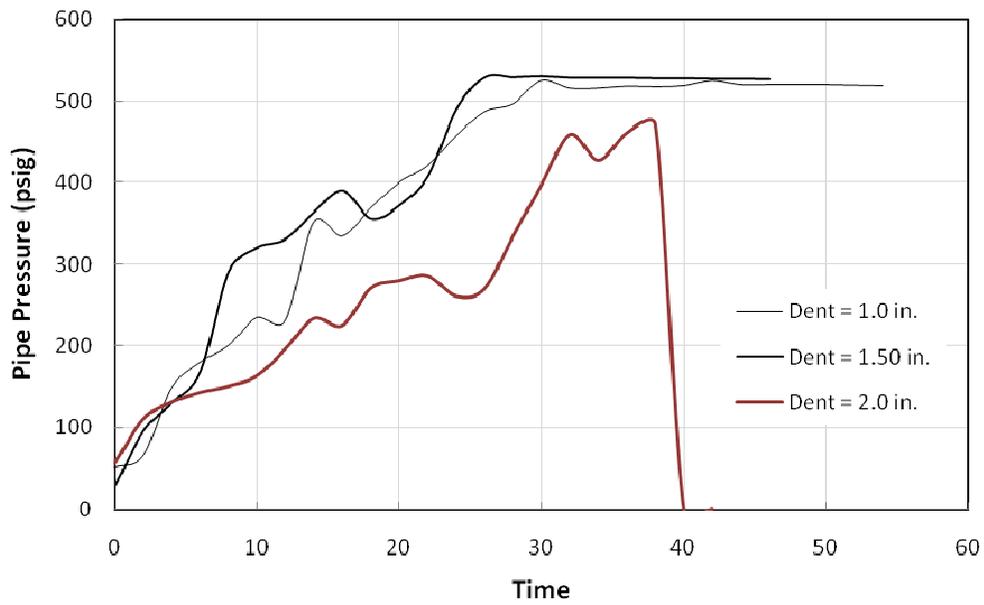
Figure 38 - Results of Test 4 with 90° gouge and various dents

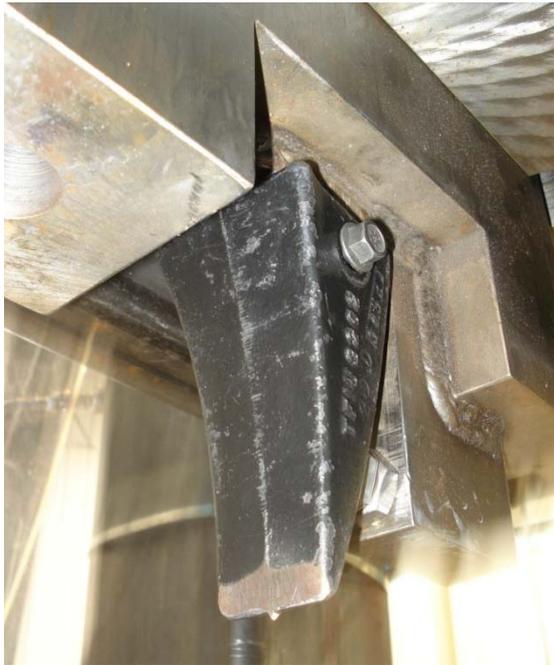
Figure 39 - View of the backhoe tooth used in Set E

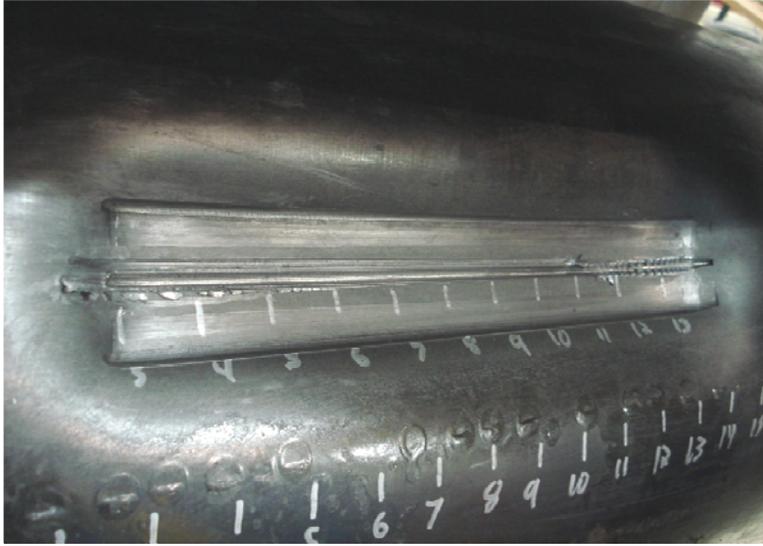
Figure 40 - View of the damage caused by the backhoe tooth application

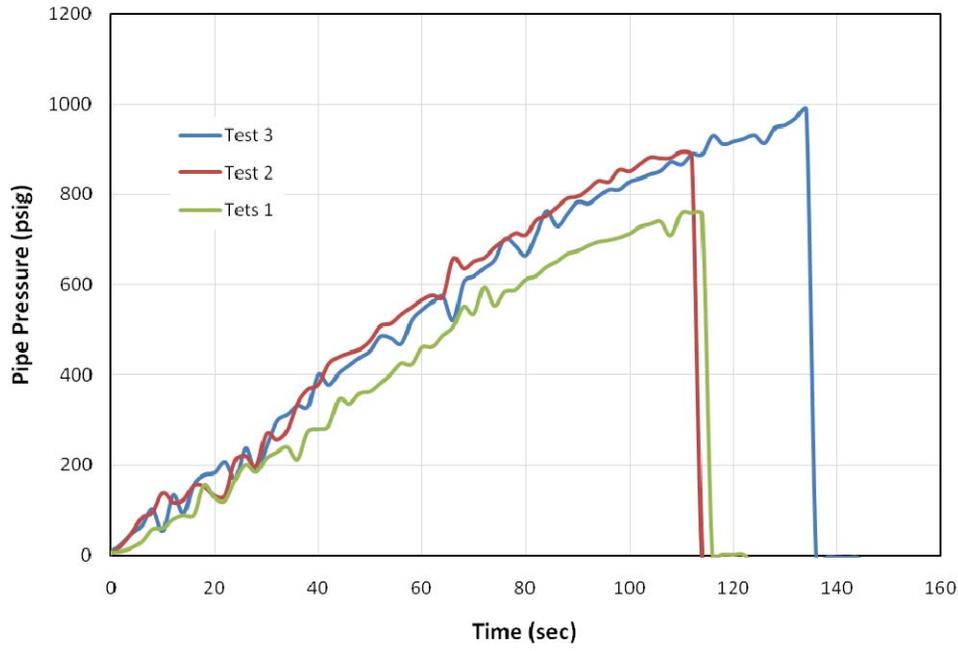
Figure 41 - Results of pressure tests of Set F
