FINAL REPORT

GTI Project Number 20754

Validation for Flaw Acceptance of Mechanical Damage to Low-Stress Natural Gas Pipelines

U. S. Department of Transportation
Pipeline and Hazardous Materials Safety Administration
Office of Pipeline Safety
DOT Project No.: 257
Contract Number: DTPH56-08-T-000023

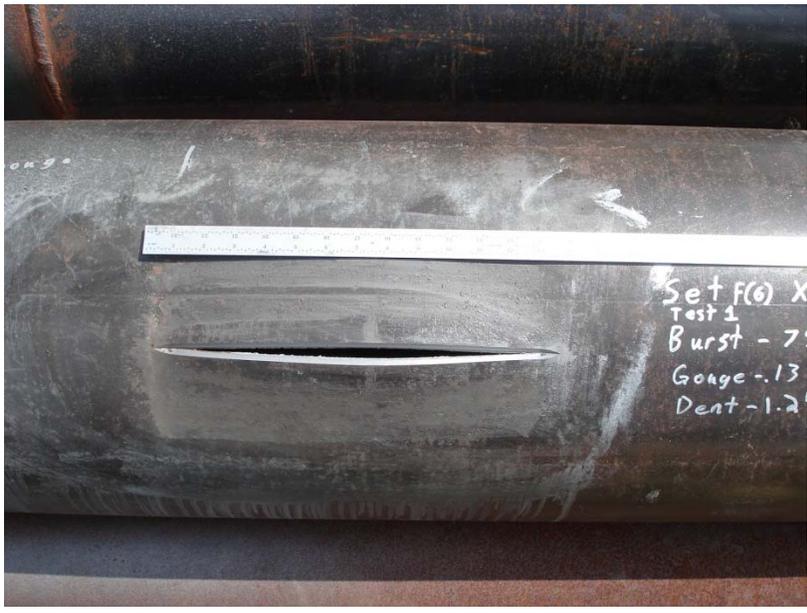
Figure 42 - View of the pipe at the completion of pressure test 3

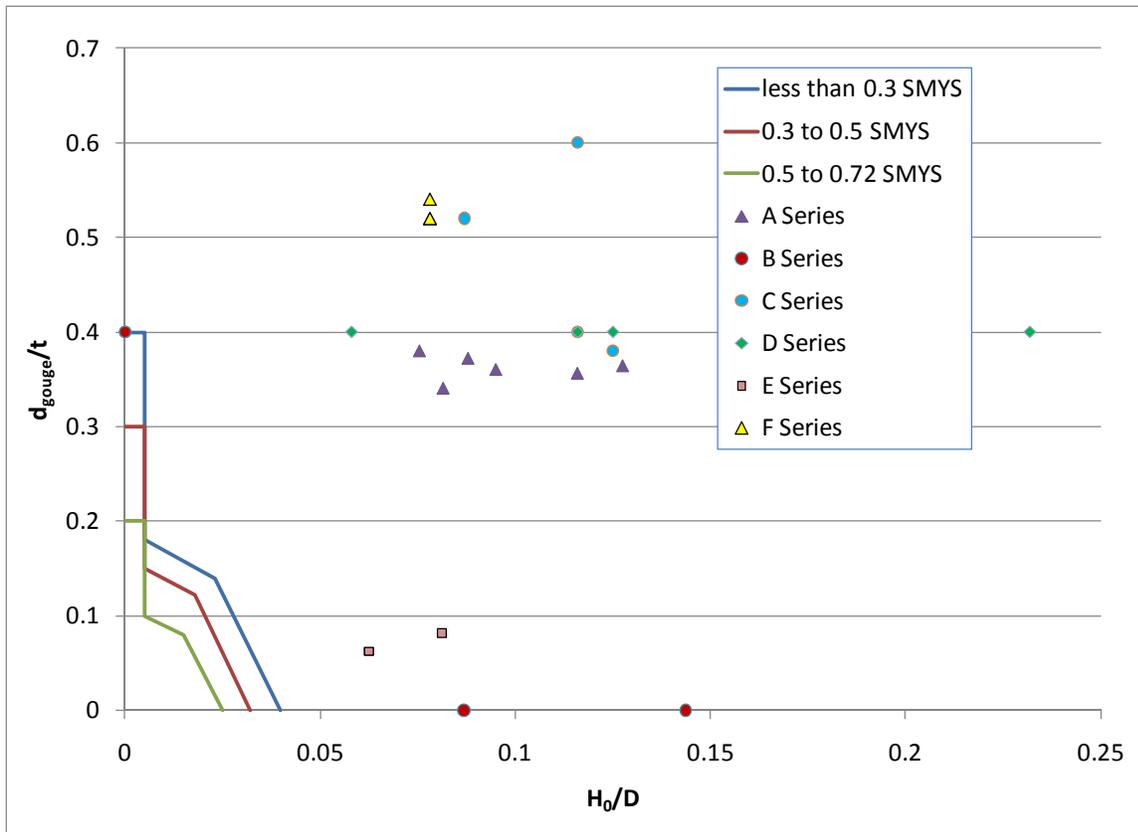
Figure 43 - Comparison of test results with EPRG simplified failure model

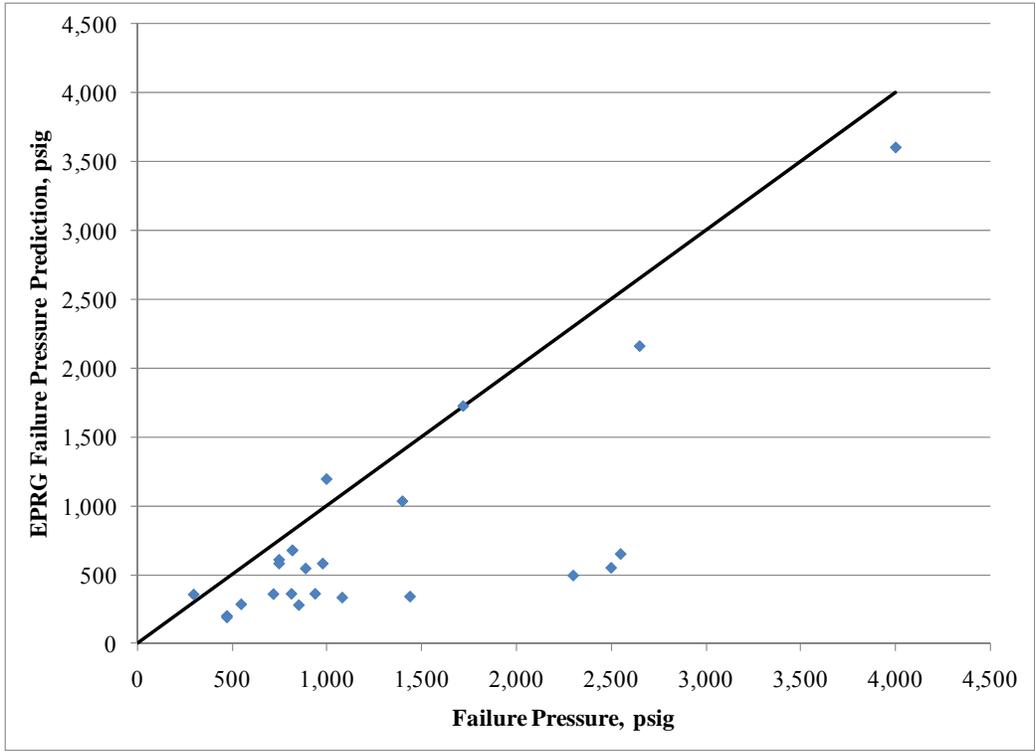
Figure 44 - Comparison of advanced EPRG failure prediction with actual failure pressure

The advanced EPRG model conservatively predicted failure in most cases. There were 2 neoconservative predictions. The model has the advantage of predicting a failure pressure as opposed to the go/no go criteria in the simplified model. If the advance model were to be used, we would recommend using a lower bound estimate of failure as is recommended in Reference 13.

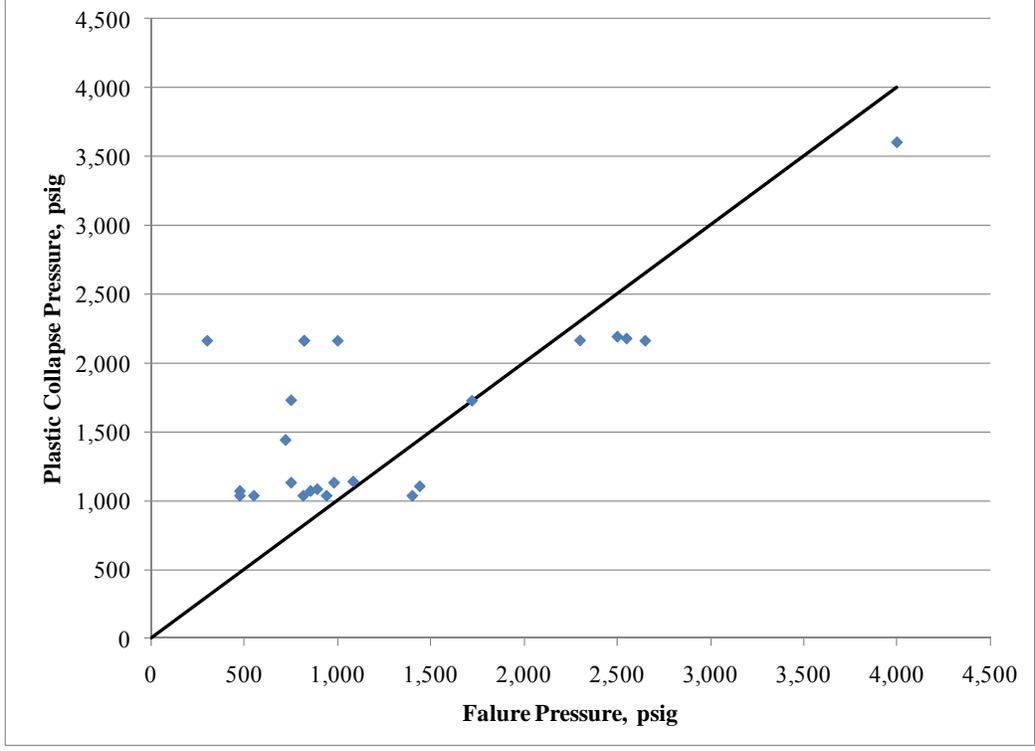
Figure 45 - Comparison of plastic collapse prediction with actual failure pressure

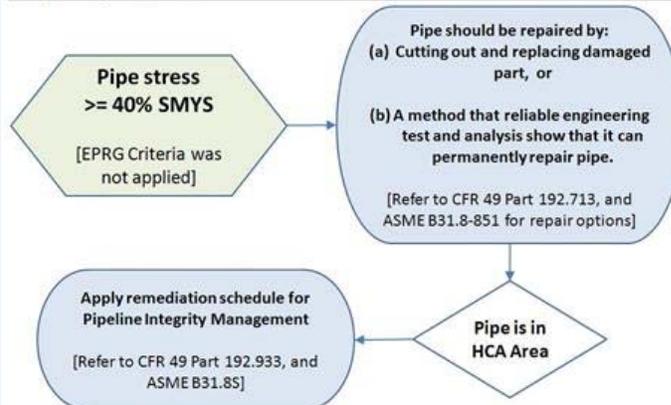
Figure 47 - Output example with operating stress larger than 40% SMYS

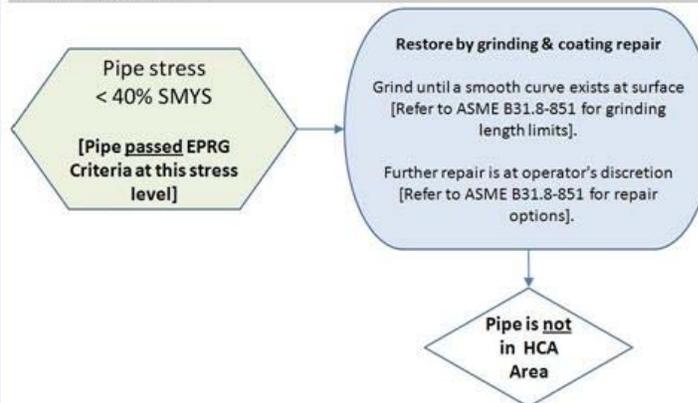
Figure 48 - Output example of damage passing EPRG criteria and not in HCA area

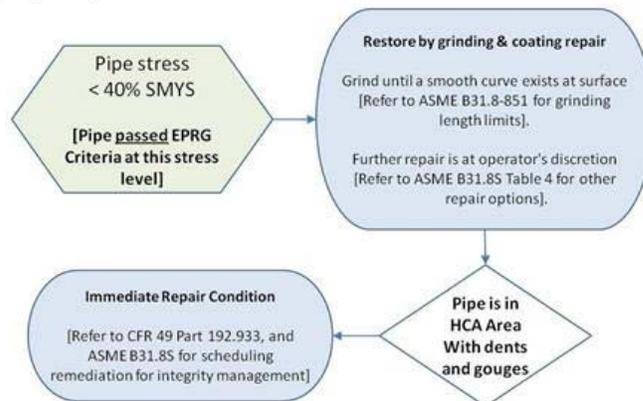
Figure 49 - Output example of damage passing EPRG criteria and in HCA area

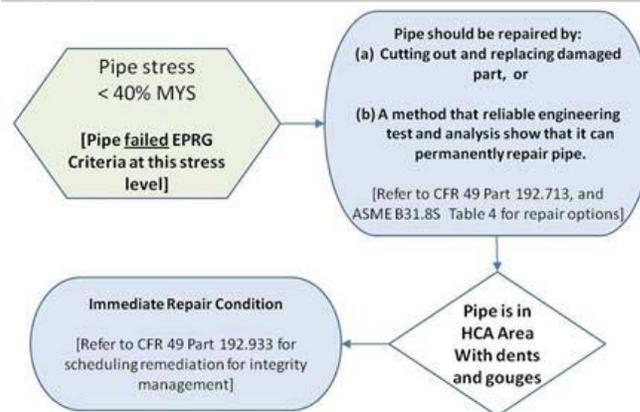
Figure 50 - Output example of damage failing EPRG criteria

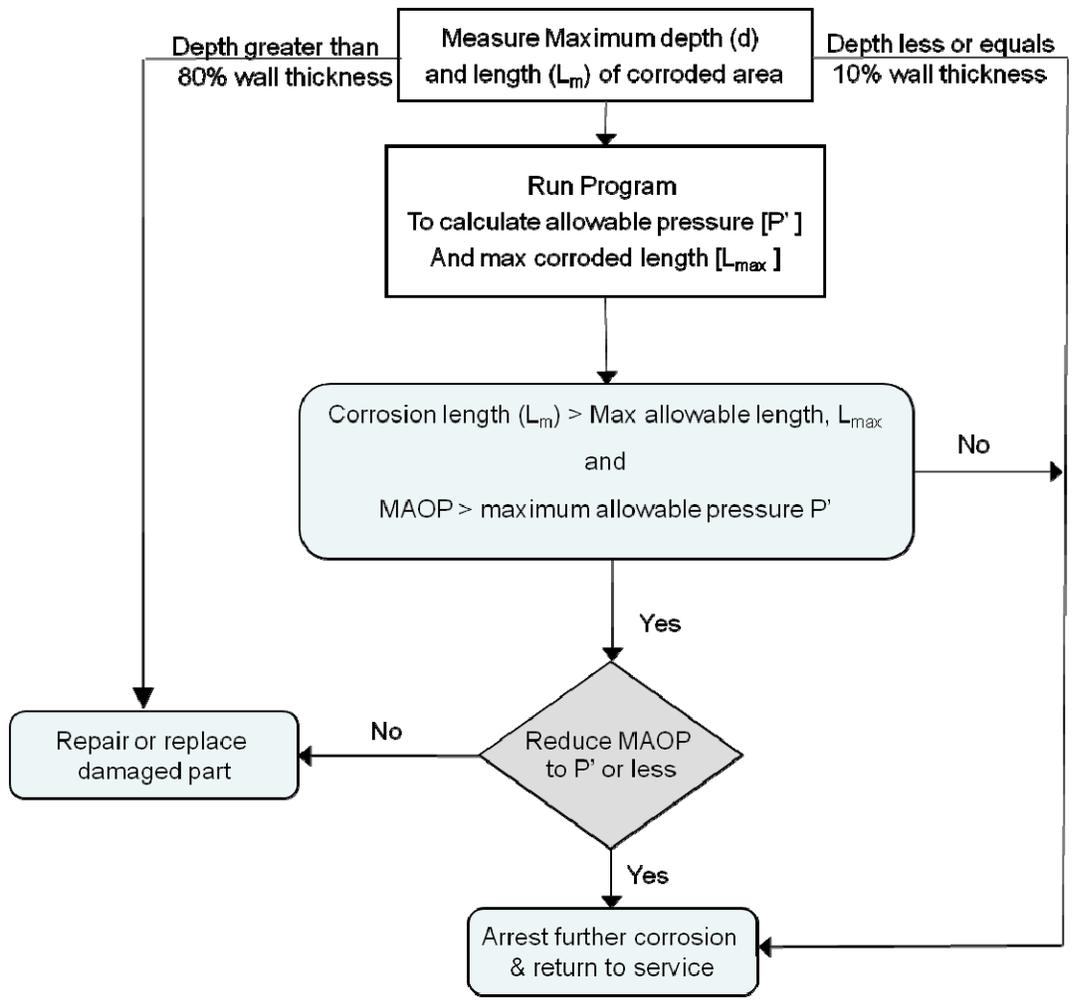
Figure 51 - Procedure for corrosion repair criteria, *after ASME B31G (14)*

The program calculates the maximum allowable corrosion length along the longitudinal axis of the pipe. The program also determines the safe maximum operating pressure (P') for the corroded length as entered by the user. Figure 52 shows an example of the program output for the calculation of the remaining strength of the corrosion damage.

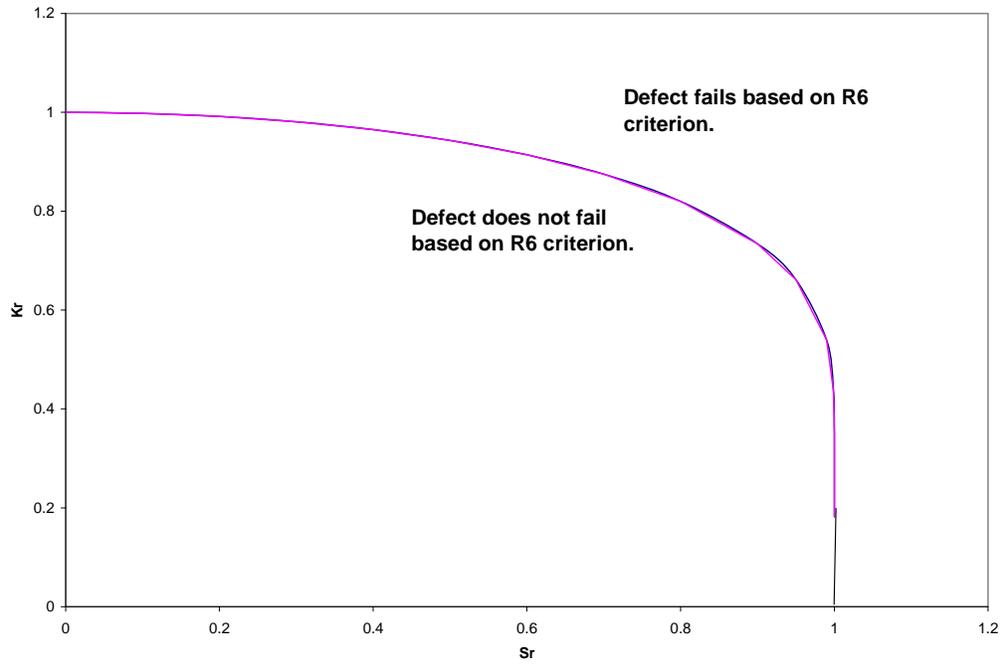
Figure B-1. Failure Assessment Diagram

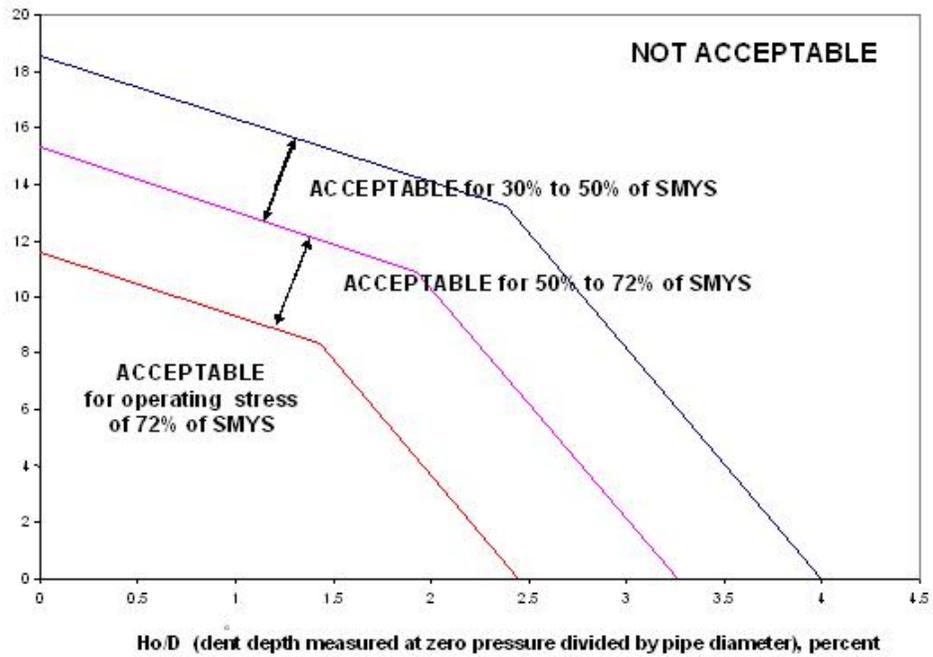
Figure B-2. The EPRG Simplified Model

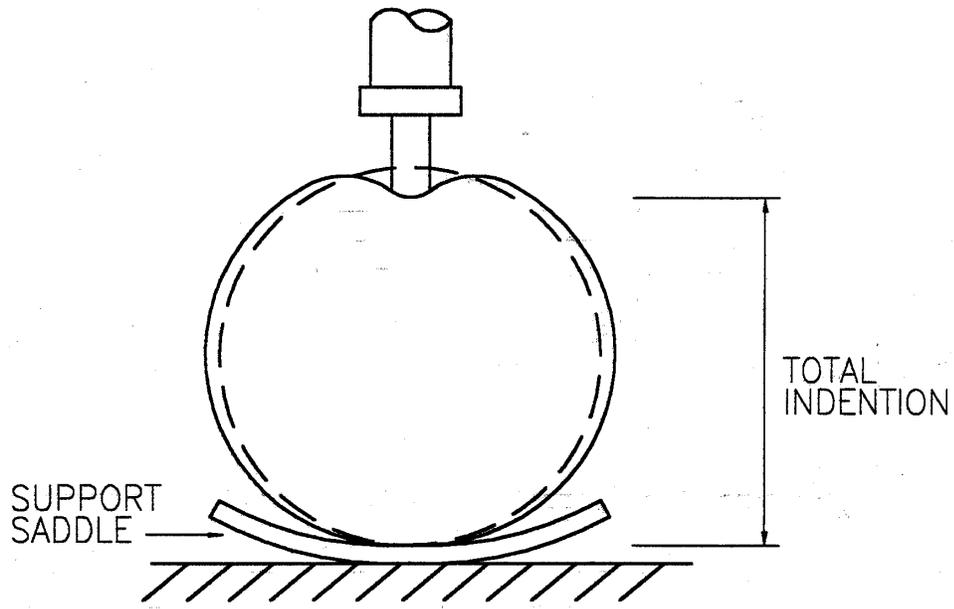
Figure B-3. Typical Indentation Process Associated with Methods 1 and 3

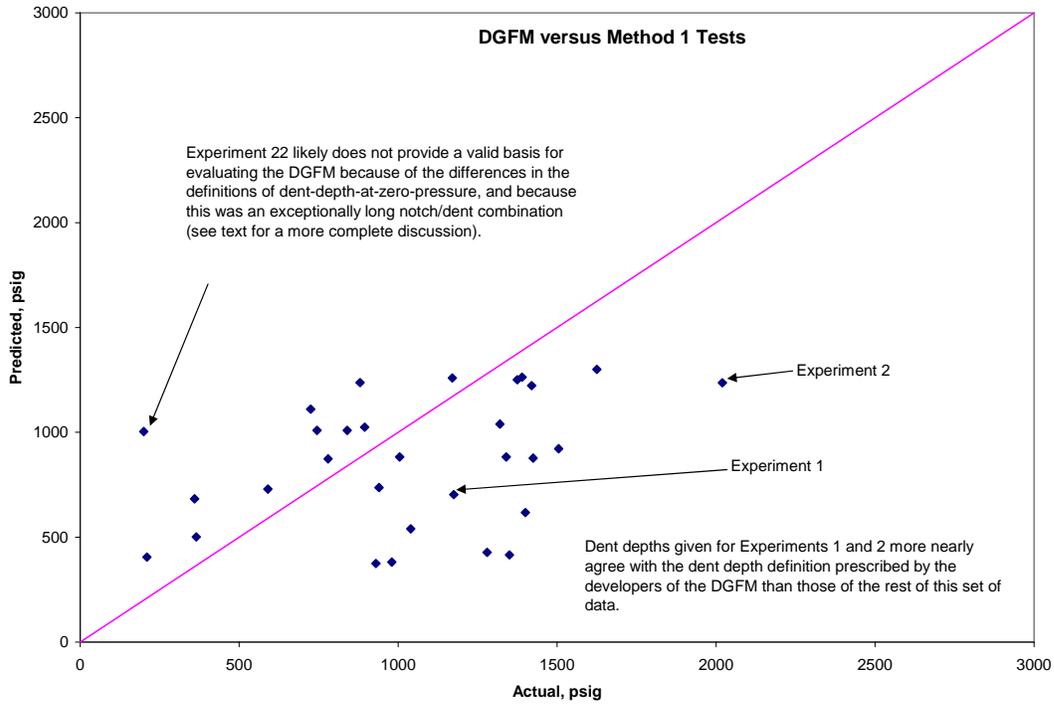
Figure B-7. Comparison between DGFM Predictions and Method-1 Test Data

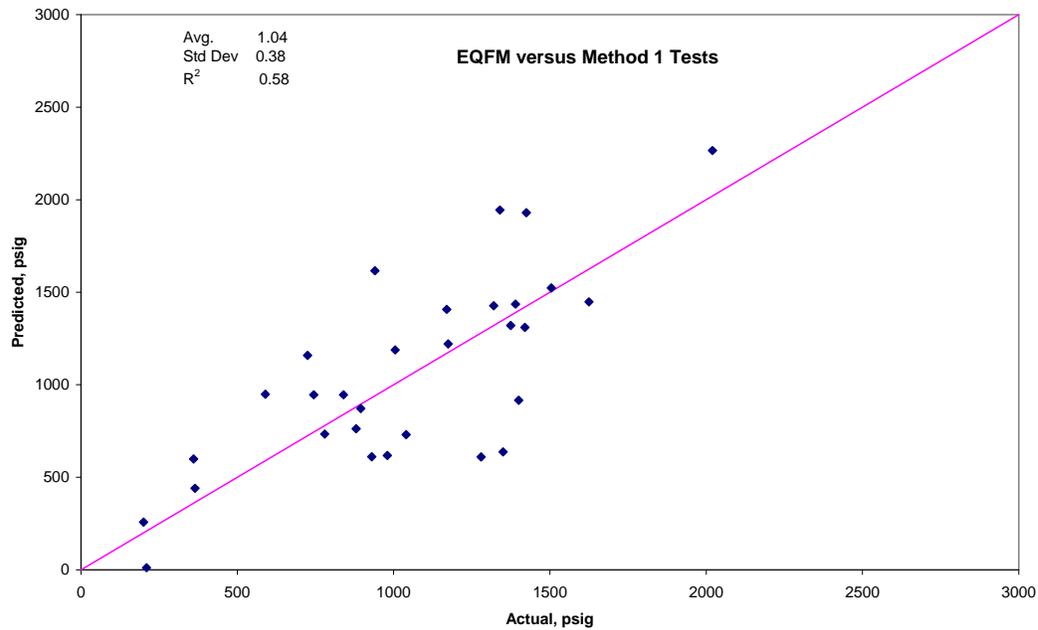
Figure B-8. Comparison between EQFM Predictions and Method-1 Test Data

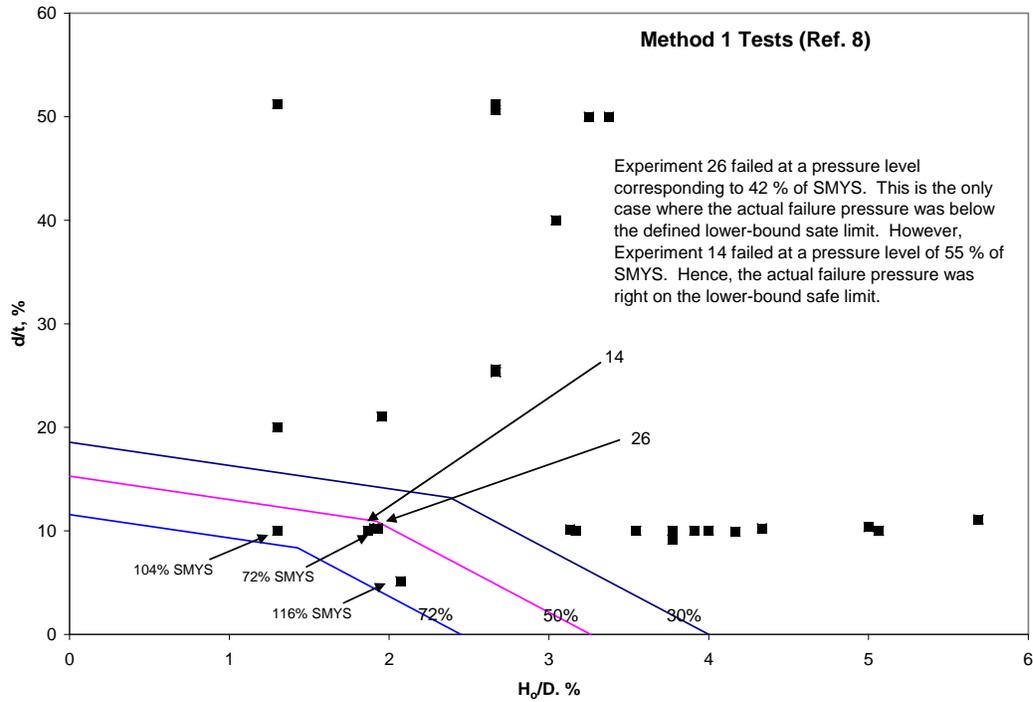
Figure B-9. Comparison between DGFm Simplified Criterion and Method-1 Test Data

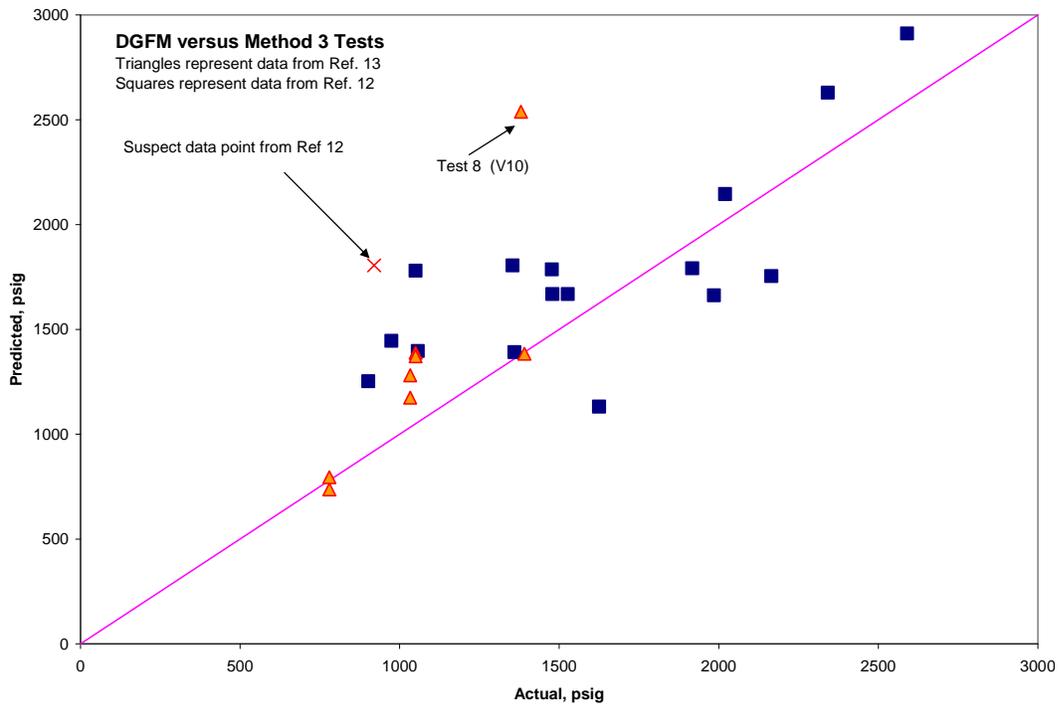
Figure B-10. Comparison between DGFm Predictions Based on Dent Depth at Zero Pressure and Method-3 Test Data

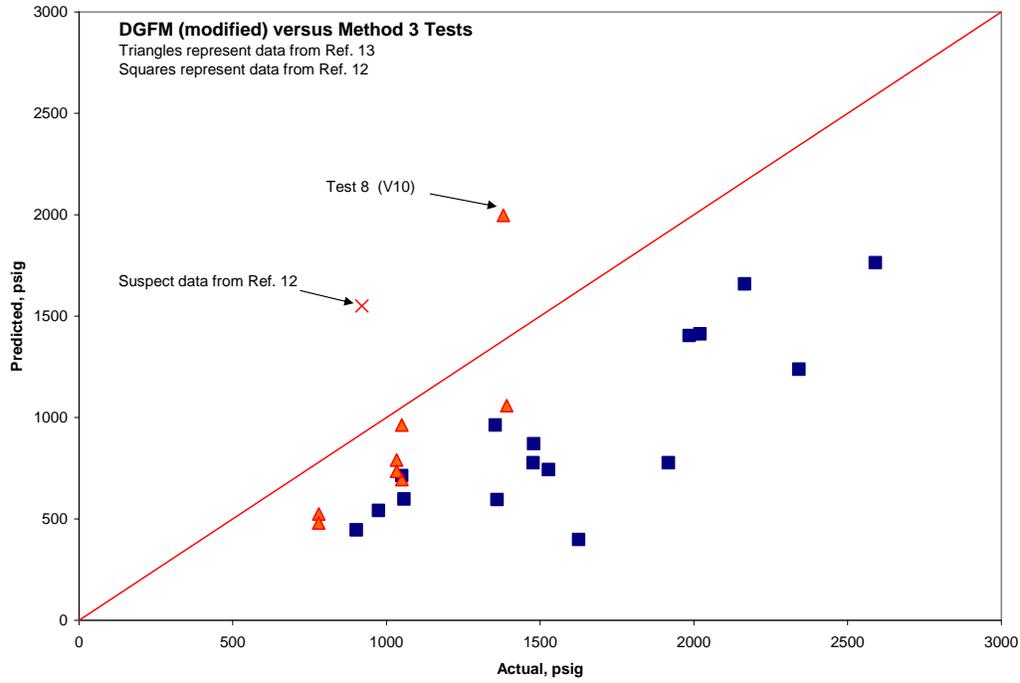
Figure B-11. Comparison between DGFM Predictions Based on Maximum Dent Depth and Method-3 Test

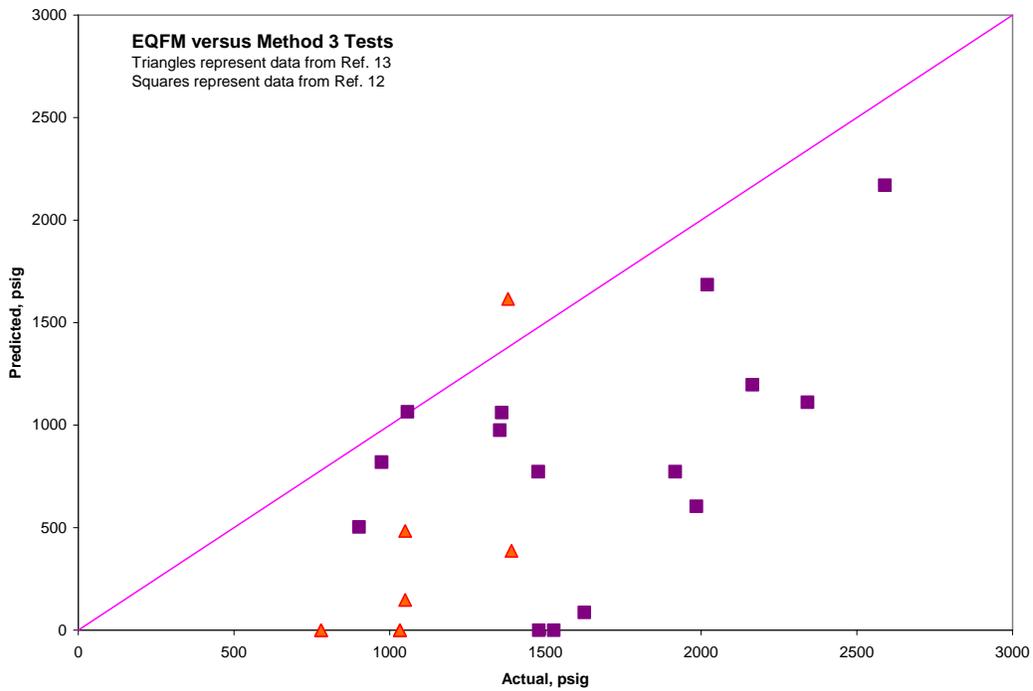
Figure B-12. Comparison between EQFM Predictions and Method-3 Test Data

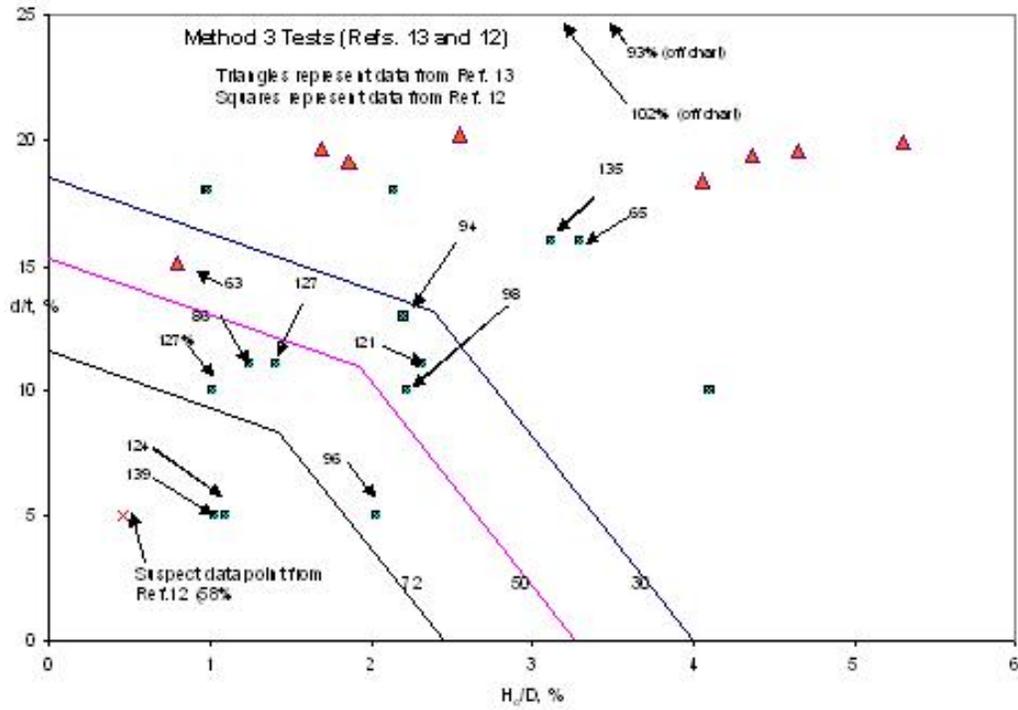
Figure B-13. Comparison between DGFMSimplified Criterion and Method-3 Test Data

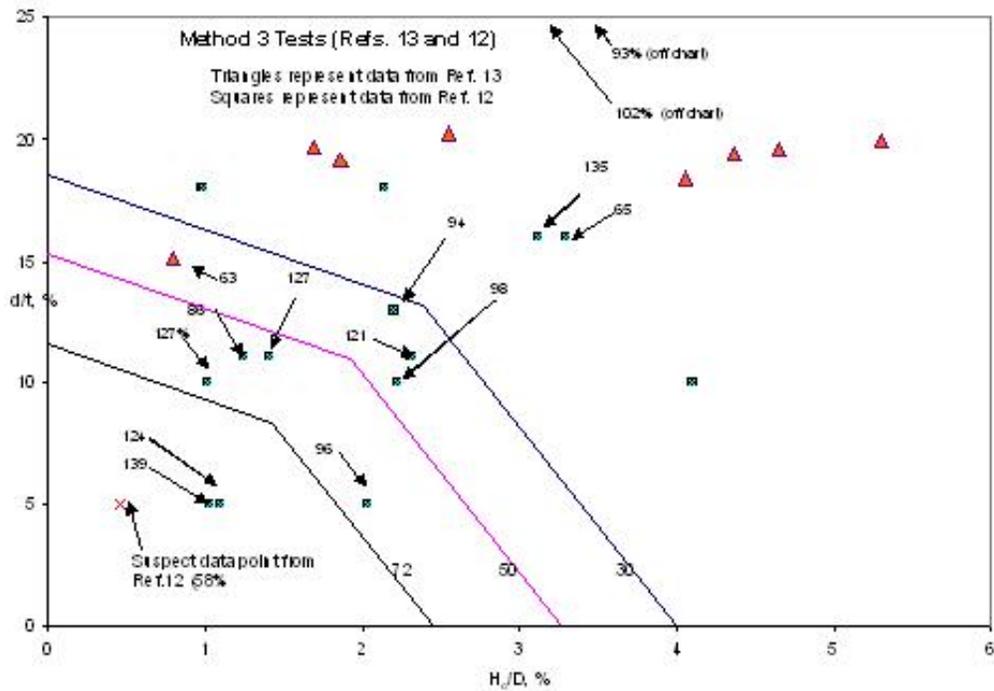
Figure B-14. Characteristic of Dent Formation in Pressurized Pipe

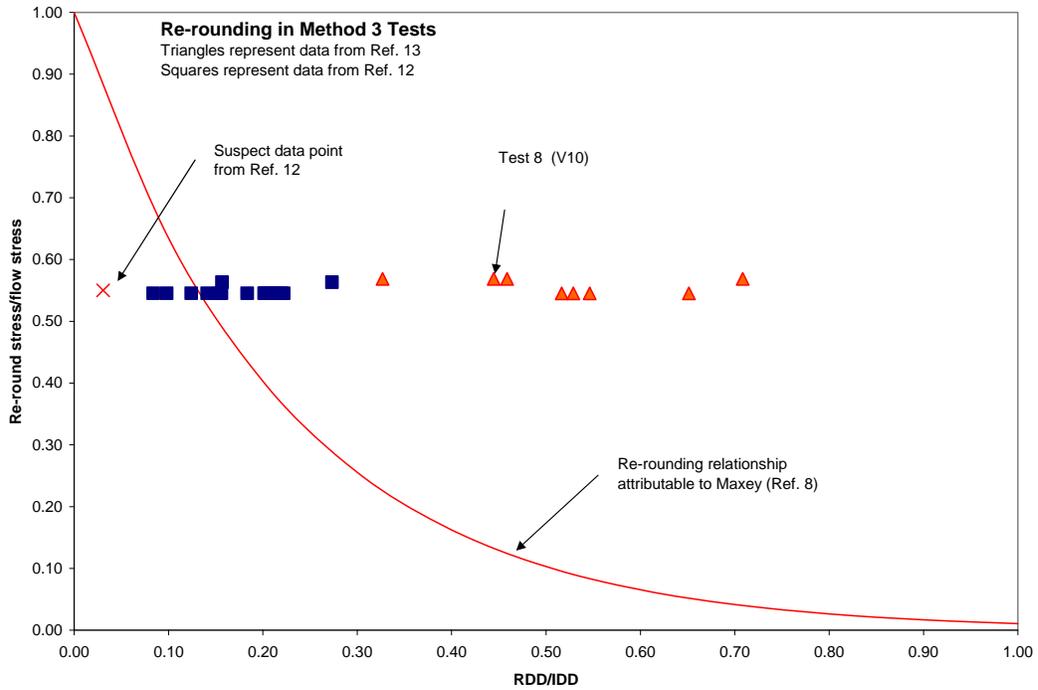
Figure B-15. Re-rounding at Pressure

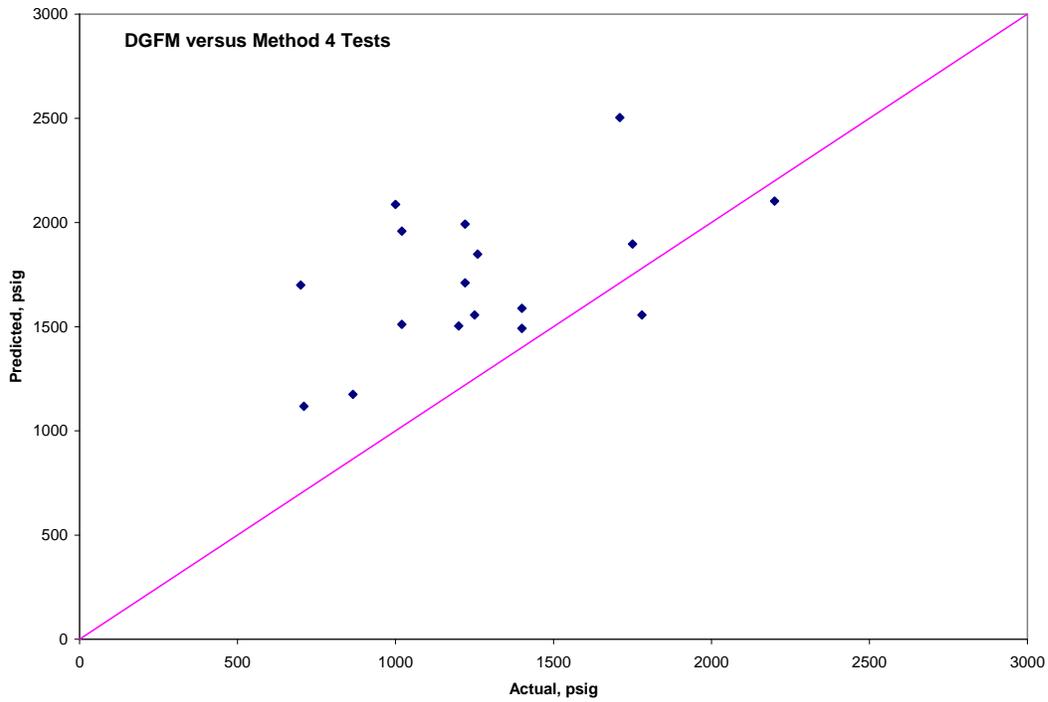
Figure B-16. Comparison between DGFM Predictions Based on Dent Depth at Zero Pressure and Method-4 Test Data

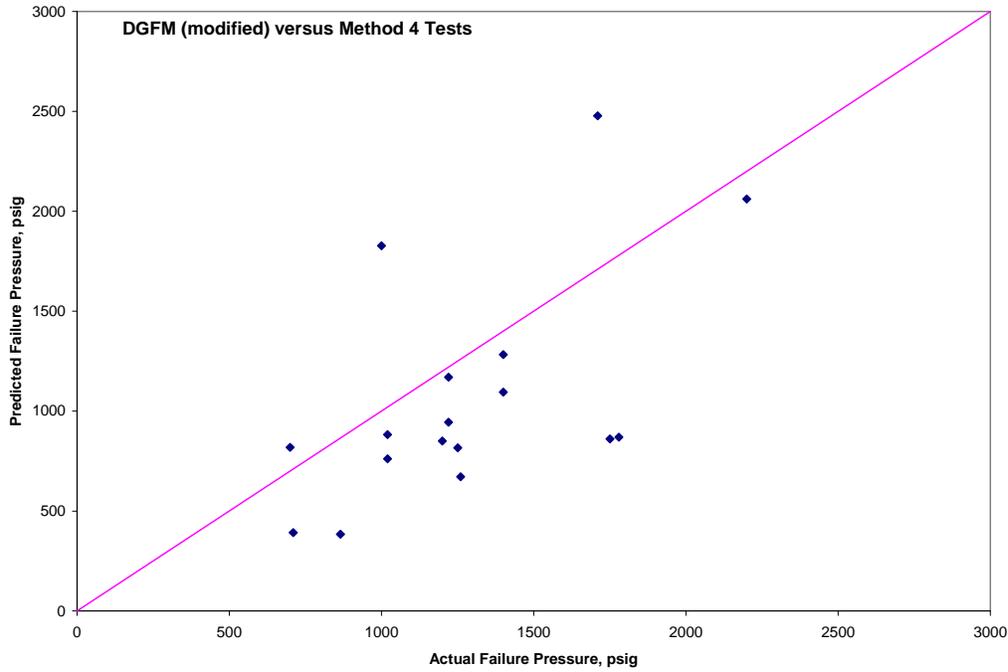
Figure B-17. Comparison between DGFM Predictions Based on Maximum Dent Depth and Method-4 Test Data

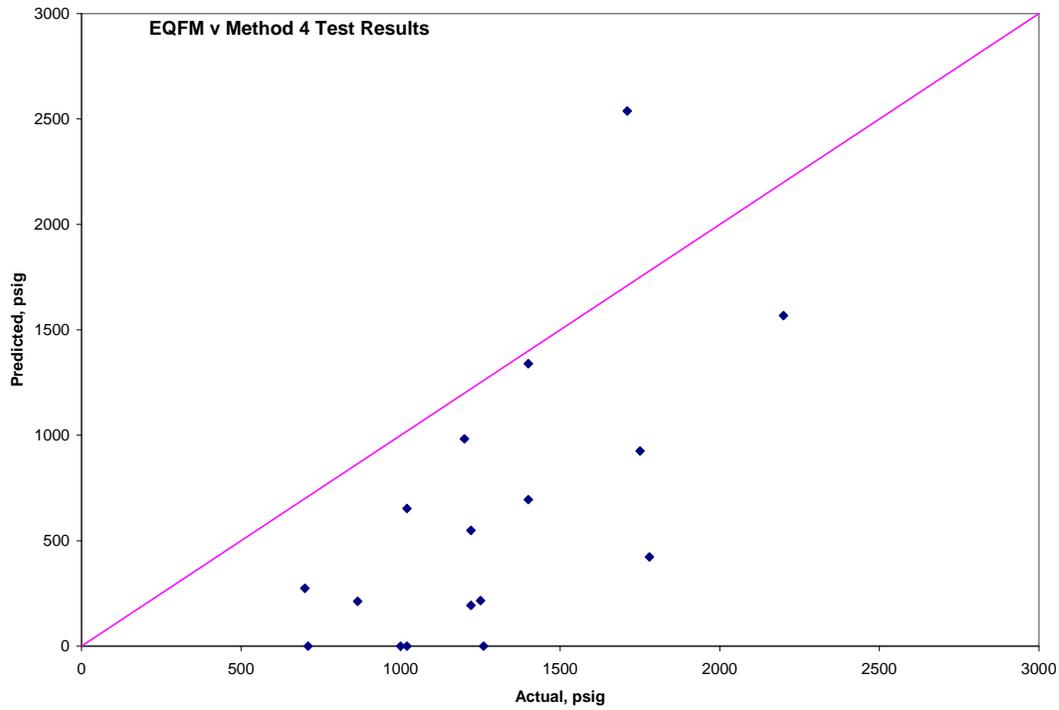
Figure B-18. Comparison between EQFM Predictions and Method-4 Test Data

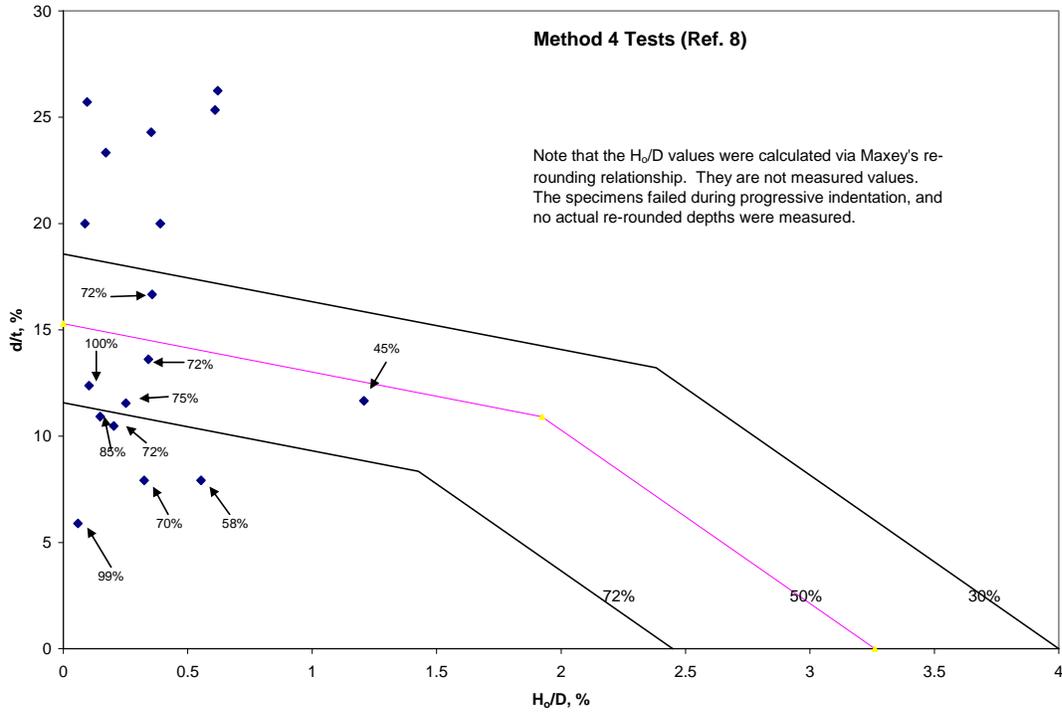
Figure B-19. Comparison between DGFm Simplified Criterion and Method-4 Tests

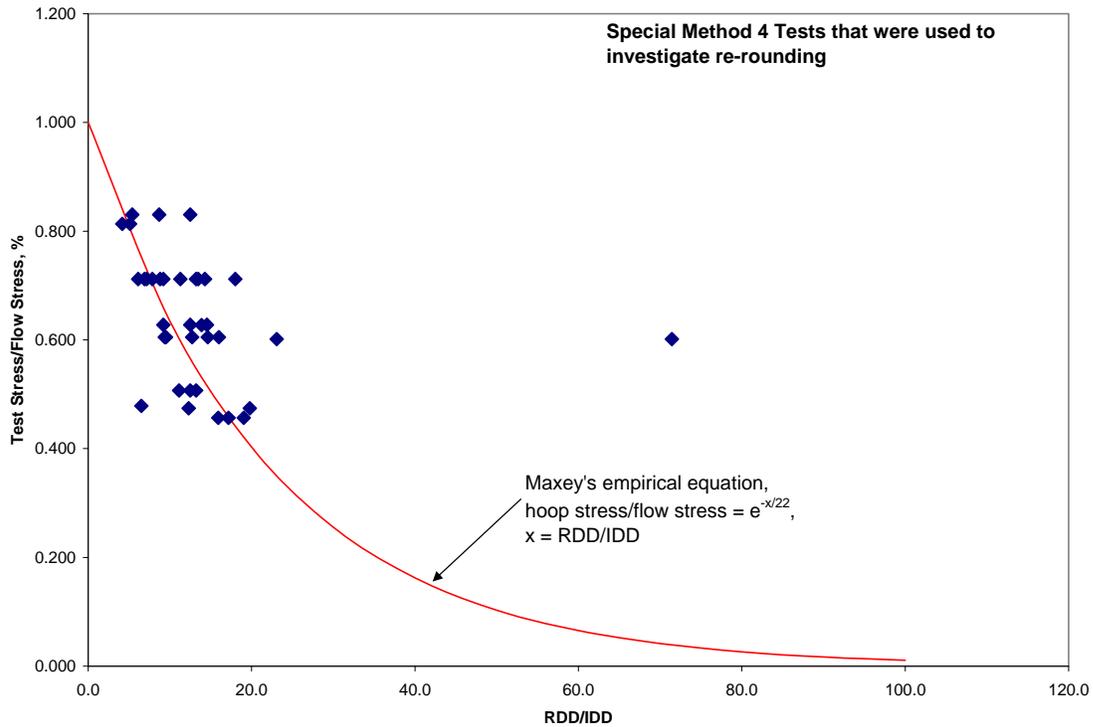
Figure B-20. Special Method-4 Tests that Show Characteristics of Re-rounding

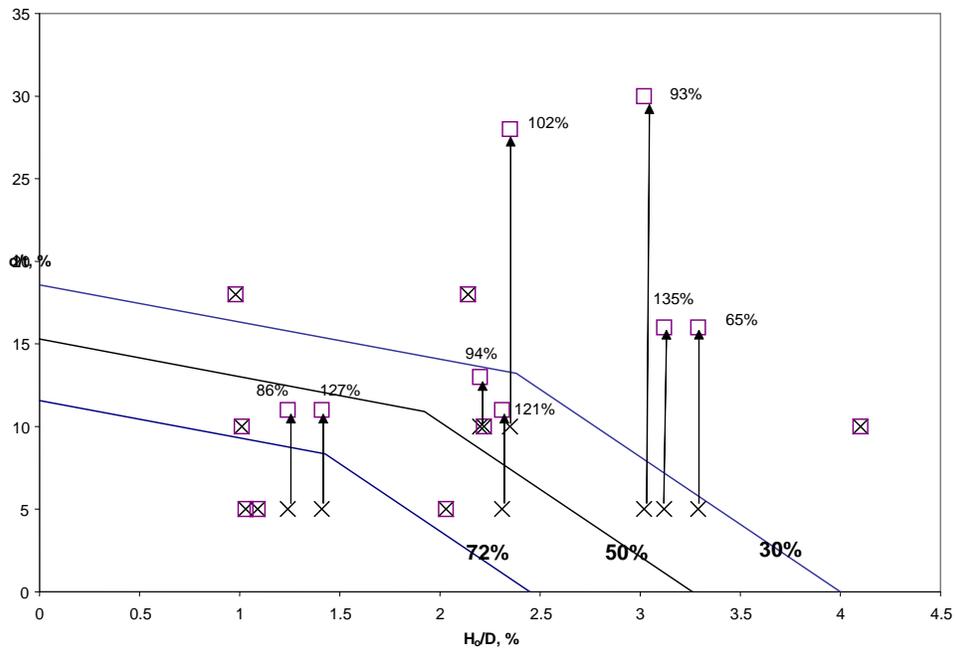
Figure B-21. Repositioned data from Figure 13 with crack depth included

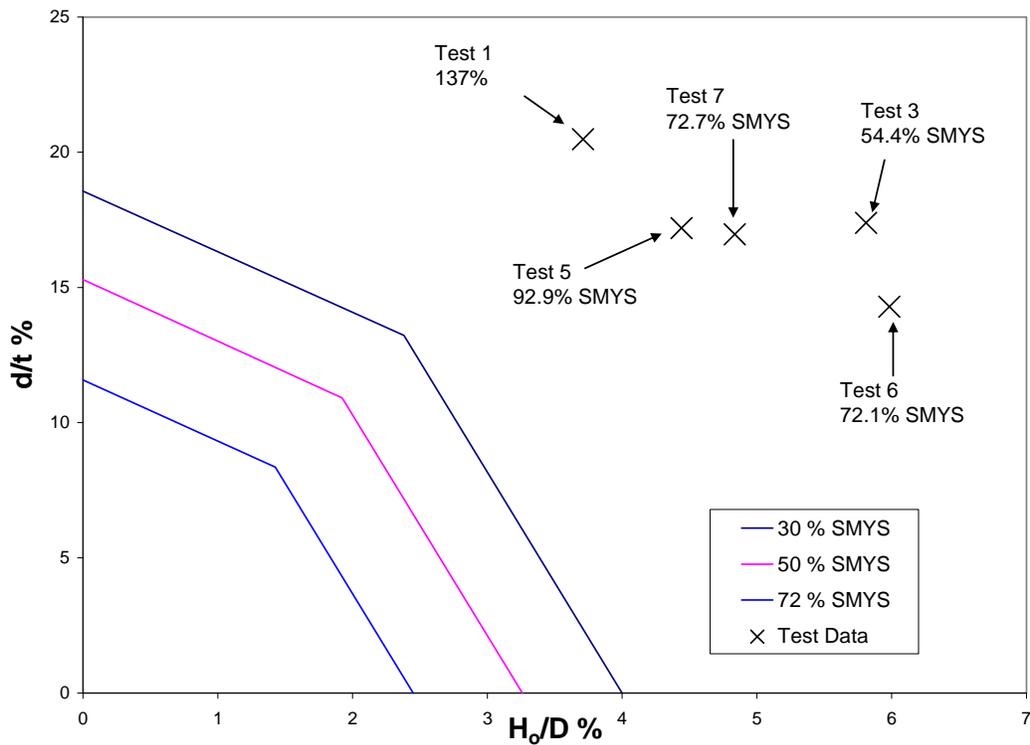
Figure B-22. EPRG simplified model compared to GTI's test data

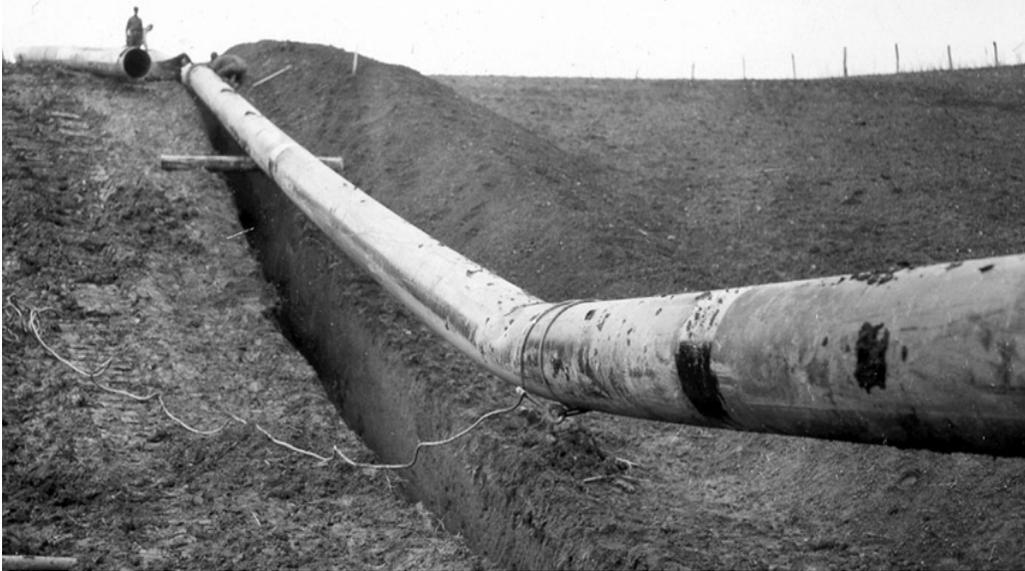
Figure C-1a. Hot formed bend with diamond shaped buckle from Reference (1)

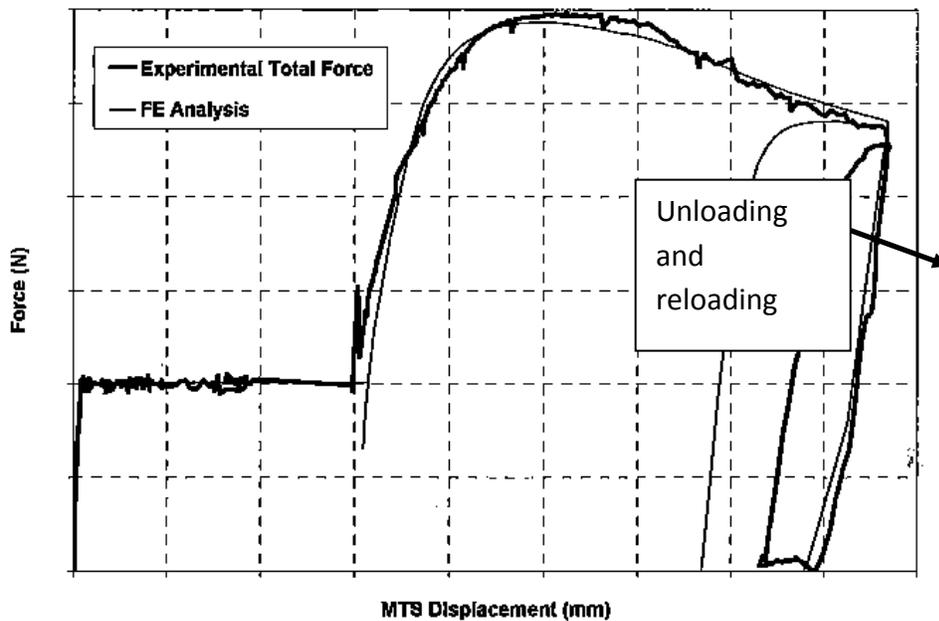
Figure C-2. Moment-displacement diagram from a displacement controlled pipe buckling test taken from Reference (11)

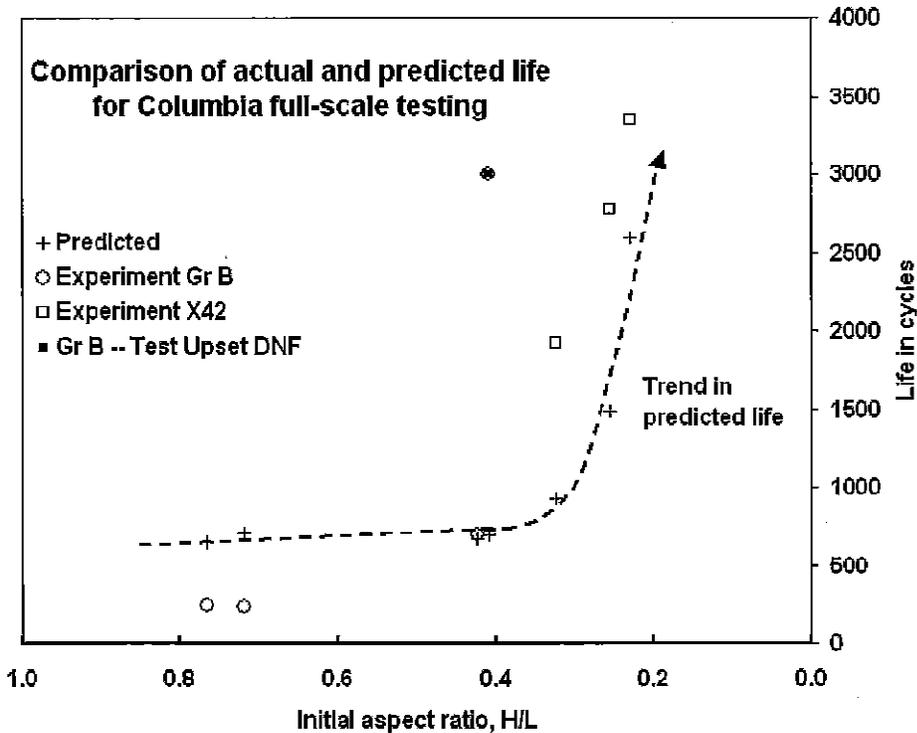
Figure C-3. Columbia Gas wrinkle bend test results
