# Mechanical Damage

## FINAL REPORT

**U.S. Department of Transportation  
Pipeline and Hazardous Materials Safety Administration  
Office of Pipeline Safety**

**Integrity Management Program  
Under Delivery Order DTRS56-02-D-70036  
(Technical Task Order 16)**

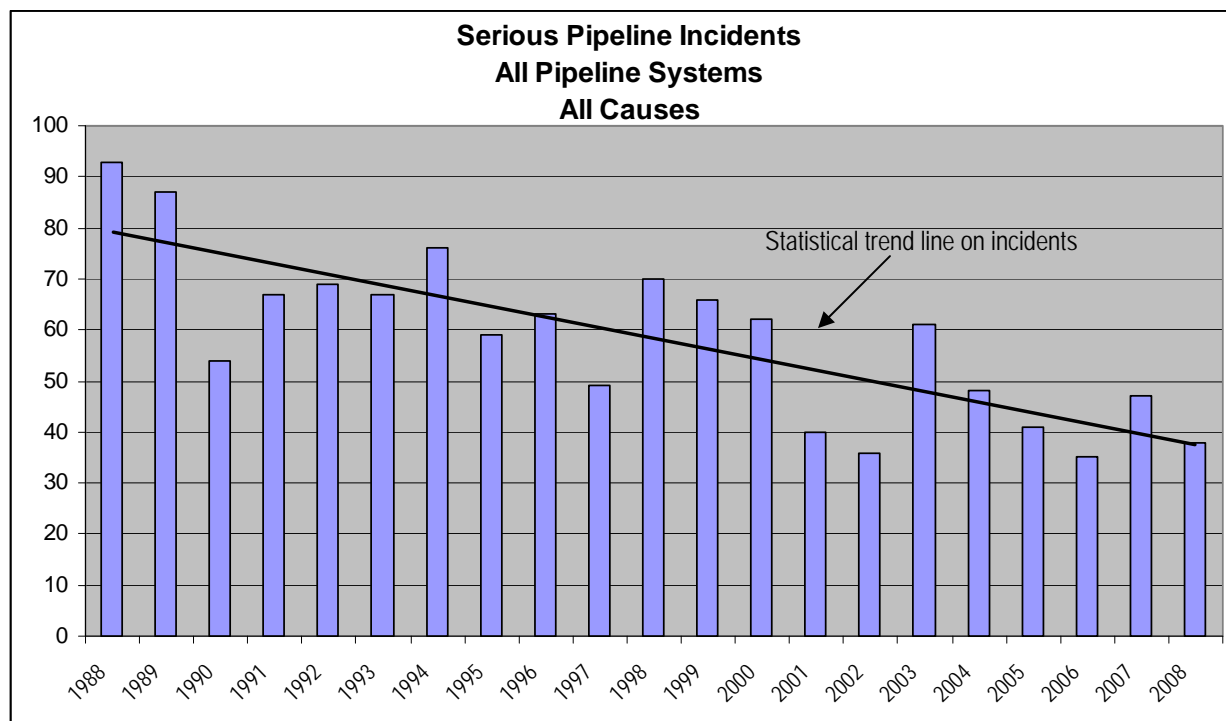
*Figure 1.1 – Serious Pipeline Incidents – All pipeline systems (onshore and offshore)  
Source: DOT/PHMSA Pipeline Incident Data*

injury requiring in-patient hospitalization) from all causes including excavation damage, corrosion, human error, natural force damage, material failure and other outside force damage. As illustrated in Figure 1.1, the data indicates a downward trend of serious incidents from all causes on all types of pipelines from 1988-2008.

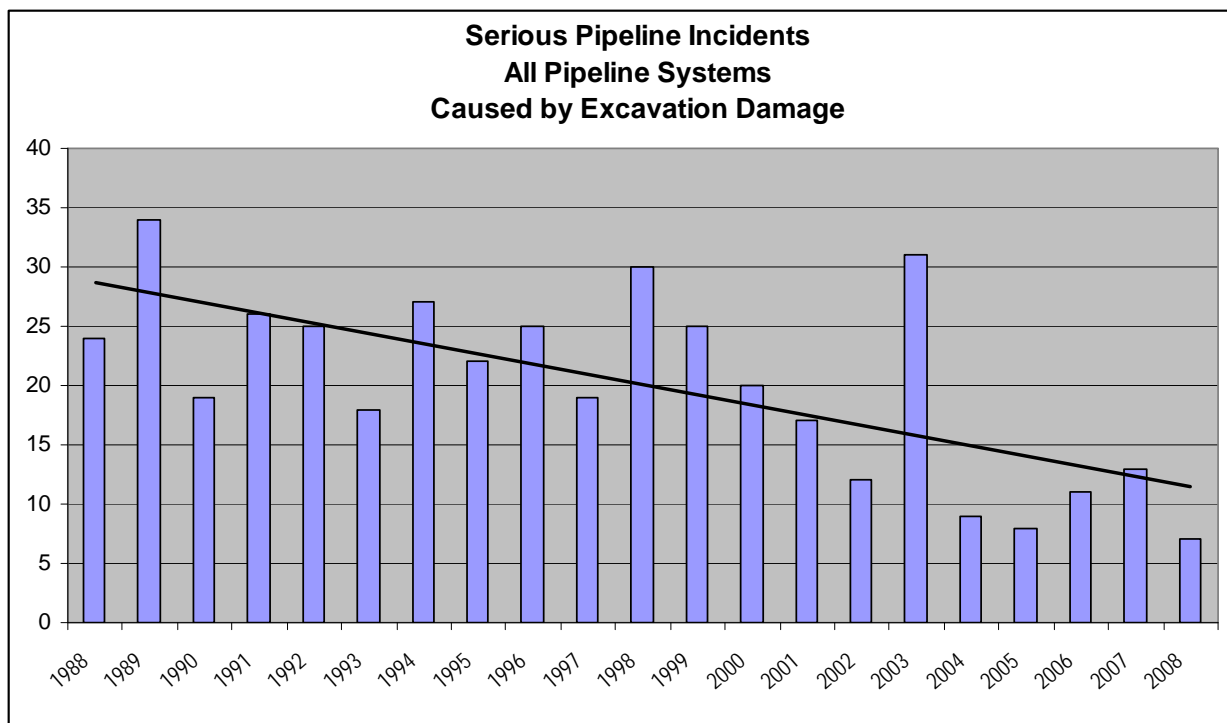
*Figure 1.2 – Serious Pipeline Incidents Caused by Excavation Damage - All pipeline systems (onshore and offshore)  
Source: DOT/PHMSA Pipeline Incident Data*

Figure 1.2 indicates a similar trend for serious pipeline incidents caused by excavation damage for the same 20- year period. This positive trend is the result of a broad array of initiatives at all levels designed to engage all stakeholders in efforts to reduce the risk of damage to underground facilities.

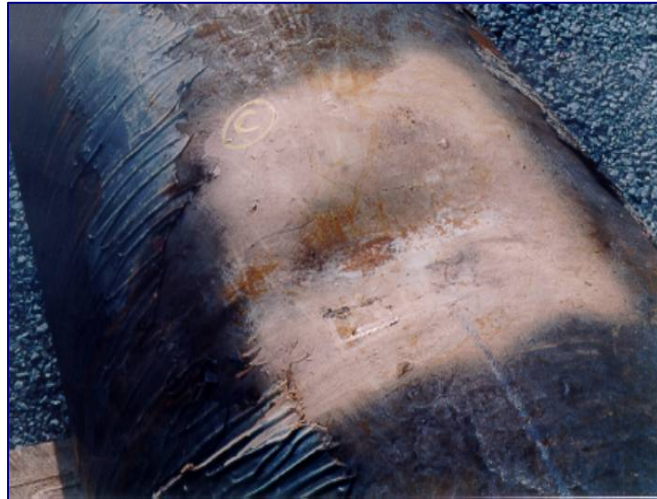
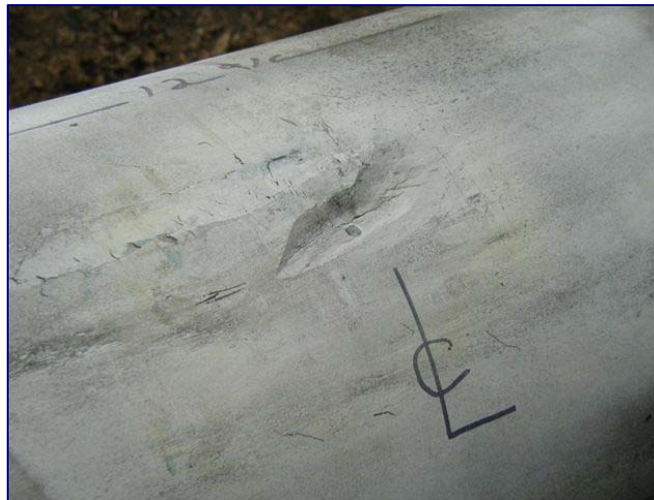
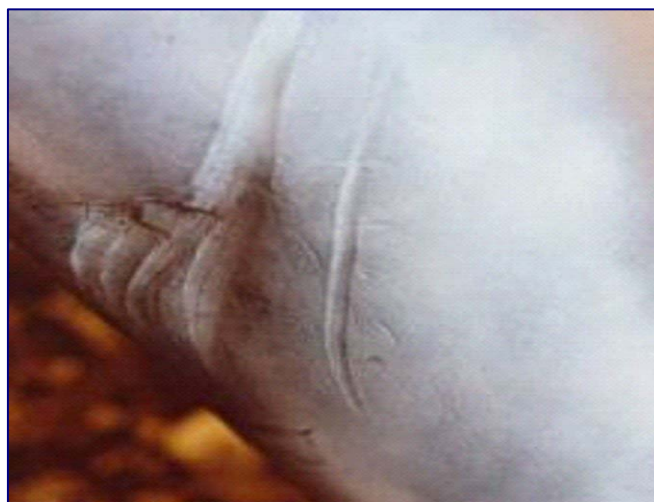
A. Dent

B. Gouge

C. Dent with Gouge

*Figure 4.1 – Examples of Mechanical Damage Features*

In this section, mechanical damage is discussed in three broad categories: dents, gouges, and combined dent/gouge defects. Figure 4.1 shows examples. Each mechanical damage defect reflects a unique combination of conditions, such as the indenter size and shape, as well as force, angle, orientation, and duration of impact. The different forms of damage can be generalized to facilitate assessment and prioritization of repairs, as explained below (Cosham and Hopkins, 2002).

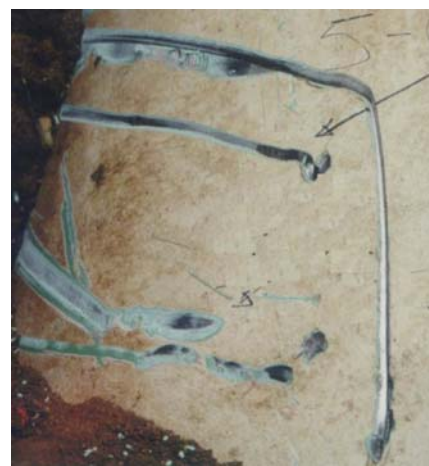
*Figure 4.2 – Gouge Characteristics*

When dents and gouges are found together, containing cracks or damaged metal, or when one or both are near a seam or girth weld, the damage should be treated with caution. Complex mechanical damage is not easy to evaluate, nor are the simple "rules of thumb" discussed later in this report applicable.

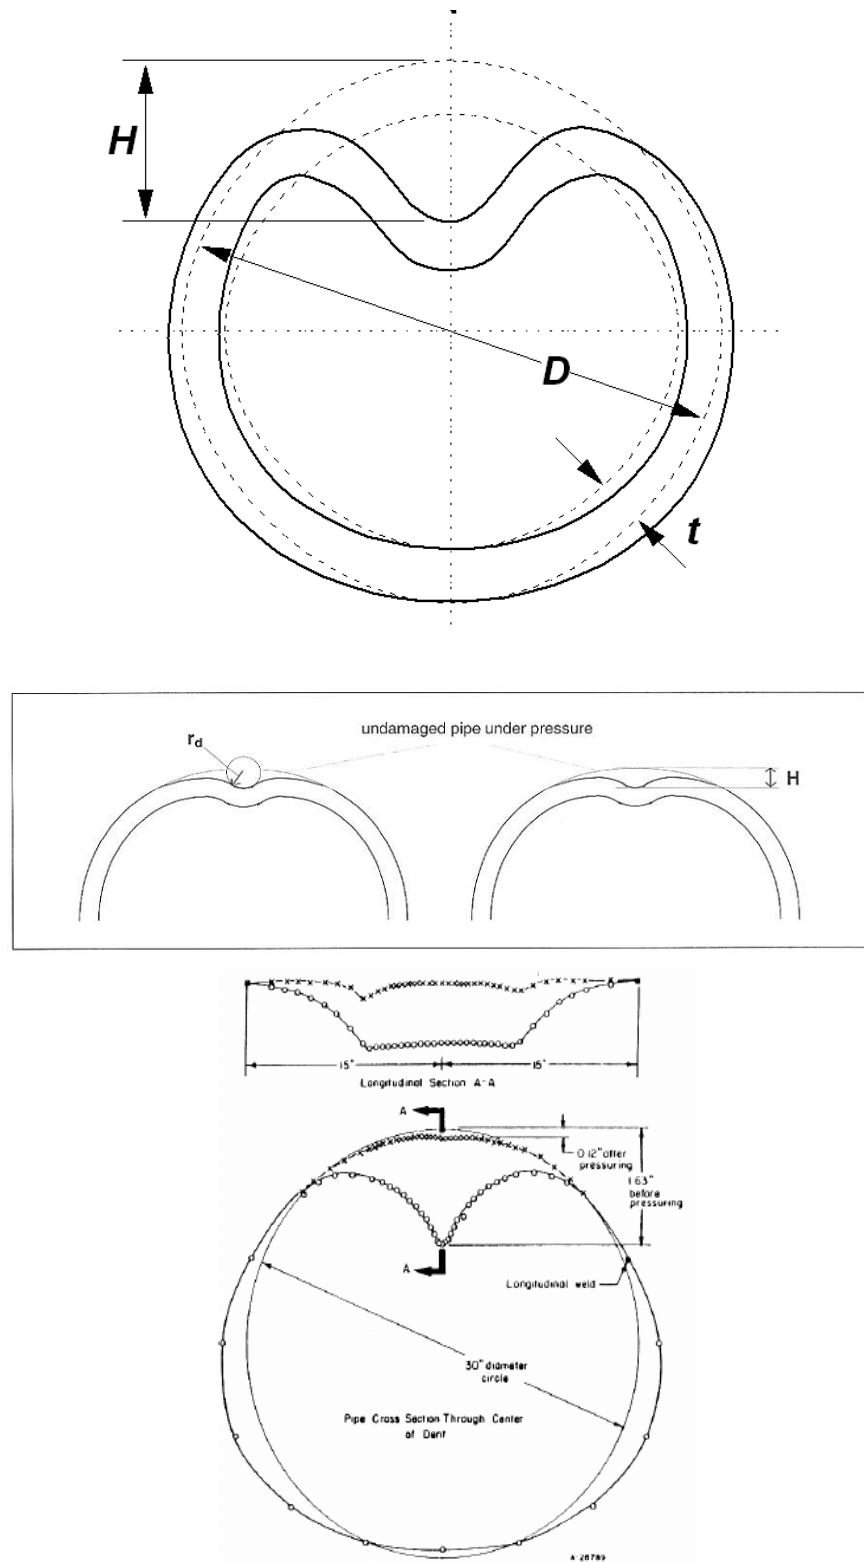
Figure 4.3 – Dent Depth Measurement (Hopkins and Leis, 2003)

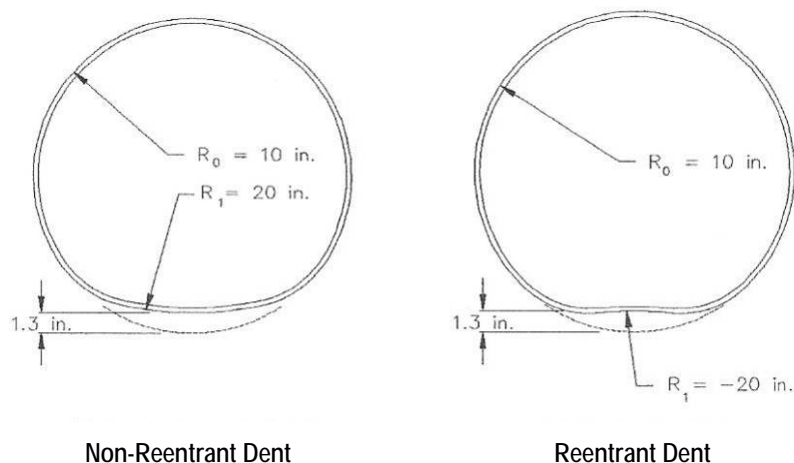
*Figure 4.4 – Measurement of Re-Entrant and Non-Re-Entrant Dent Depth (Baker, Jr., M., 2004)*

Dents can be described as either non-reentrant or reentrant (Figure 4.4). A positive radius value defines a non-reentrant dent, in which the outer surface of the pipe is flattened but retains its convexity. A negative radius value defines a reentrant dent, in which the outer surface of the pipe is dented deeply enough that it becomes concave. Dent shape has also been described in terms of the maximum angle subtended by the flanks of the dent (Baker, 2004)

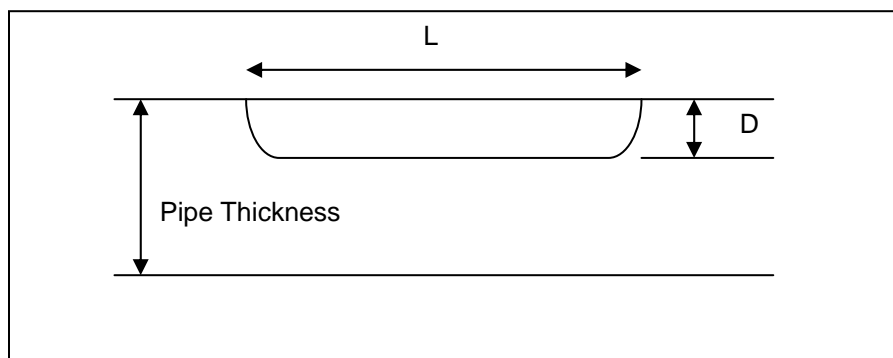
*Figure 4.5 – Gouge Depth Measurement (OPS TTO10, 2004)*

The geometric parameters used to characterize a gouge are the depth, length, width, and angle to axis, etc. These are usually measured from the undeformed outer radius of the pipe (Figure 4.5).

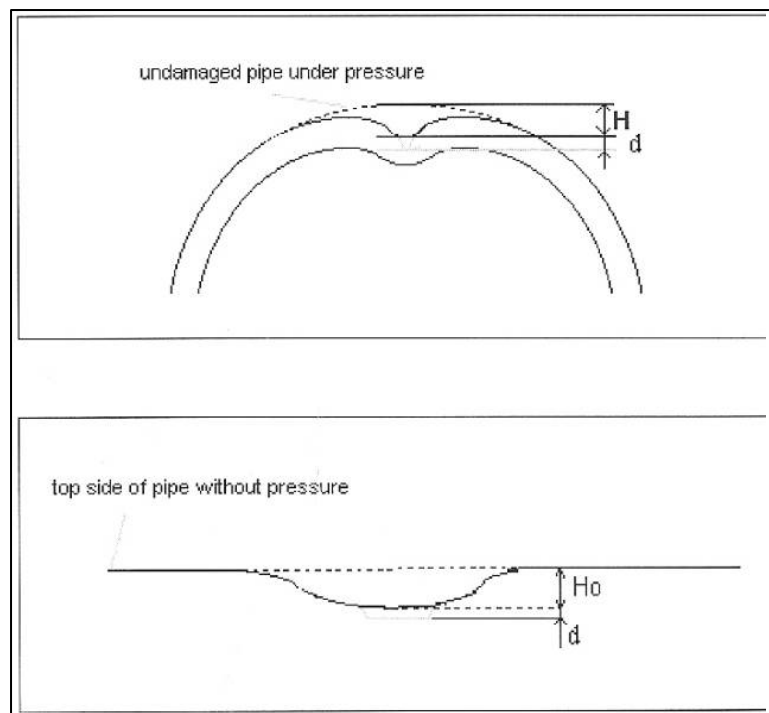
Figure 4.6 – Depth Measurement for Combined Dents and Gouges

For combined dents and gouges, the gouge length and depth are usually measured from the metal surface at the shoulder of the gouge – that is, not including the depth or length of the dent (Figure 4.6). Similarly, the depths of cracks are measured from the metal surface, excluding the depth or length of the associated dent and/or gouge. However, for assessment purposes, it sometimes may be appropriate to add the gouge and crack depths (see Section 7).

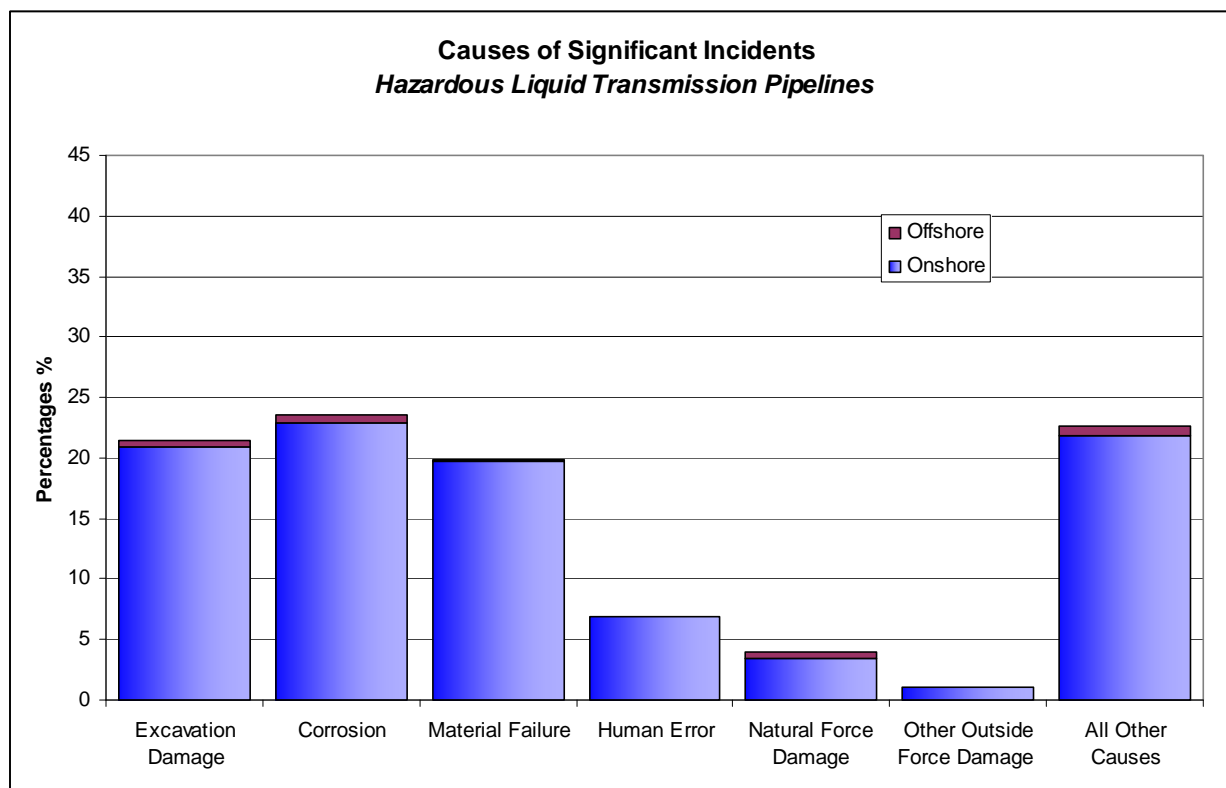
*Figure 4.7 – Causes of Significant Pipeline Incidents on Hazardous Liquid Transmission Pipelines from 1988-2008*  
Source: DOT/PHMSA Pipeline Incident Data

Figure 4.7 shows the breakdown of significant pipeline incidents by cause for hazardous liquid transmission pipelines for the period 1988-2008. During this period, there were 43 fatalities reported and 234 injuries requiring hospitalization, all on onshore pipelines. Of these, 14, or 33 percent of fatalities, and 87, or 37 percent of inquiries, were the result of excavation damage. Only by a slightly larger percentage were fatalities and injuries attributed to “all other causes.” This category includes those incidents whose causes could not be specifically determined. Total property damage costs in excess of \$1.54 billion were reported for all liquid pipeline incidents, with 14 percent, or \$223 million, resulting from excavation damage. Eighty-five percent of the excavation damage property cost was to onshore pipelines.

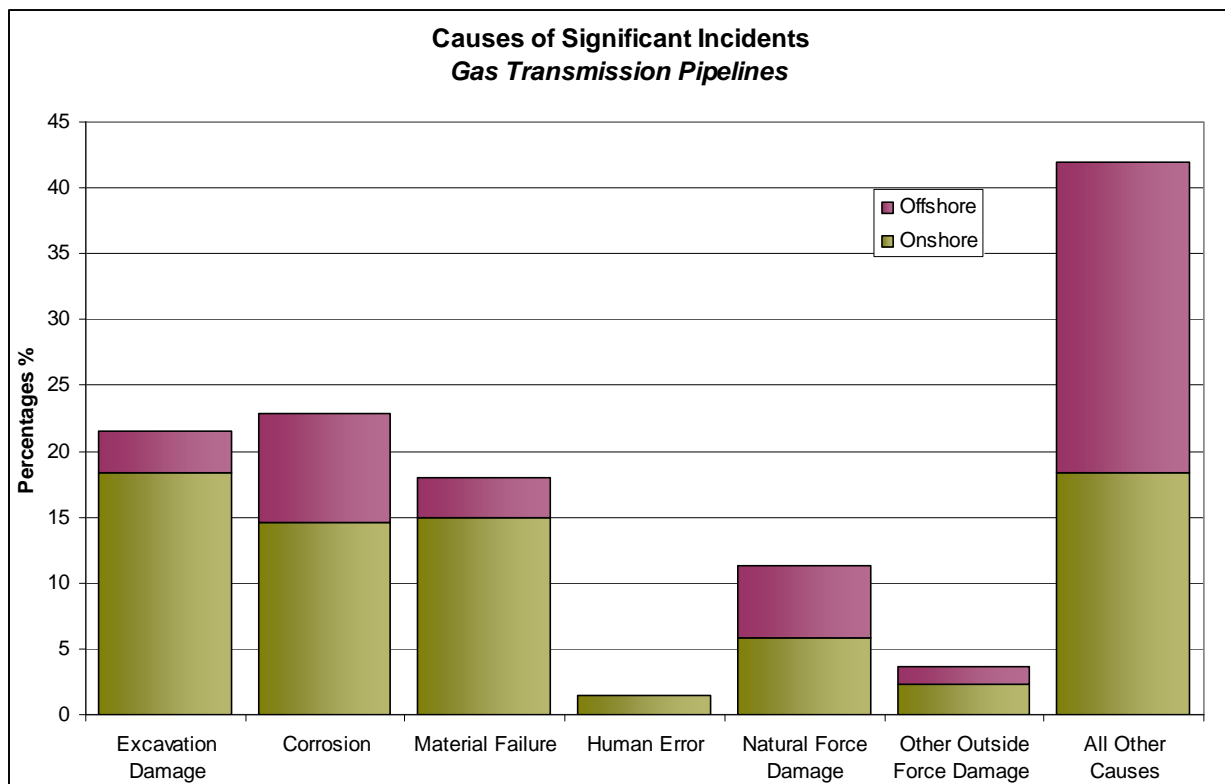
*Figure 4.8- Causes of Significant Pipeline Incidents on Gas Transmission Pipelines from 1988-2008*  
Source: DOT/PHMSA Pipeline Incident Data

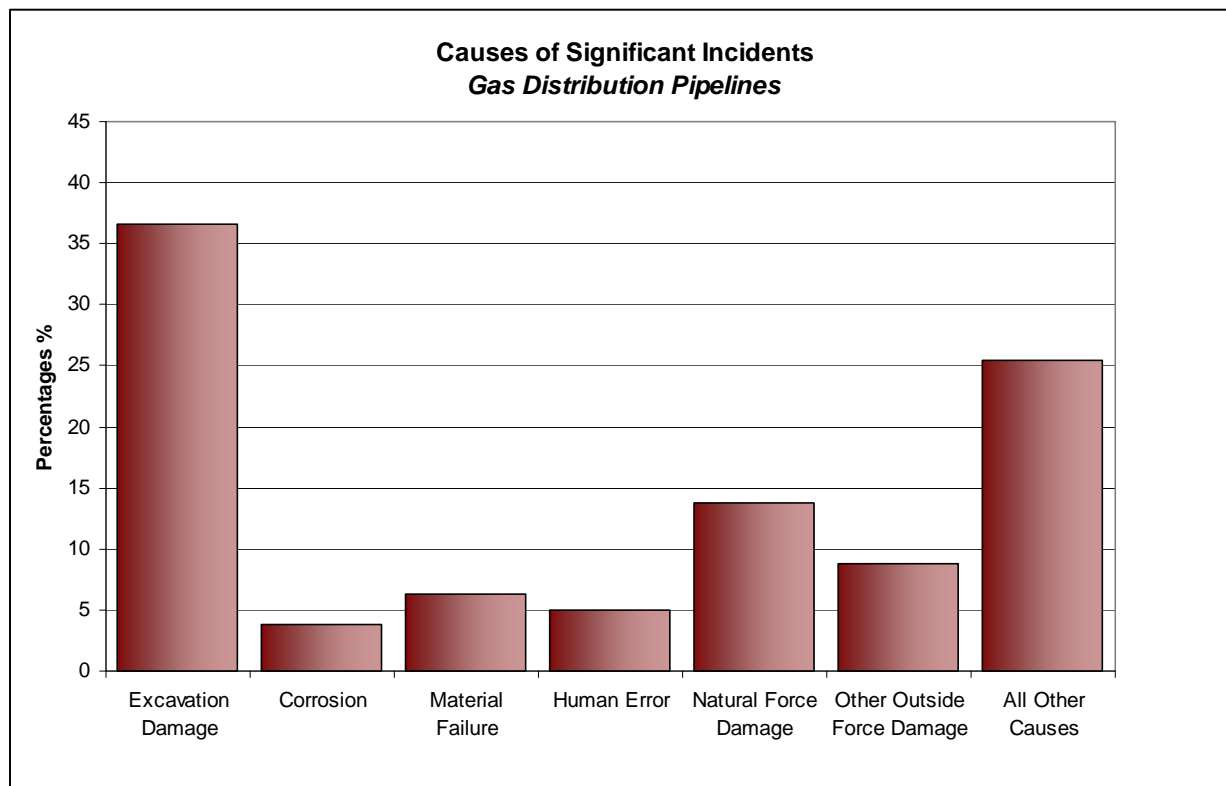
Figure 4.9 - Causes of Significant Pipeline Incidents on Gas Distribution Pipelines from 1988-2008  
Source: DOT/PHMSA Pipeline Incident Data

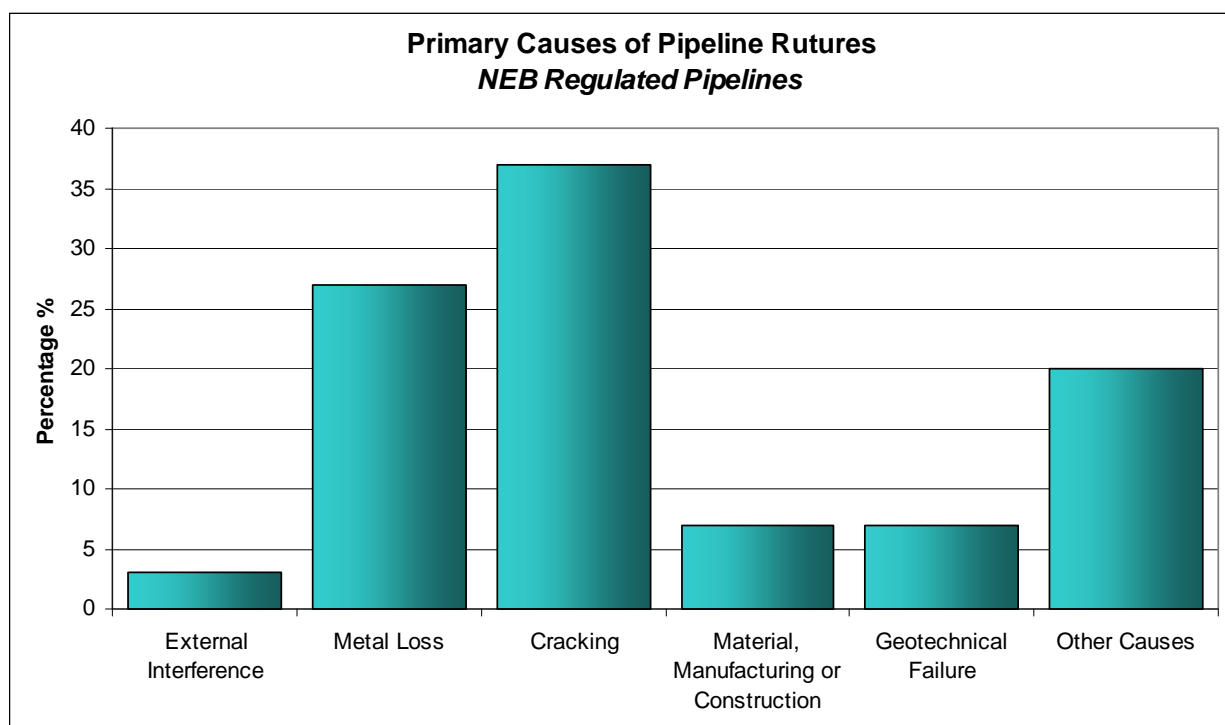
Figure 4.10 – Primary Causes of Pipeline Ruptures on NEB Regulated Pipeline (NEB, 2008)

Figure 4.10 shows that the primary cause of ruptures on pipelines regulated by Canada's National Energy Board (NEB) between 1991 and 2006 was cracking, followed by metal loss. Cracking includes hydrogen-induced and mechanical damage delayed cracking, stress corrosion, and corrosion fatigue. Metal loss includes both internal and external corrosion. The category of "Other Causes" includes improper operation, fire, and yet-to-be-determined causes. The NEB defines a rupture for natural gas pipelines as any unintended or uncontrolled release of natural gas, and as any unintended or uncontrolled release of liquid hydrocarbons associated with pipe body failure and a release volume in excess of 1.5 cubic meters. It should be noted that the total number of ruptures reported during this time period was 30, with only one rupture attributed to external interference. The low number of ruptures due to excavation damage has been primarily attributed to the remoteness of most NEB-regulated pipelines. (NEB, 2008)

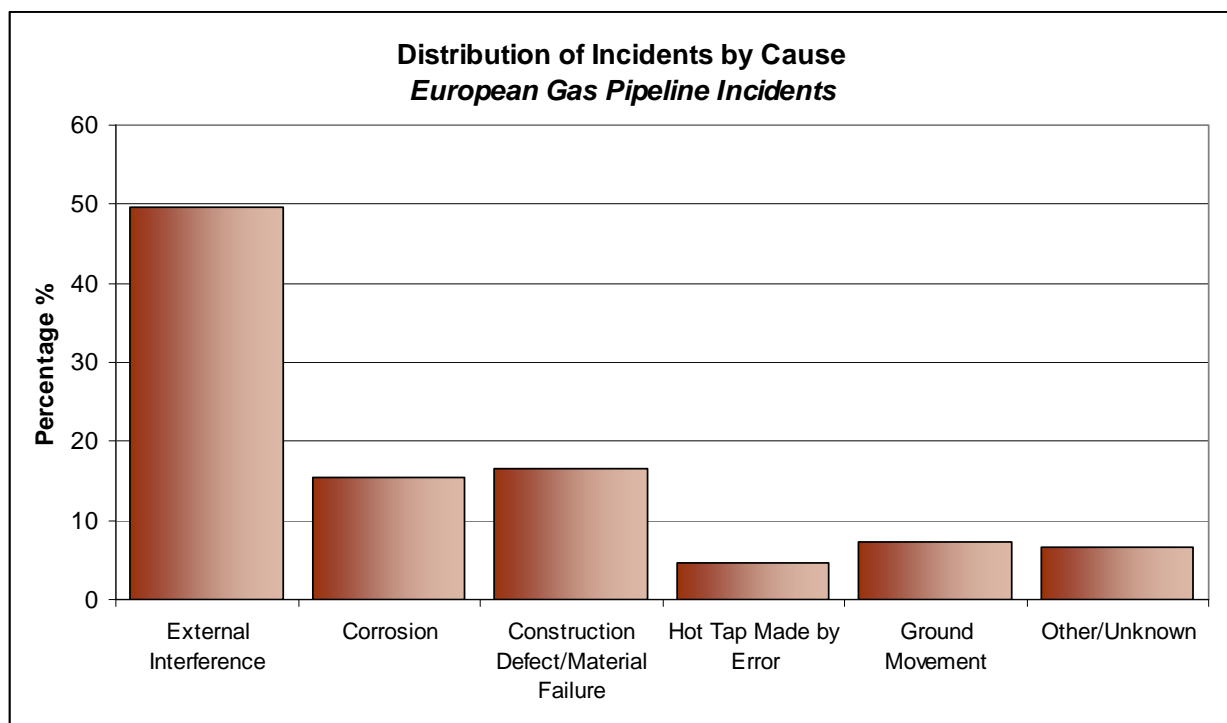
Figure 4.11 – Distribution of Incidents by Cause  
(7<sup>th</sup> EGIG Report 1970-2007, Doc. No. EGIG 08.TV-B.0502, December 2008)

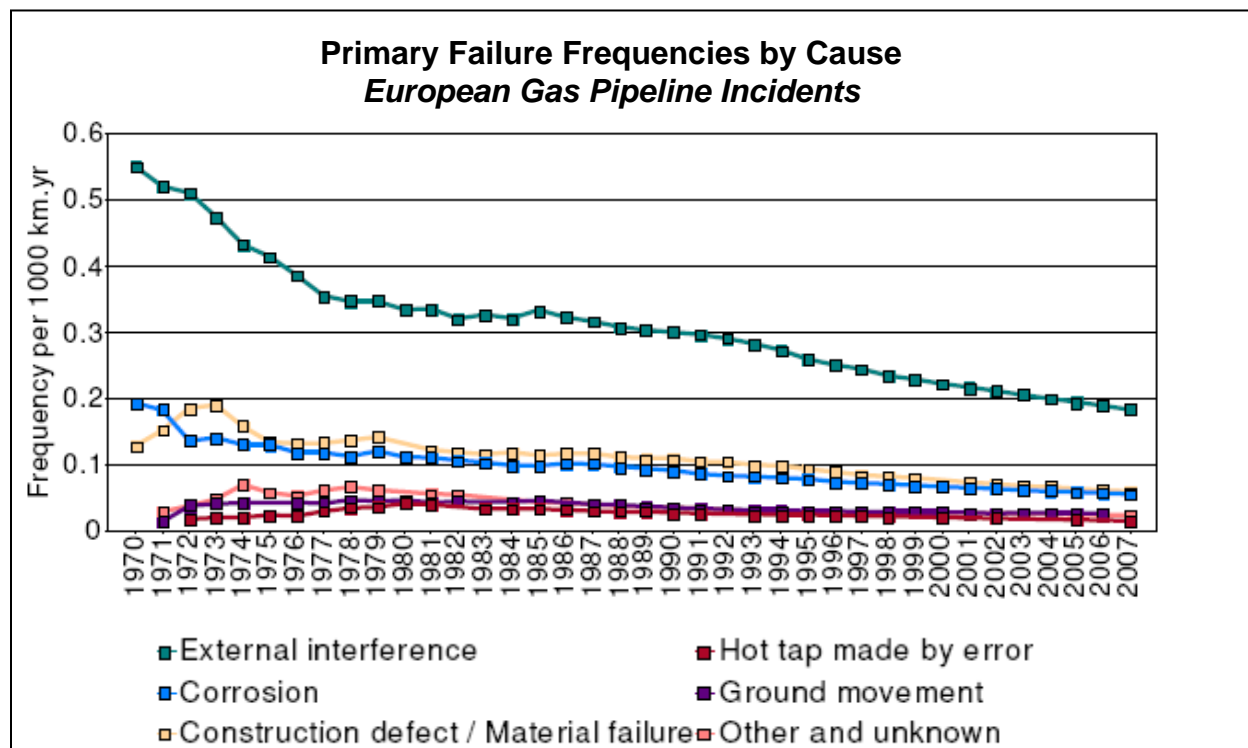
Figure 4.12– Primary Failure Frequencies by Cause - (1970-2007) The 7<sup>th</sup> EGIG Report 1970-2007, Doc. No. EGIG 08.TV-B.0502, December 2008)

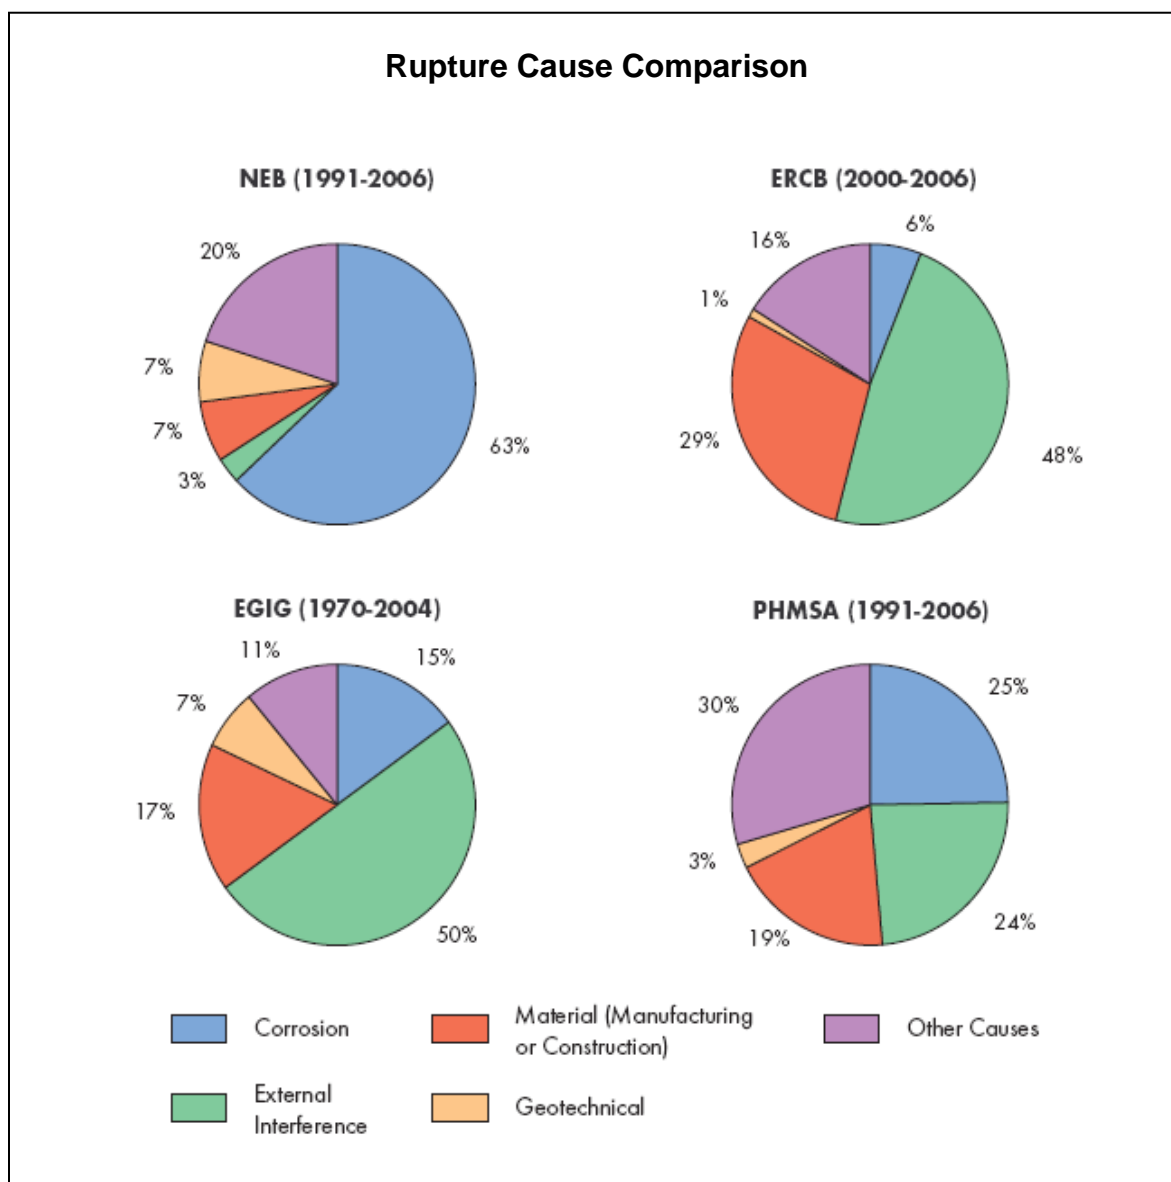
Figure 4.13 – Comparison of Pipeline Ruptures by Cause (National Energy Board, 2008)

Figure 4.13 shows the comparison of Canada’s NEB-regulated pipeline ruptures since 1991 by cause to those reported by the Energy Resources Conservation Board (ERCB) (formerly the Alberta Energy and Utility Board [EUB]), EGIG, and PHMSA. Table 4.1 clarifies the definition of “rupture” for purposes of comparison. Note that the requirements for reporting vary, and there may be some differences in terminology. While each organization reports different time frames over which rupture causes are examined, the results suggest that the leading cause of ruptures generally remains constant over time.

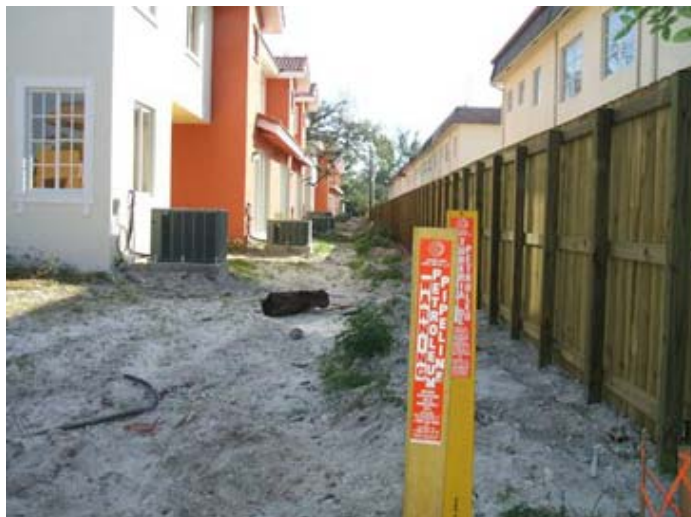
Figure 5.1 – Pipeline encroachment in residential development.  
[http://www.apga.org/library/PHMSA%20notices/PIPA\\_Flier\\_Final.pdf](http://www.apga.org/library/PHMSA%20notices/PIPA_Flier_Final.pdf)

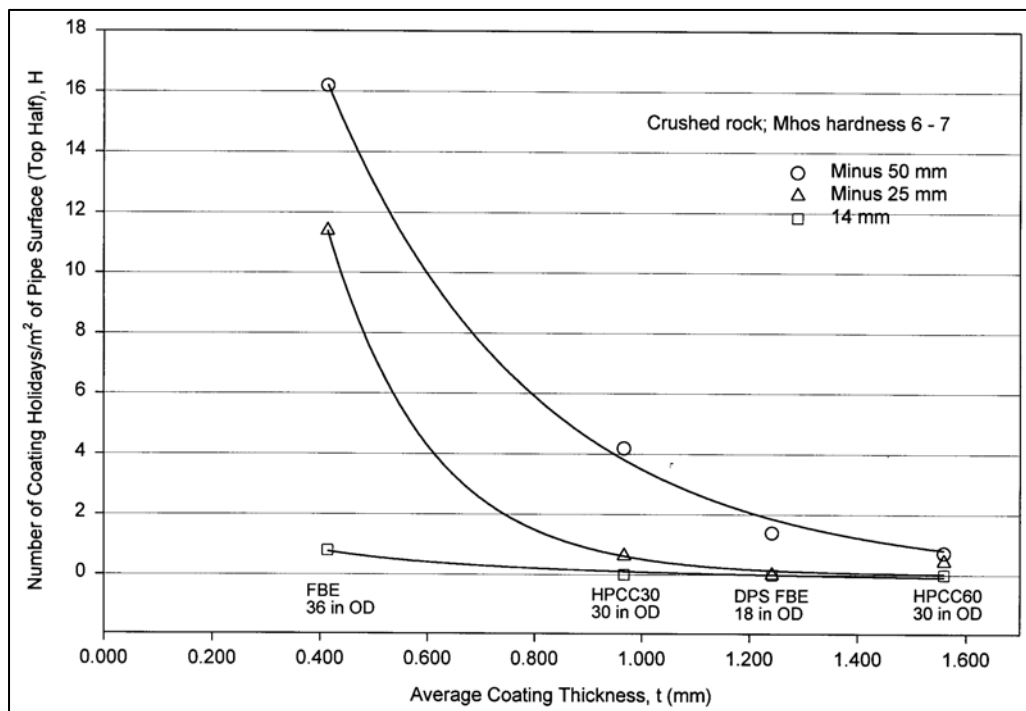
Figure 5.2 – Number of Coating Holidays/m<sup>2</sup> of Pipe Surface (top half) Caused During a 12 Day Test of Coating Performance on Buried Pipe

coating type. A quantitative relationship between coating damage and coating thickness was defined, as shown in Figure 5.2.

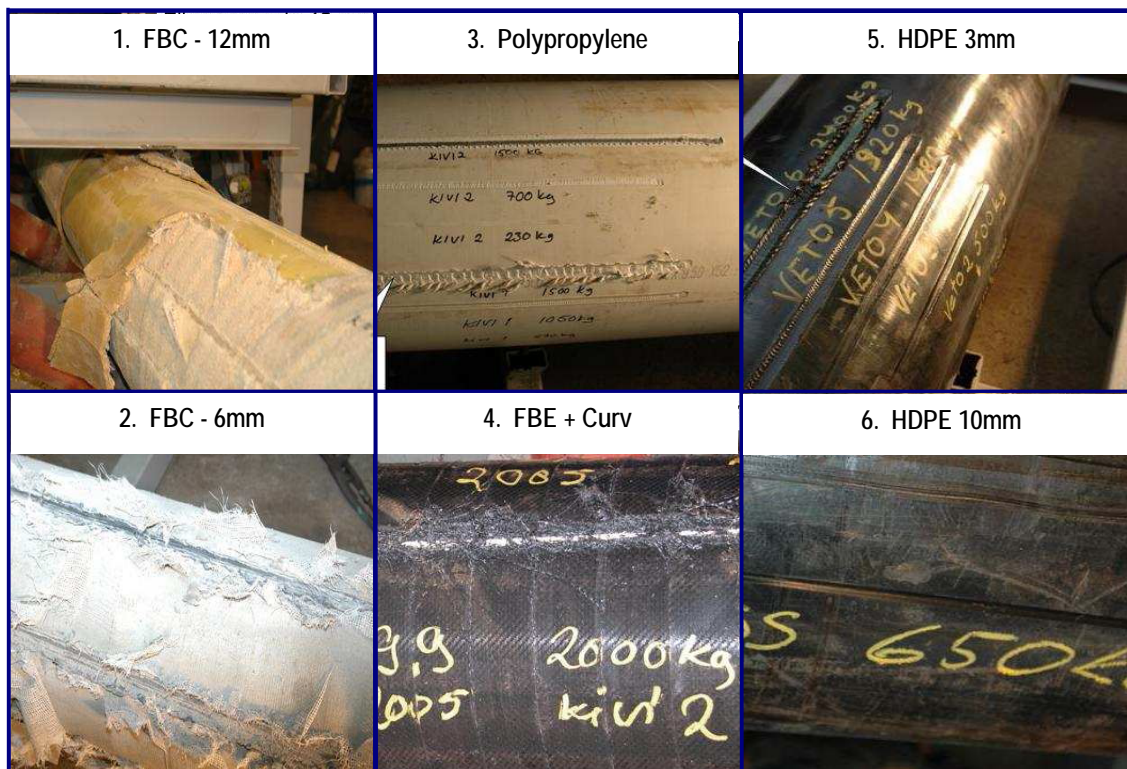
Figure 5.3 – Pipeline Coatings Tested for Severe Construction Conditions (Christianson, 2006)

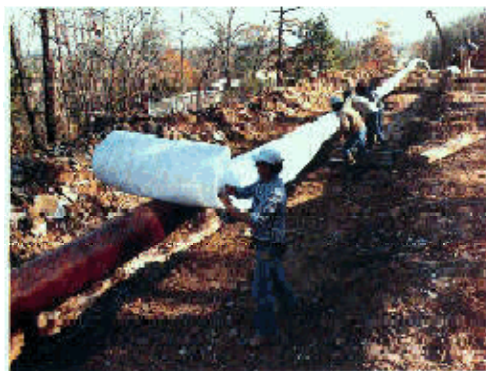
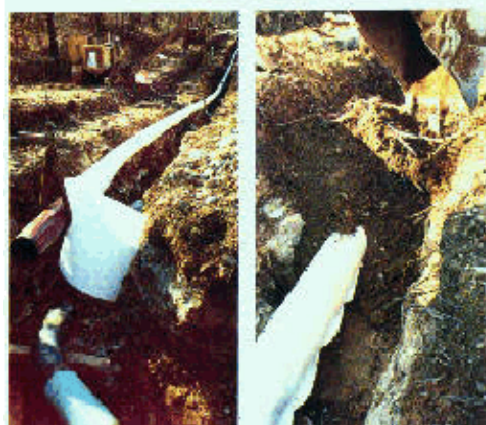
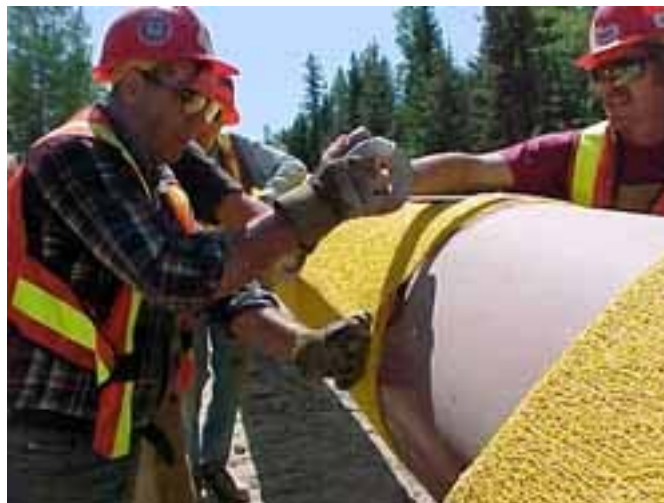
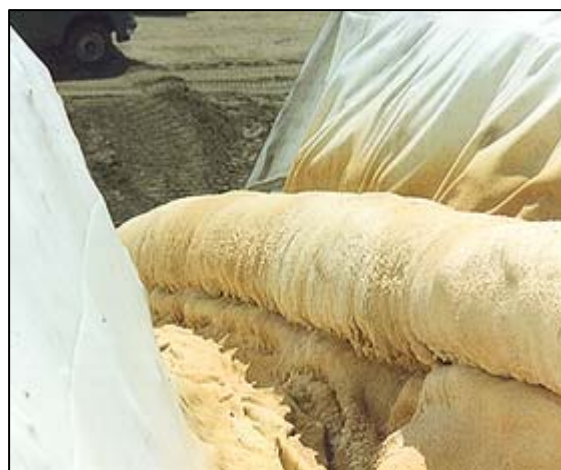
*Composite Foam Cushion Wrap*  
(<http://www.farwestcorrosion.com>)

*Wrapped Rock Shield* (<http://www.tuff-n-enough.com>)

*Polyurethane Foam Rock Shield* (<http://www.pedero.com/>)

**Rock Shields.** There are a variety of coating types that are meant to protect the pipe from being damaged by rocks in the backfill. Many are wraparound products, similar in many respects to the geotextiles discussed above. Others are flexible mats placed above, below, or around the pipe. Still others are sprayed on in the ditch. Figure 5.4 illustrates such examples.

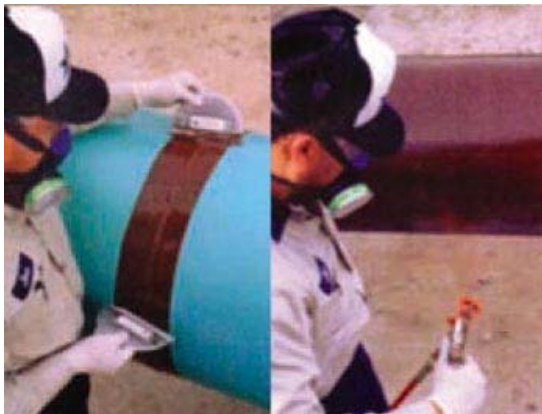
Figure 5.5 – Powercrete® pipeline coating application (<http://www.petropages.com/vendors/v19548.htm>)

impact resistance and can also be used as a rockshield. Should any damage occur due to severe repeated blows, the area can be repaired easily by using the same material after cleaning, when the surface becomes dry. Figure 5.5 shows an application of Powercrete®.

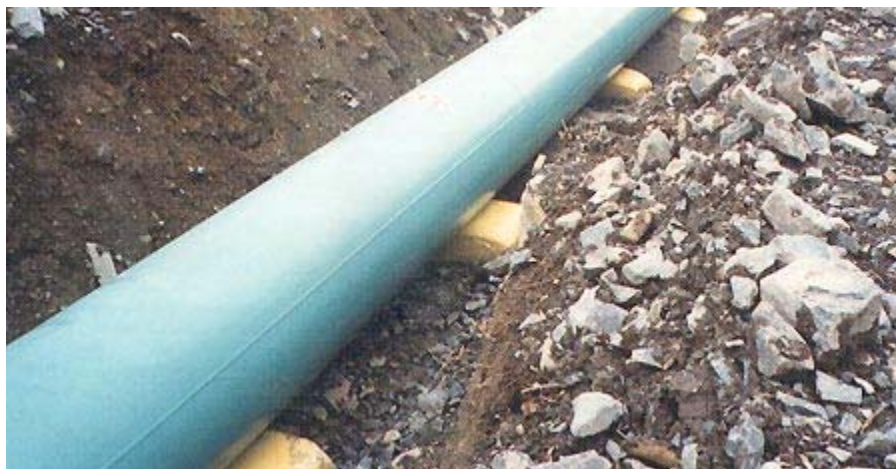
Figure 5.6 – Pipeline on Foam Supports (<http://www.pedero.com>)

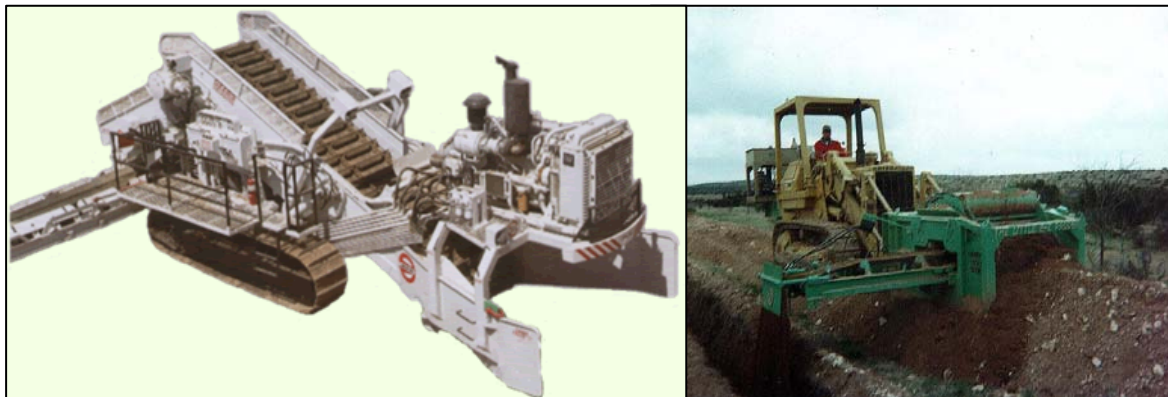
Figure 5.7 – Backfill Screening and Padding Machines (<http://www.ozzies.com/> (left); <http://www.ezpadding.com/> (right)).

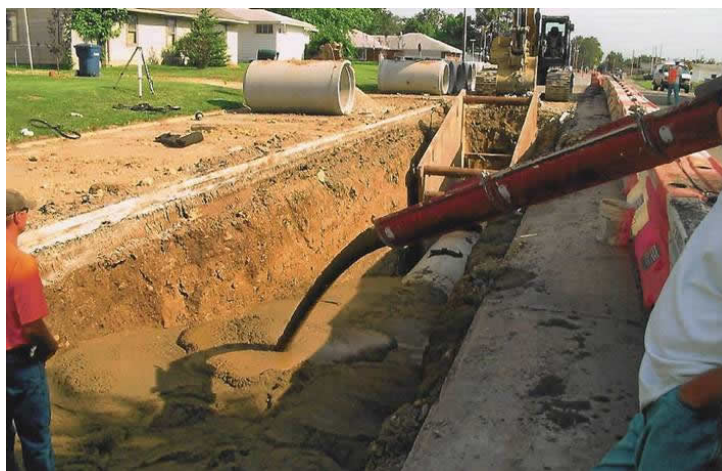
Figure 5.8 – Flowable fill being poured to fill the pipe excavation area. (<http://www.irmca.com/Topics/flow.asp>)

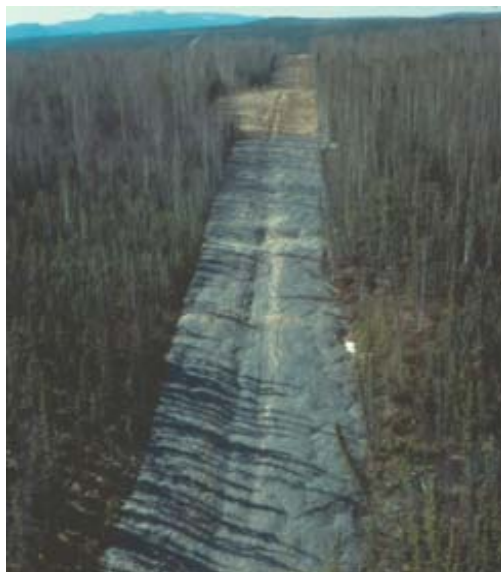
*Figure 5.9 – Illustration of a cleared right-of-way along a pipeline route*

the view of the right-of-way are removed to facilitate aerial patrol. In addition, tree roots that extend near the pipeline are removed, since these can also damage the pipeline coating or even the pipe itself. Figure 5.9 shows a cleared right-of-way along a pipeline route.

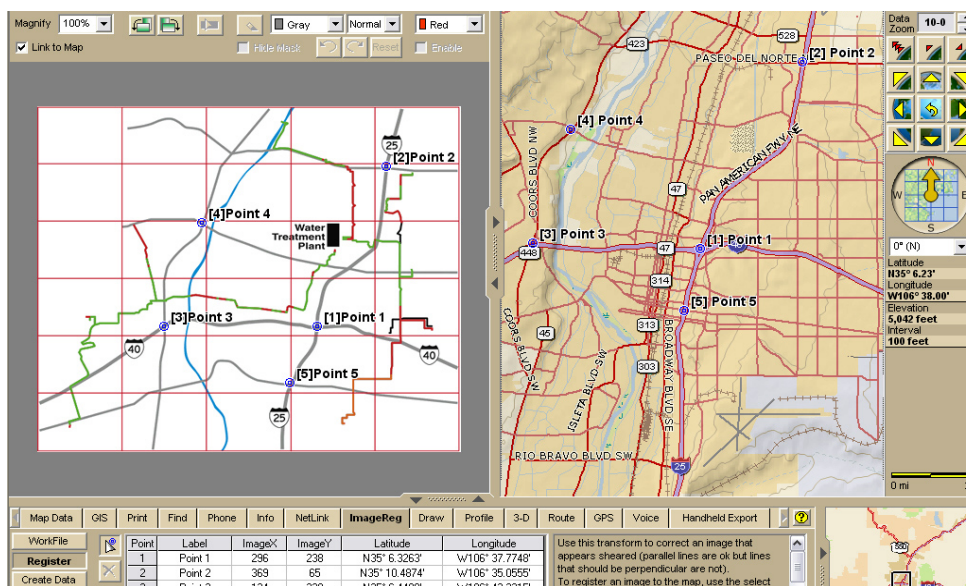
Figure 5.10 – GIS Image of a Pipeline Network

However, while GIS and GPS provide convenient access to pipeline maps and databases, their accuracy still relies on the accuracy of the pipeline location data and of the maps used to locate roads, topography, etc. The use of ILI tools equipped with inertial navigation systems and performance of periodic surveys to collect pipeline alignment position can improve pipeline location accuracy. Figure 5.10 shows a pipeline network registered using GIS mapping technology.

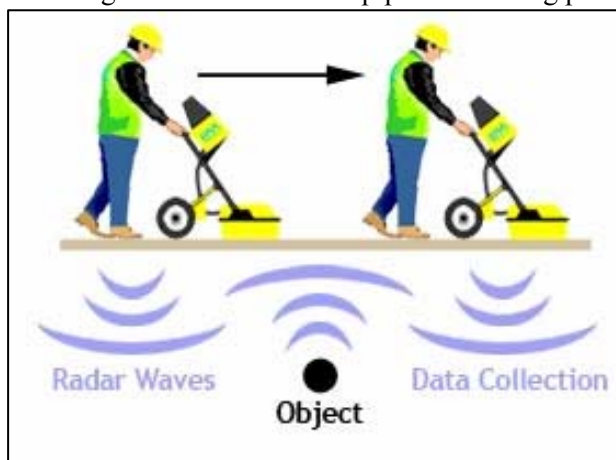
Figure 5.12 – Ground Penetrating Radar (GPR)  
Technique (Courtesy: <http://www.worksmartinc.net>)

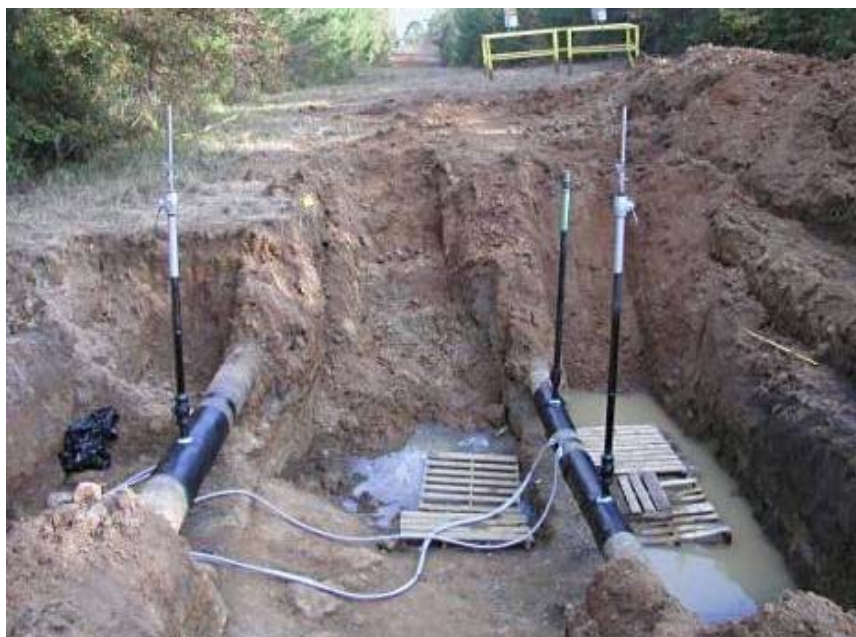
Figure 5.13 – Daylighted Pipeline Site  
(Courtesy: <http://www.process.sensorsmaq.com>)

Daylighting involves manual exposure of selected portions of the pipeline. The need for daylighting is linked to the anticipated separation distance between the edge of the excavation and the pipe face. Daylighting is done to ensure that excavation equipment operators maintain line-of-sight proximity to the buried pipeline while they are excavating. Figure 5.13 shows a daylighted excavated site.

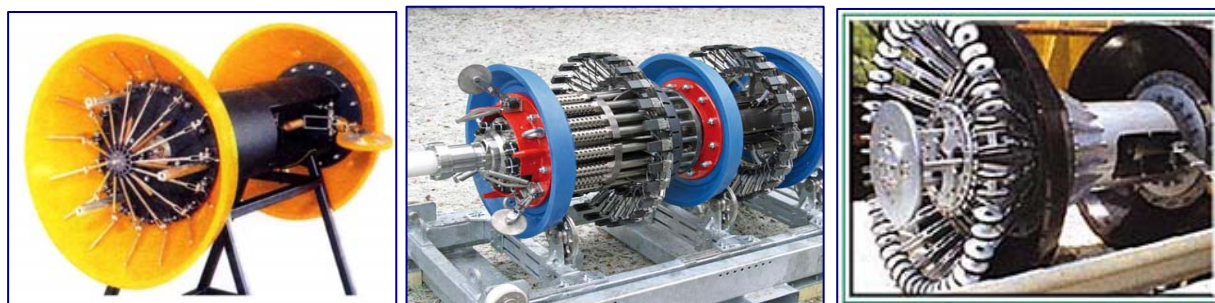
Figure 6.1 – Mechanical Caliper Tools (photos courtesy of Enduro, Rosen, and RAS GmbH)

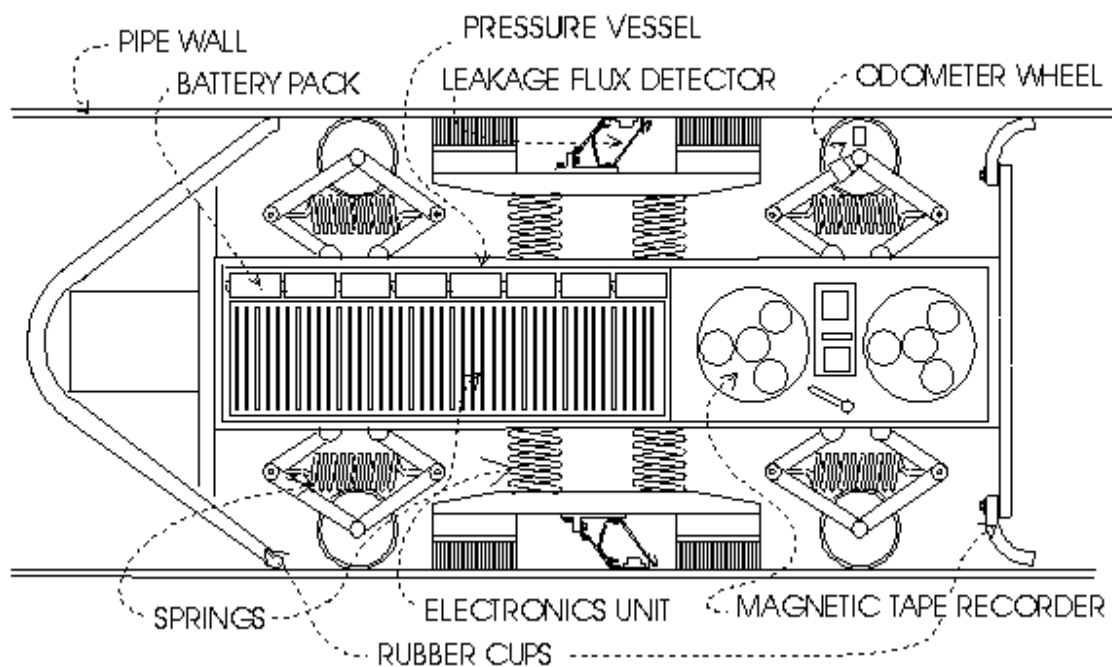
Figure 6.2 – Schematic of MFL Principle (Clapman et al., 2002)

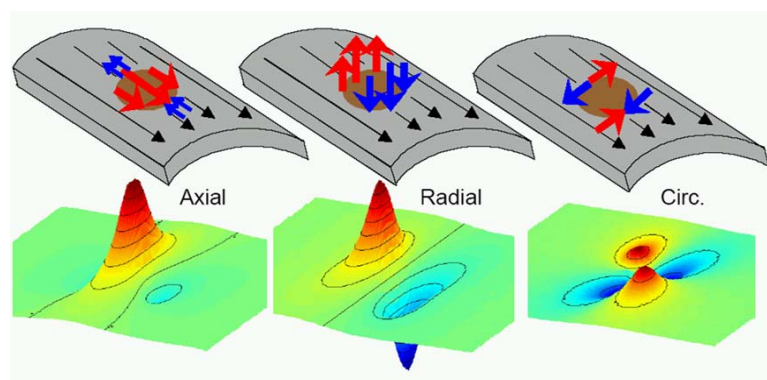
Figure 6.3 – Example of Axial, Radial and Circumferential MFL Signal at Metal Loss Region.

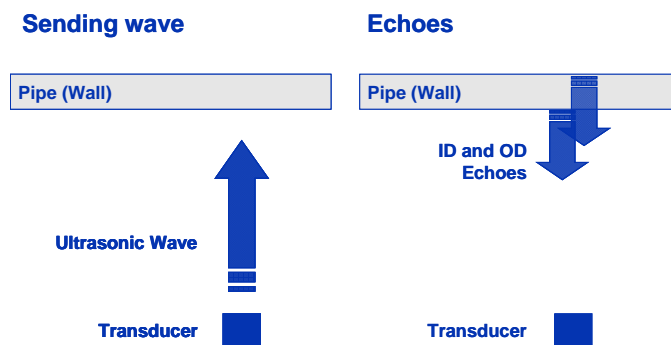
**Figure 6.4.** *Ultrasonic Wall Thickness Concept*
