# Mechanical Damage

## FINAL REPORT

**U.S. Department of Transportation  
Pipeline and Hazardous Materials Safety Administration  
Office of Pipeline Safety**

**Integrity Management Program  
Under Delivery Order DTRS56-02-D-70036  
(Technical Task Order 16)**

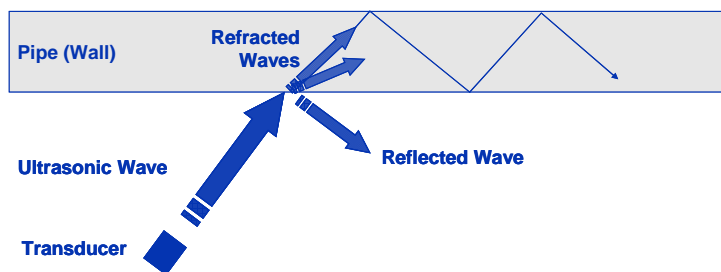
**Figure 6.5.** *Ultrasonic Shear Wave*

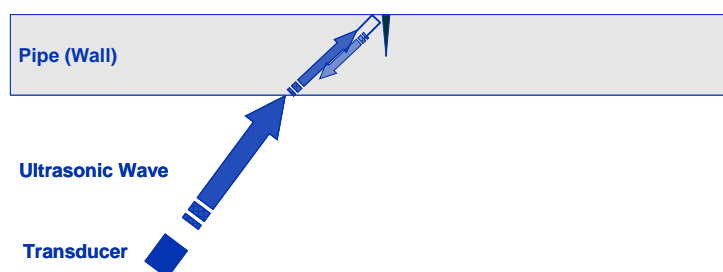
**Figure 6.6.** *Ultrasonic Wave Reflection from Crack*

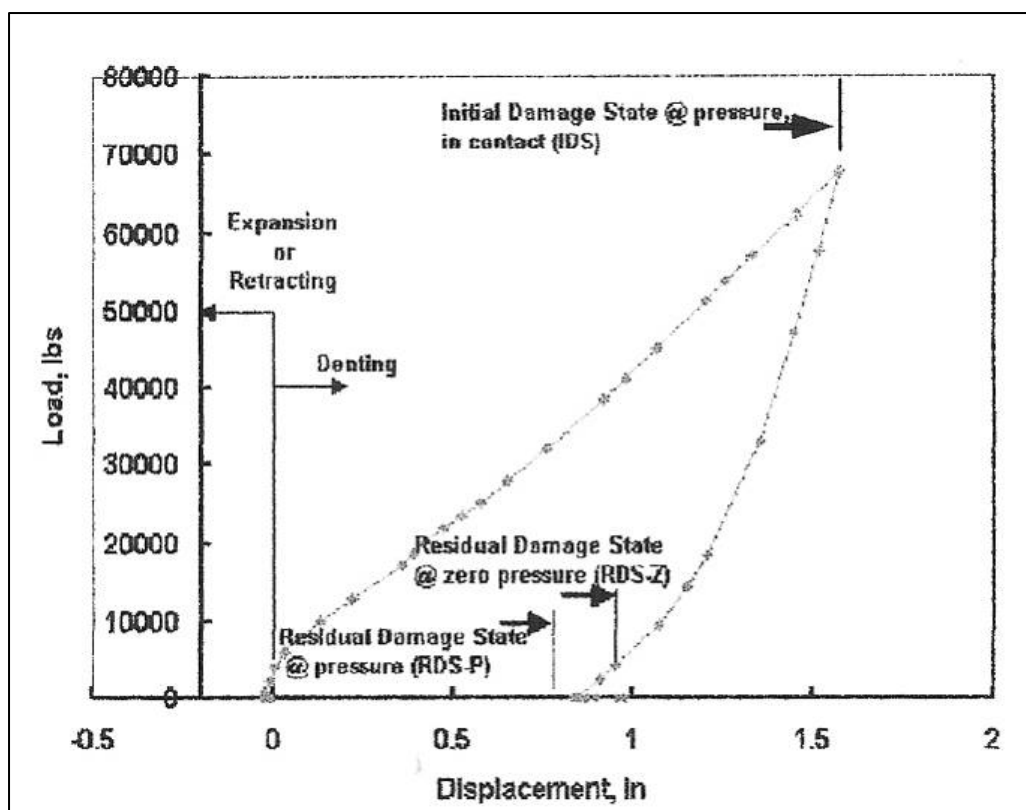
Figure 7.1 – Validation of Predicted Load-Deformation Behavior During Denting and Re-Rounding (Leis and Hopkins, 2003)

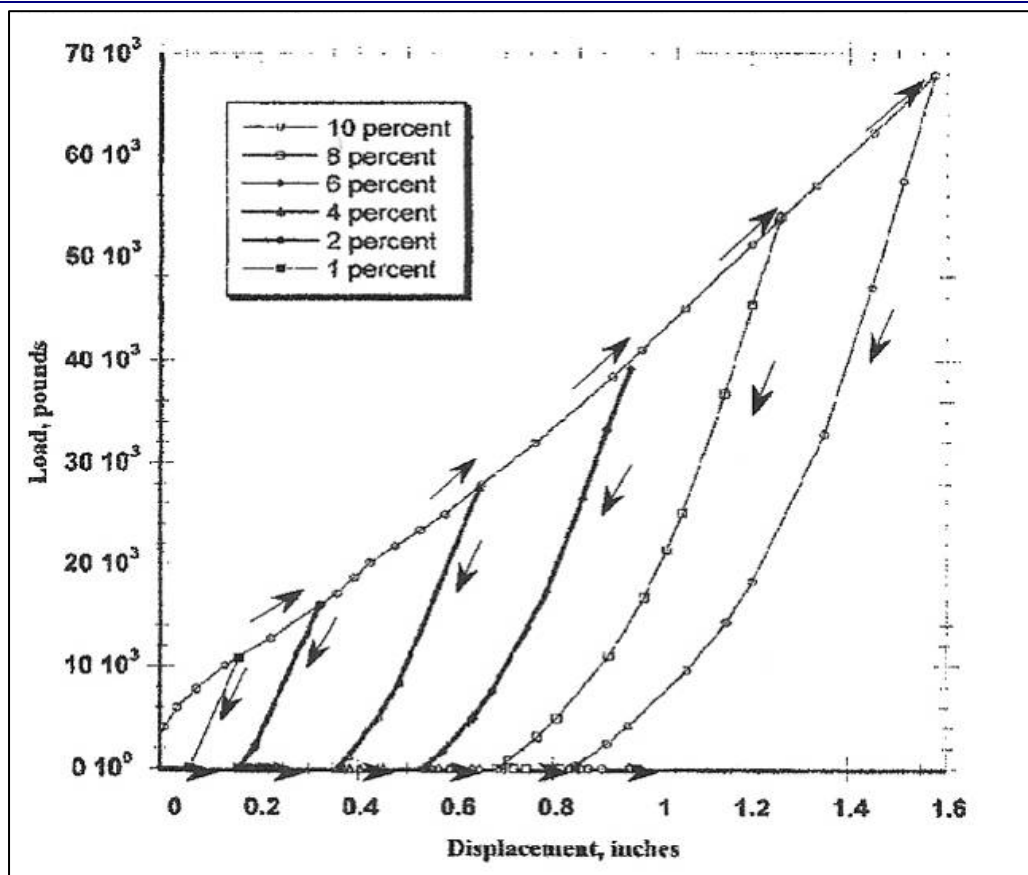
Figure 7.2 – Effect of Initial Dent Depth on Load-Displacement Behavior During Denting and Re-Rounding (Leis and Hopkins, 2003)

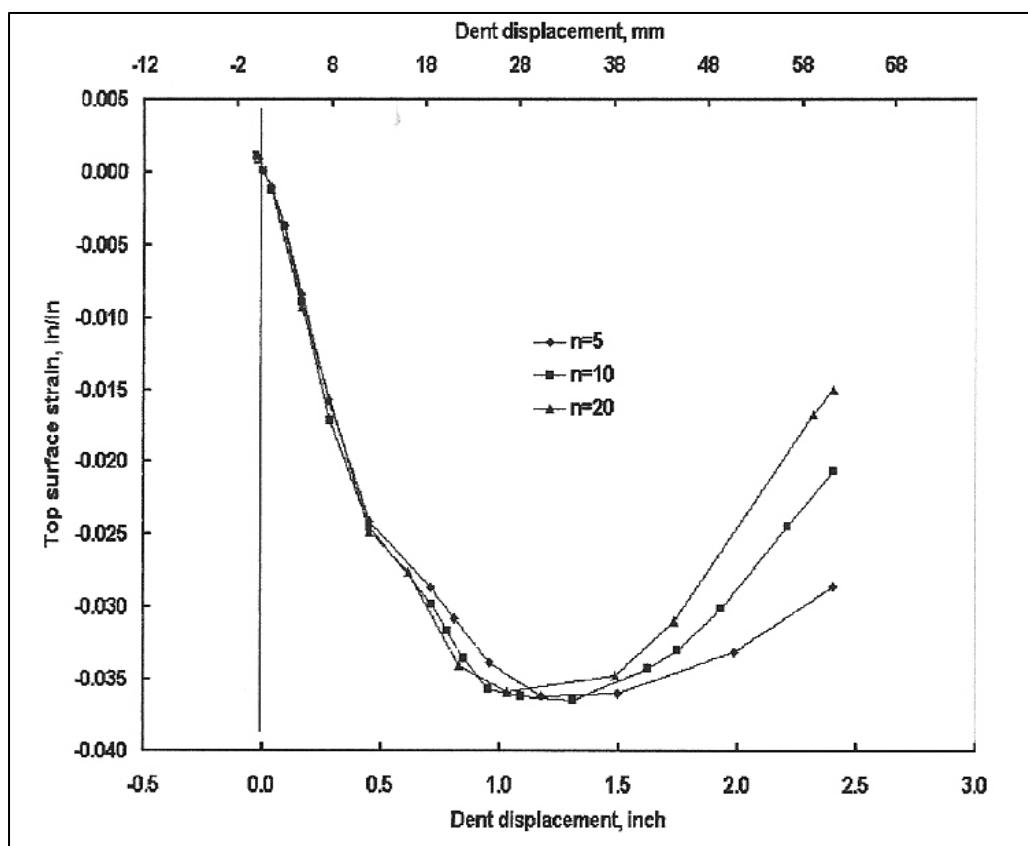
Figure 7.3 – Non-Linear Relationships Between Strain and Displacement at the Outside Centre of a Dent, During Denting to 8% of the Pipe Diameter (Leis and Hopkins, 2003)

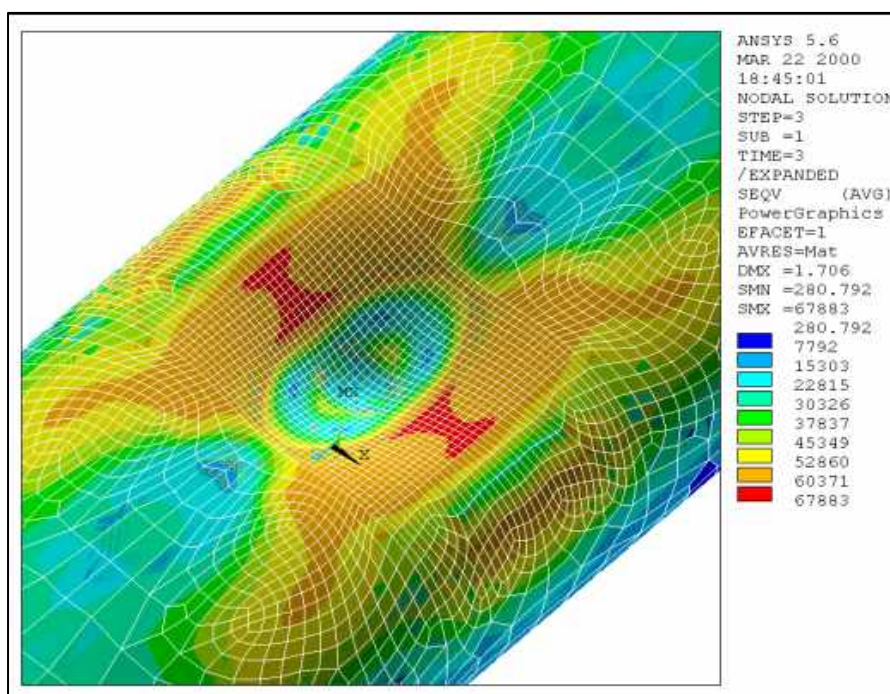
*Figure 7.4 – Finite Element Model of Stress Distribution Around a Re-Rounded Dent (Ironside and Carroll, 2002)*

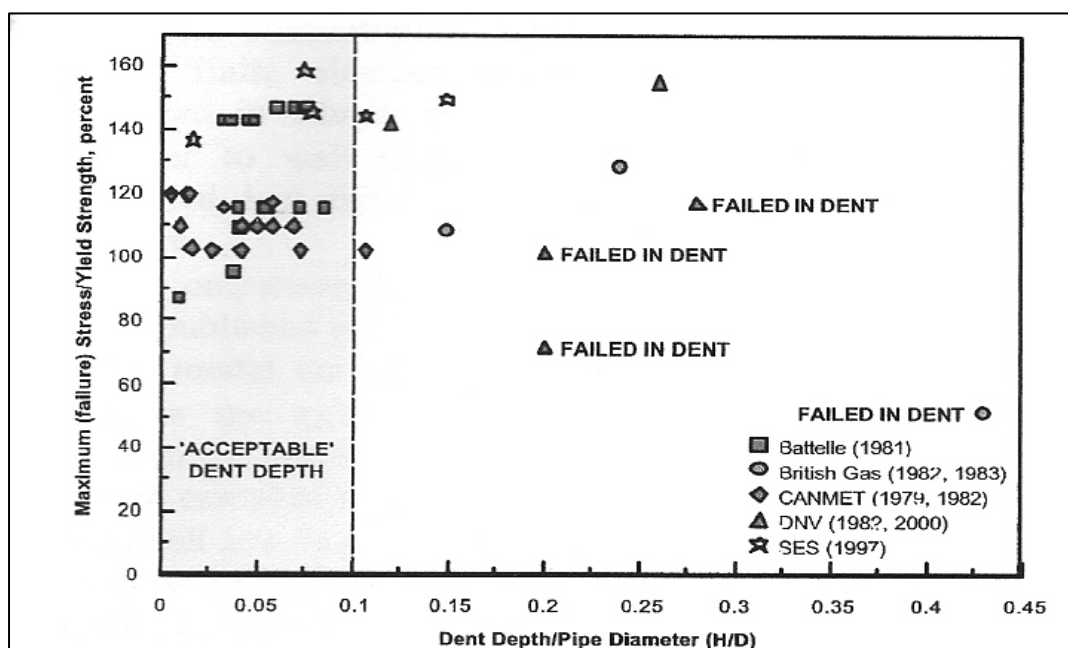
Figure 7.5 – Failure Behavior in Full-Scale Tests on Plain Dents (Cosham and Hopkins, 2004)

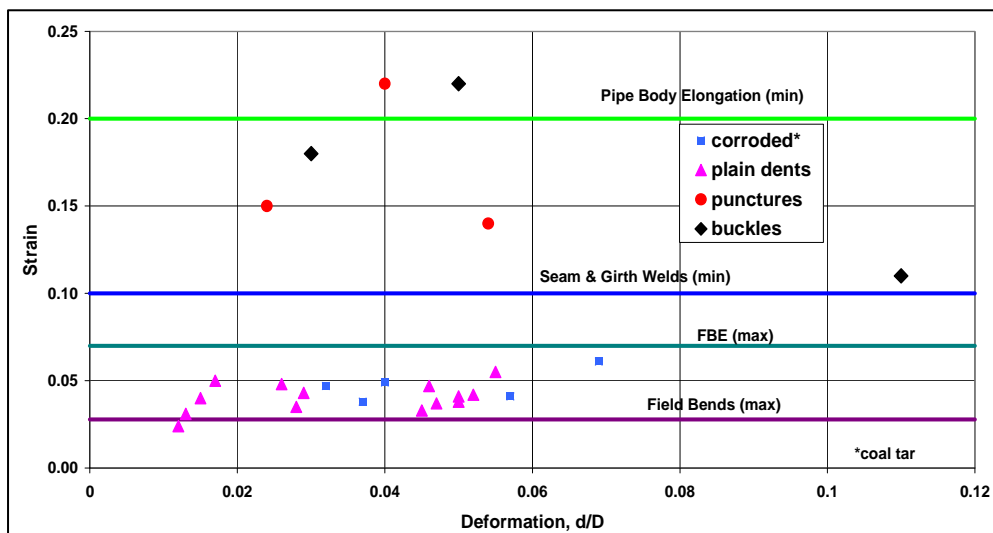
Figure 7.6 – Observed Relationship Between Strain Component, Degree of Damage, and Dent Depth (Rosenfeld, Pepper, and Leewis, 2002)

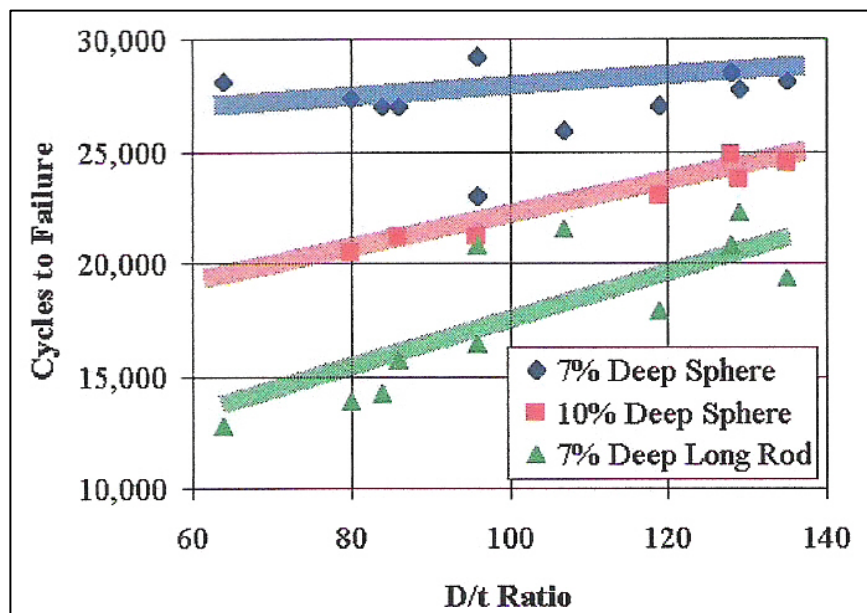
Figure 7.7 – Effect of D/t Ratio and Damage Type on the Fatigue Life of Plain Dents (Dinovitzer et al.,2002)

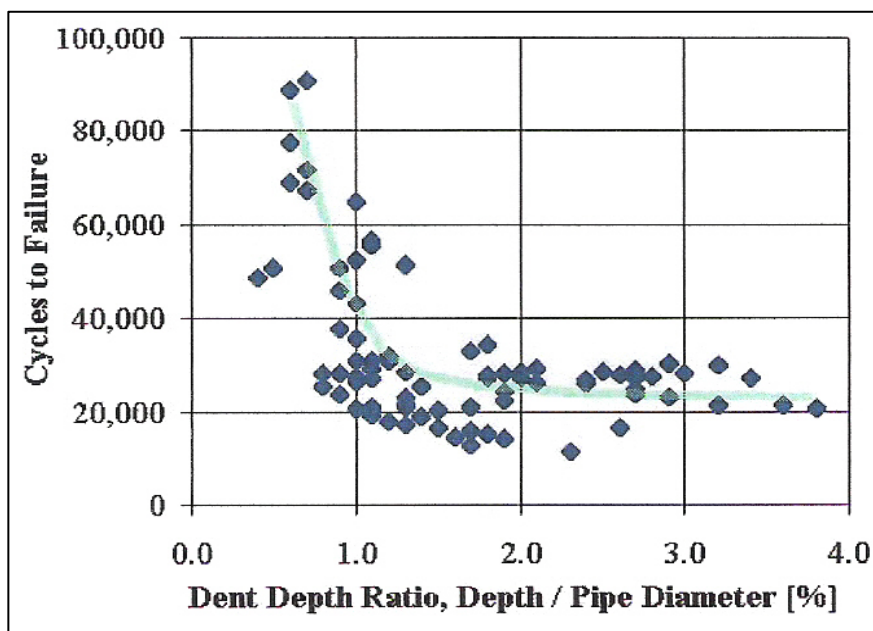
Figure 7.8 – Effect of Dent Depth on Fatigue Life of Plain Dents (Dinovitzer et al.,2002)

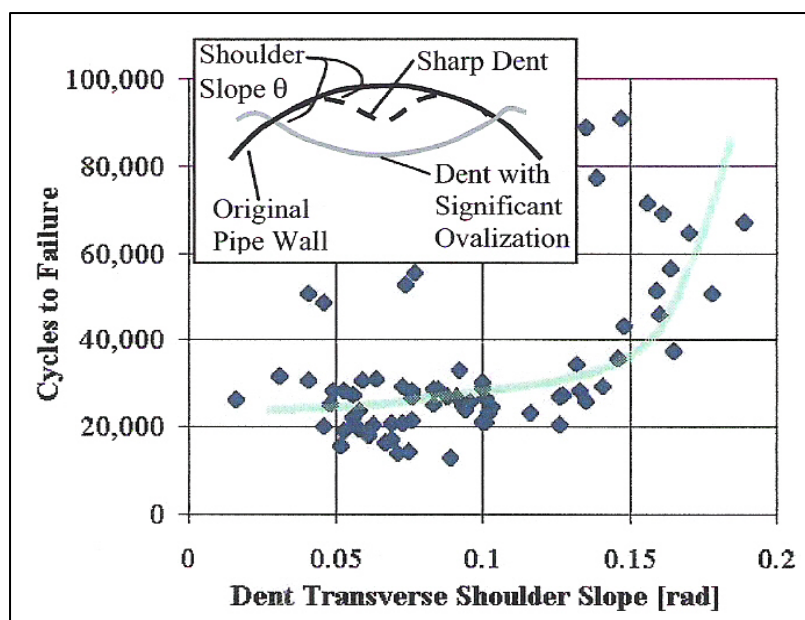
Figure 7.9 – Effect of Dent Profile on Fatigue Life of Plain Dents  
(Dinovitser et al., 2002)

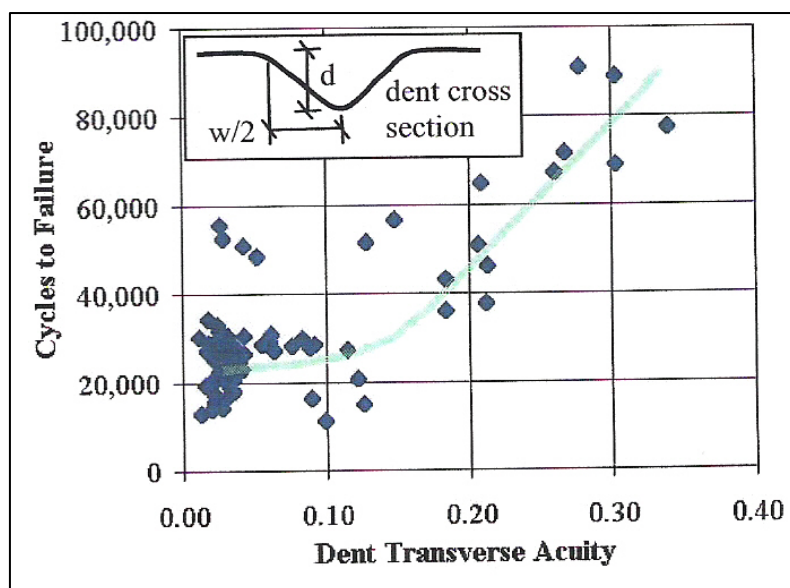
Figure 7.10 – Effect of Acuity ( $w/2d$ ) on the Fatigue Life of Plain Dents  
(Dinovitser et al., 2002)

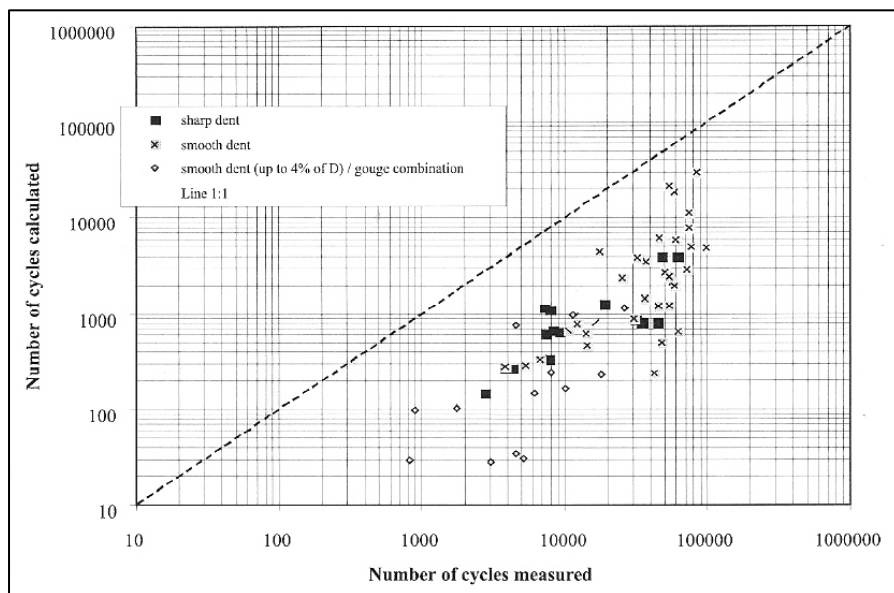
*Figure 7.11 – Comparison of Measured and Calculated Dent Fatigue Life, Including an Adjustment Factor of 10 on Predicted Fatigue Life (EPRG, 1999)*

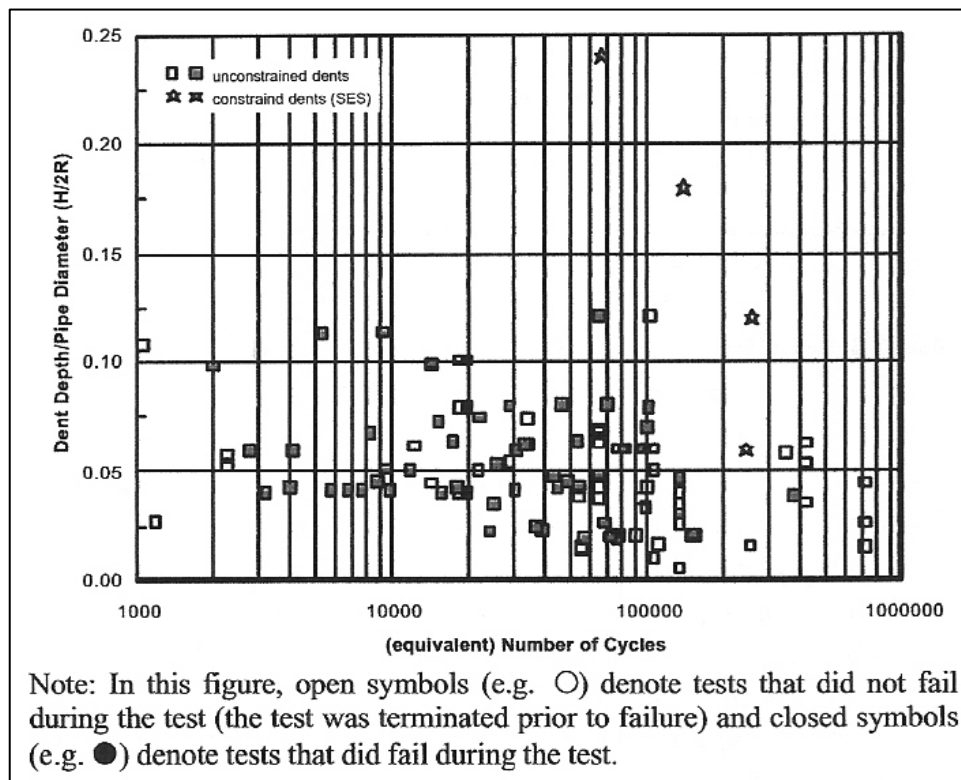
*Figure 7.12 – Fatigue Lives of Constrained and Unconstrained Plain Dents (Cosham and Hopkins, 2004)*

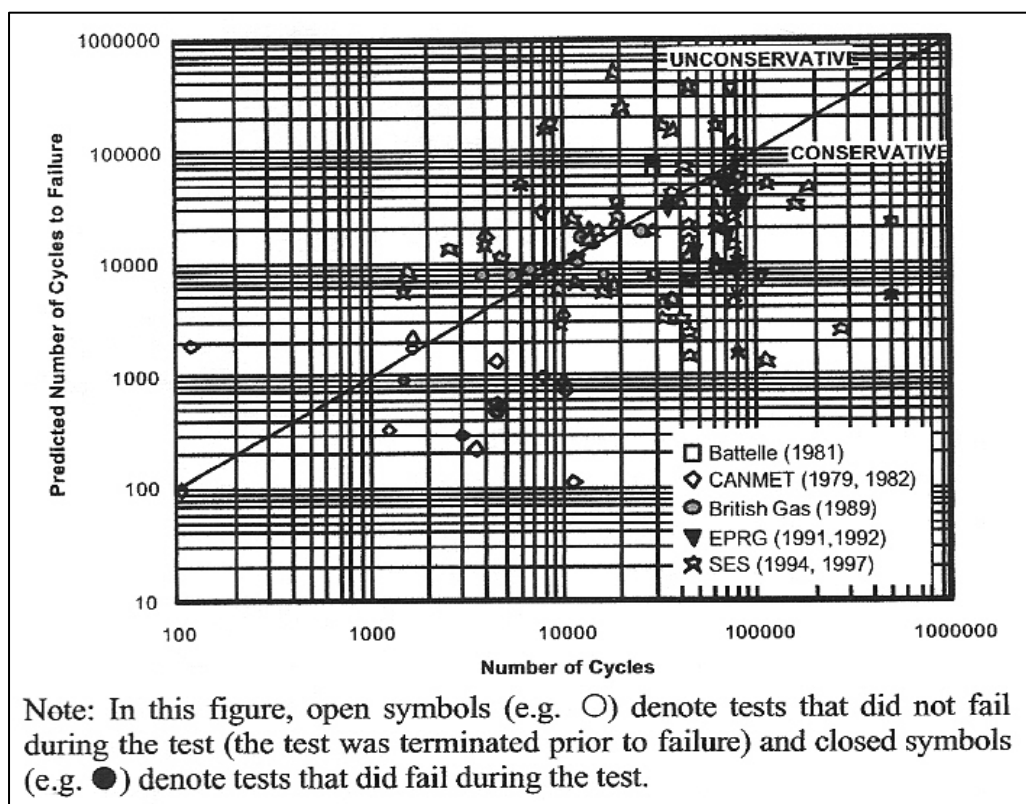
Figure 7.13 – Predictions of the Fatigue Life of Plain Dents using the EPRG Model (Cosham and Hopkins, 2004)

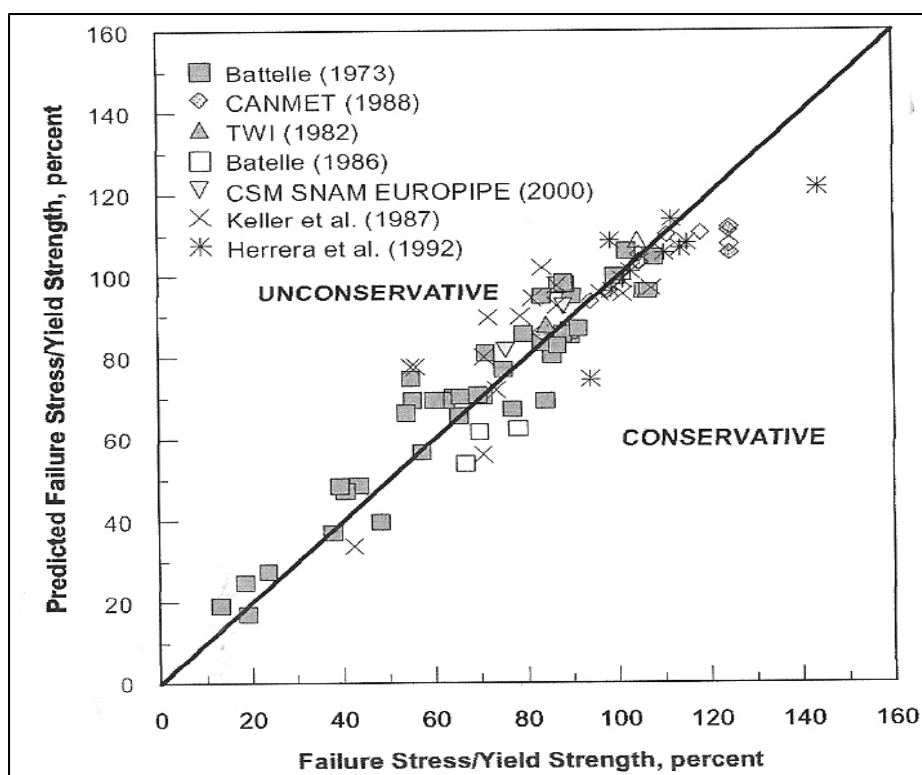
Figure 7.14 – Predictions of the Failure Pressure of Axially Oriented Gouges Using the NG-18 Equation (Cosham and Hopkins, 2002)

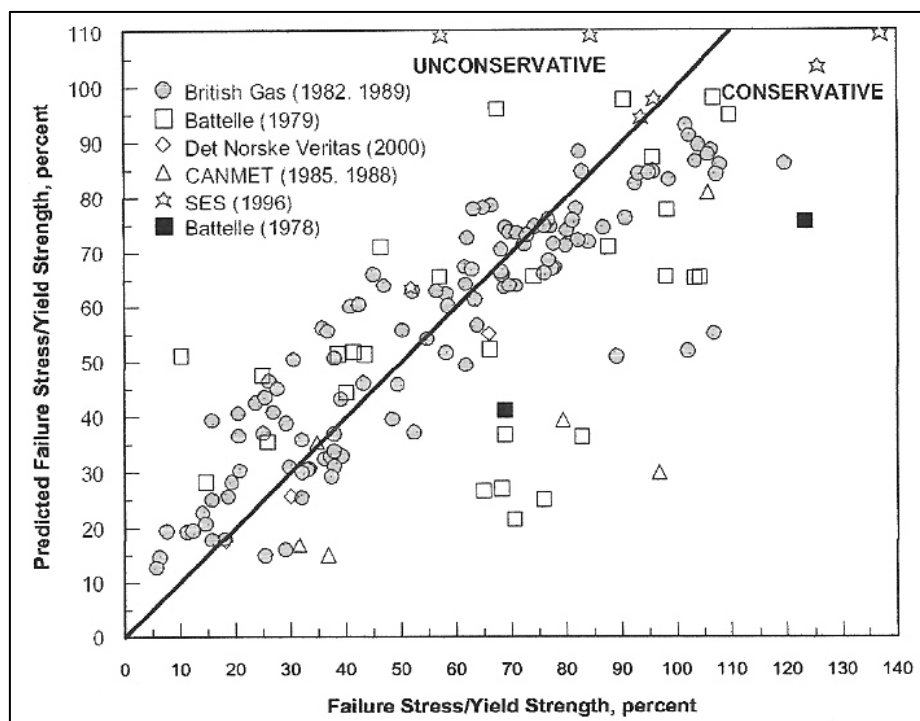
Figure 7.15 – Failure Behavior of Combined Dent and Gouge Damage Predicted Using the Dent Fracture Model (Cosham and Hopkins, 2002)

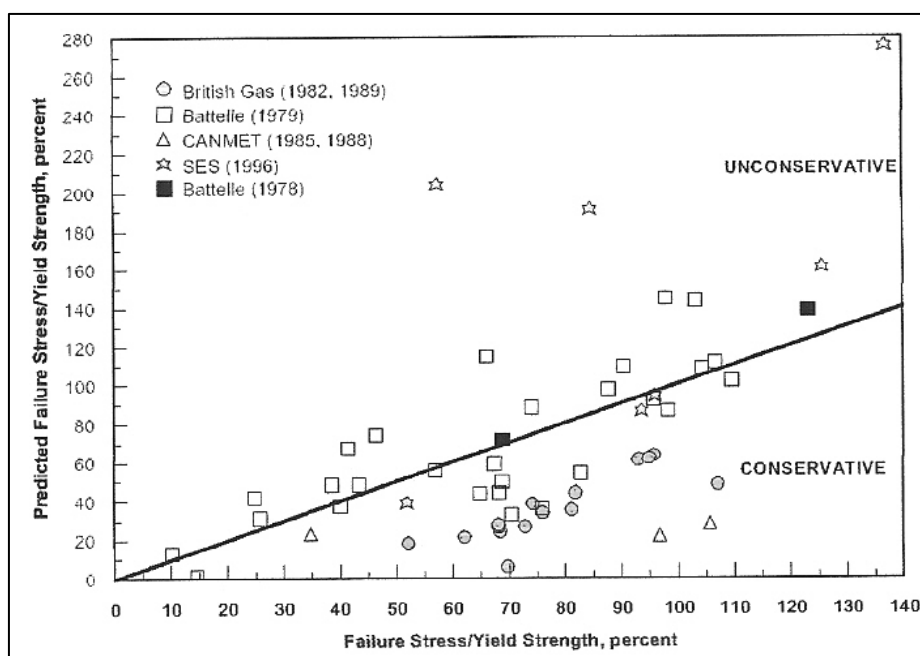
Figure 7.16 – Failure Behavior of Combined Dent and Gouge Damage Predicted Using the Q-Factor Model (Cosham and Hopkins, 2002)

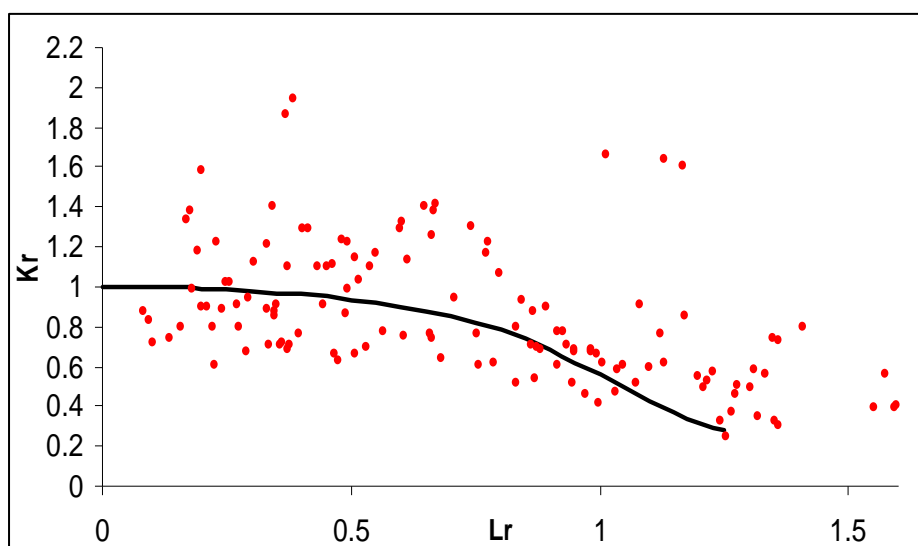
Figure 7.17 – Comparison of the Dent Fracture Model Incorporating the New Limit State Function, with Full Scale Combined Dent and Gouge Damage Test Results (Francis et al., 2005)

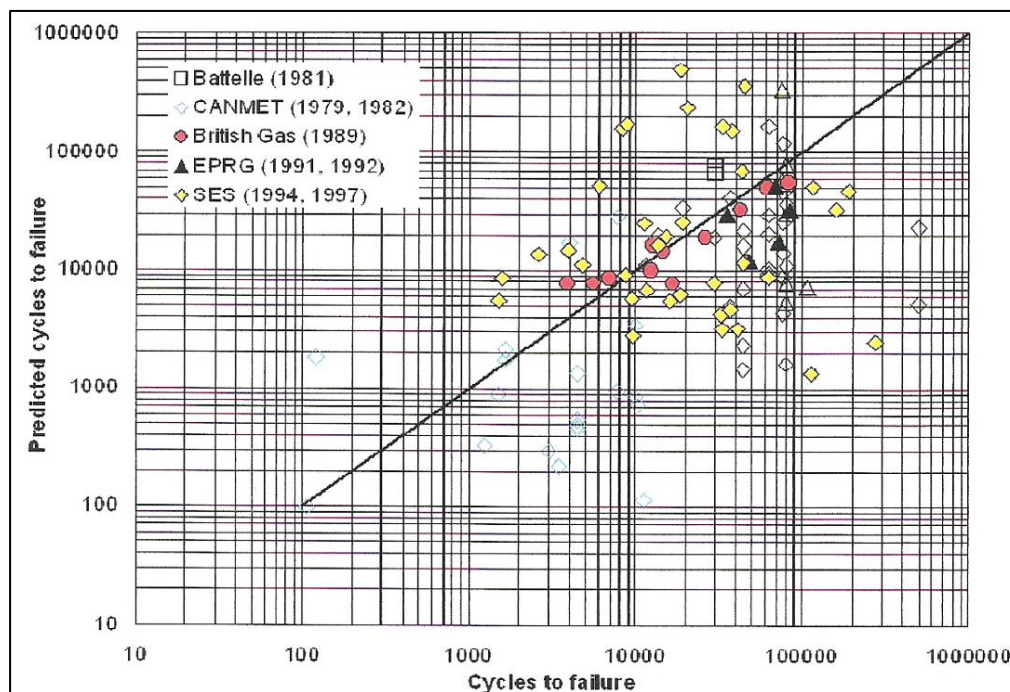
Figure 7.18 – Comparison of Full-Scale Fatigue Test Results on Combined Dents and Gouges, with the British Gas Model (Leis and Hopkins, 2003)

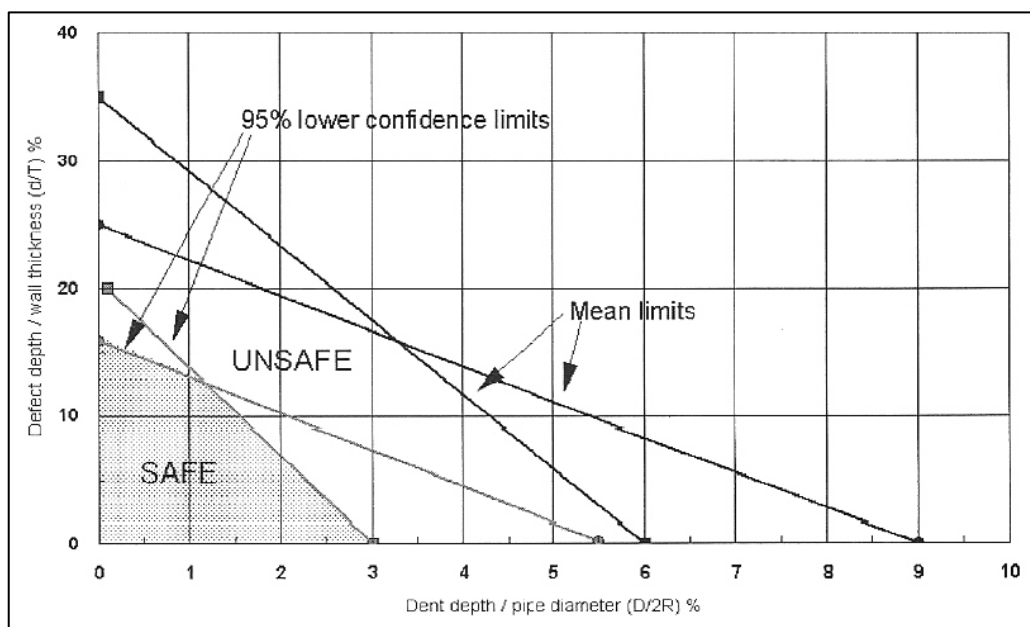
Figure 7.19 – Illustration of the Simplified Representation of Safe Limits for Combined Dents and Gouges (Bood et al., 1999)

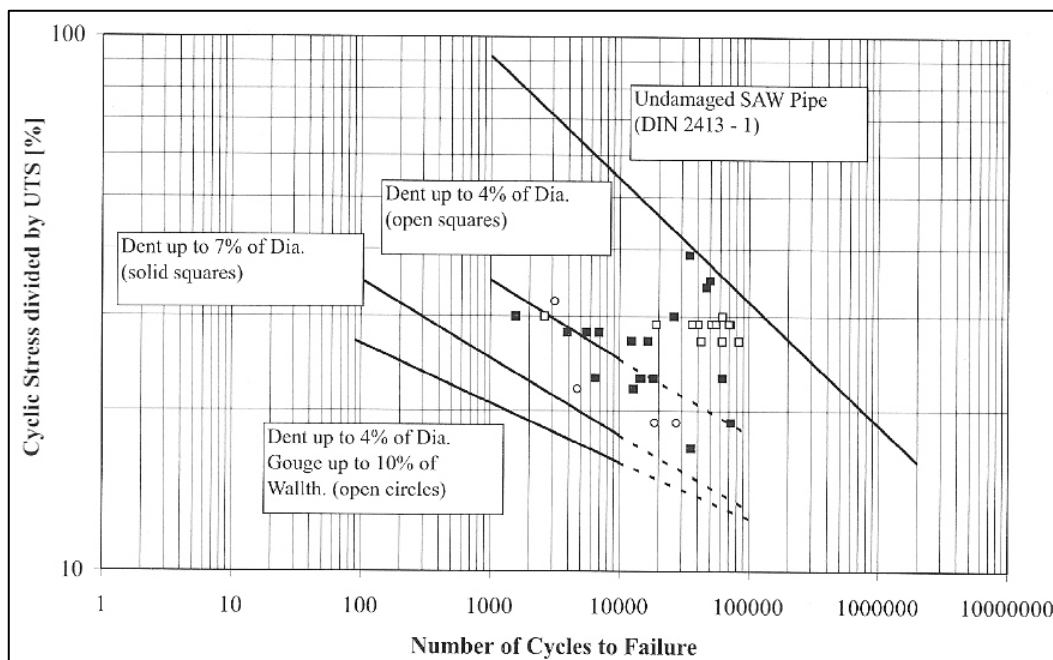
Figure 7.20 – Fatigue Limits for Dents and Combined Dents and Gouges, Related to DIN 2413-1, Including an Adjustment Factor of Ten on Life (Bood et al., 1999)

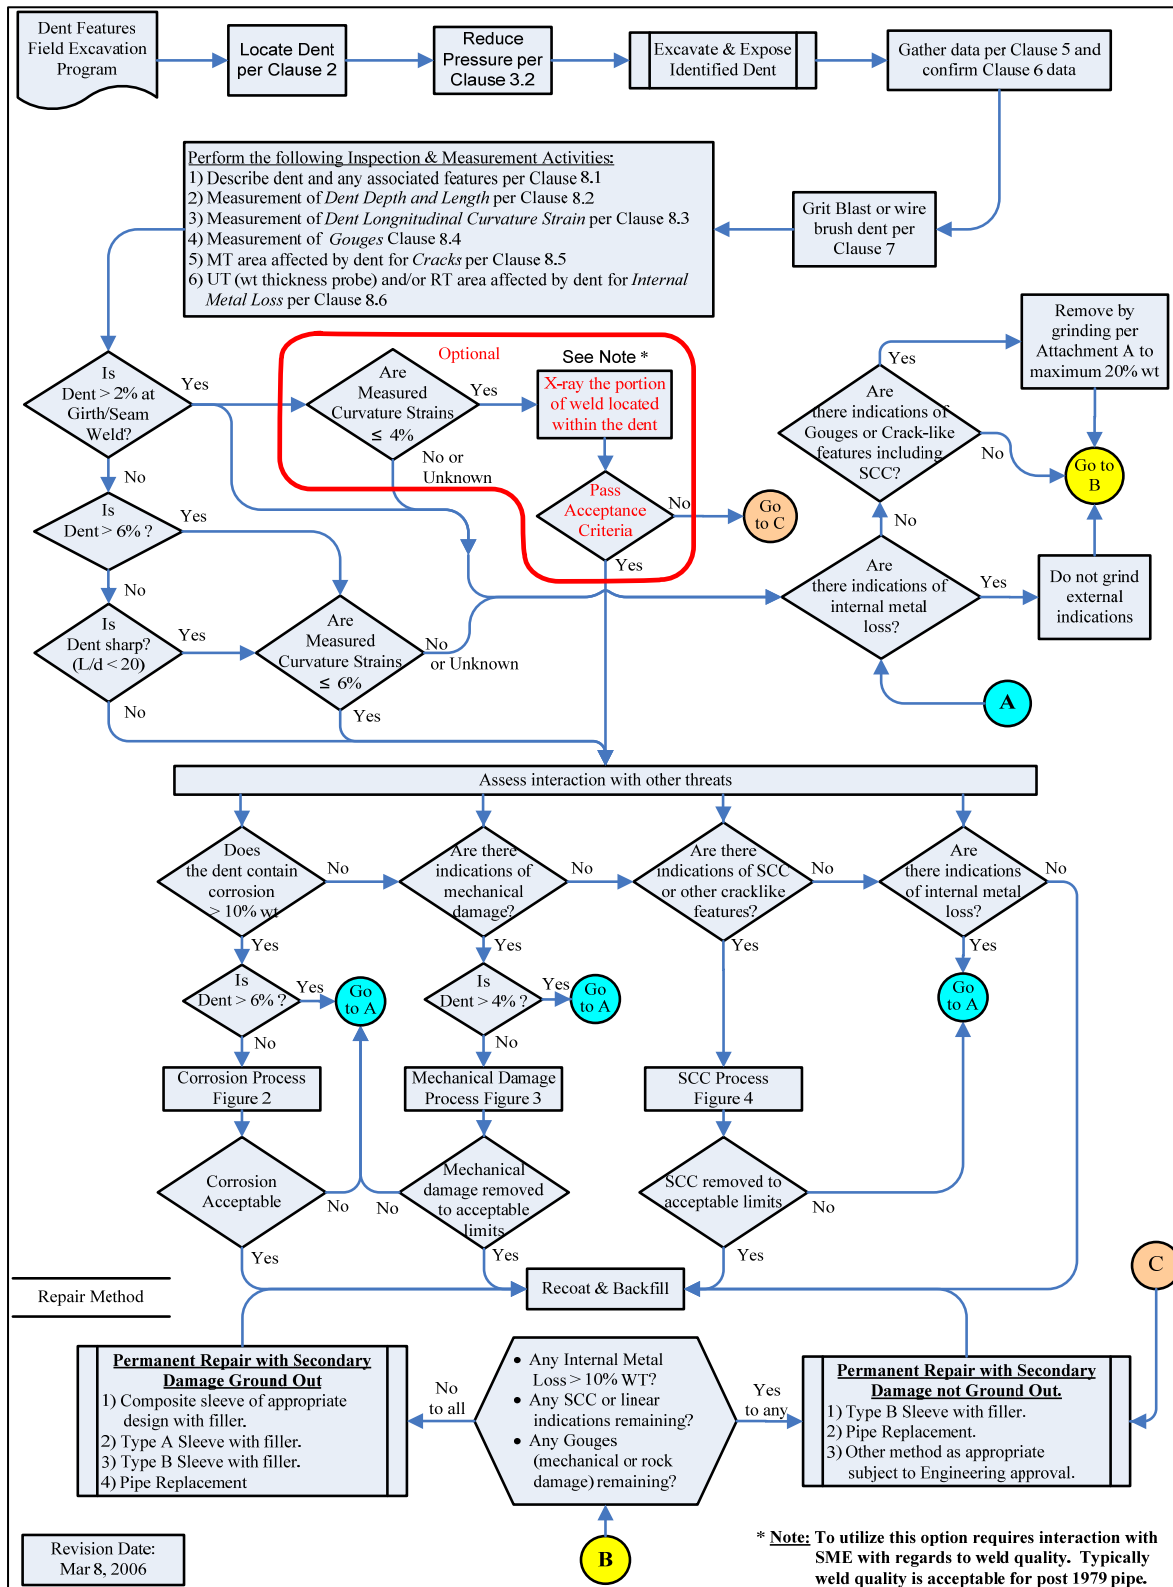
Figure 7.21 – Example of a Flow Chart for Assessing Damage Discovered Following Excavation (Warman et al., 2006)

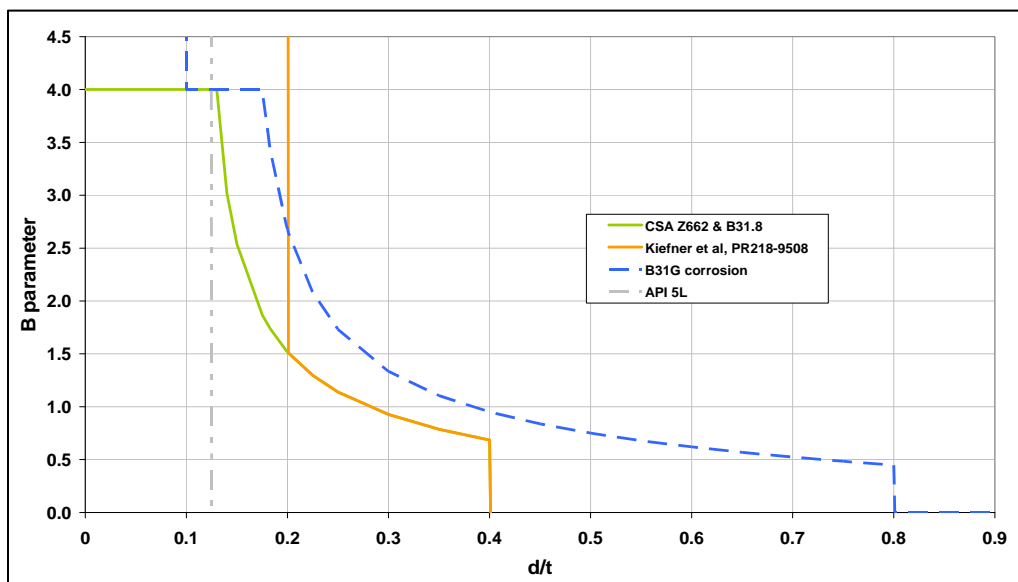
Figure 8.1 – Comparisons of Grind Criteria (Kiefner and Alexander, 1999)

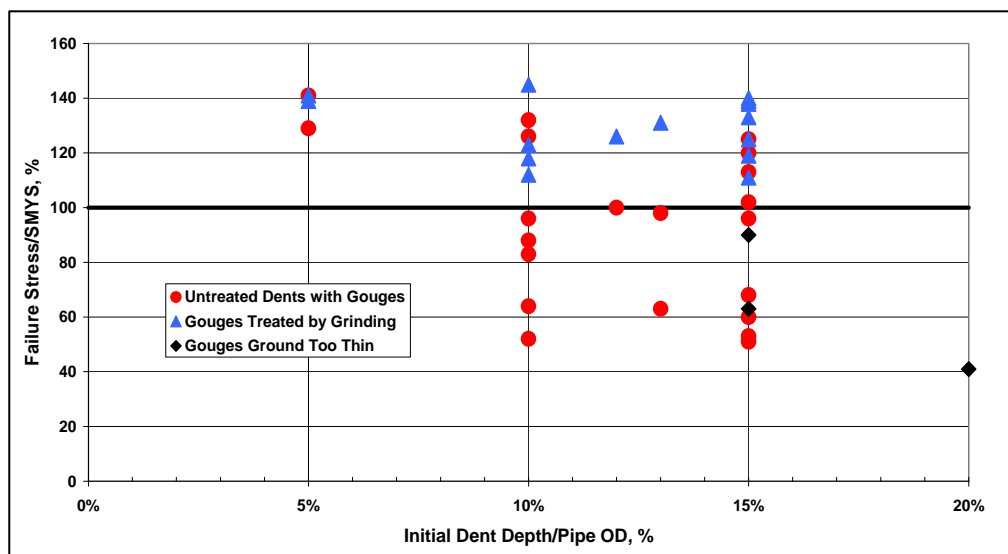
Figure 8.2 – Effectiveness of Grinding for Restoring Failure Stress (Kiefner and Alexander, 1999)

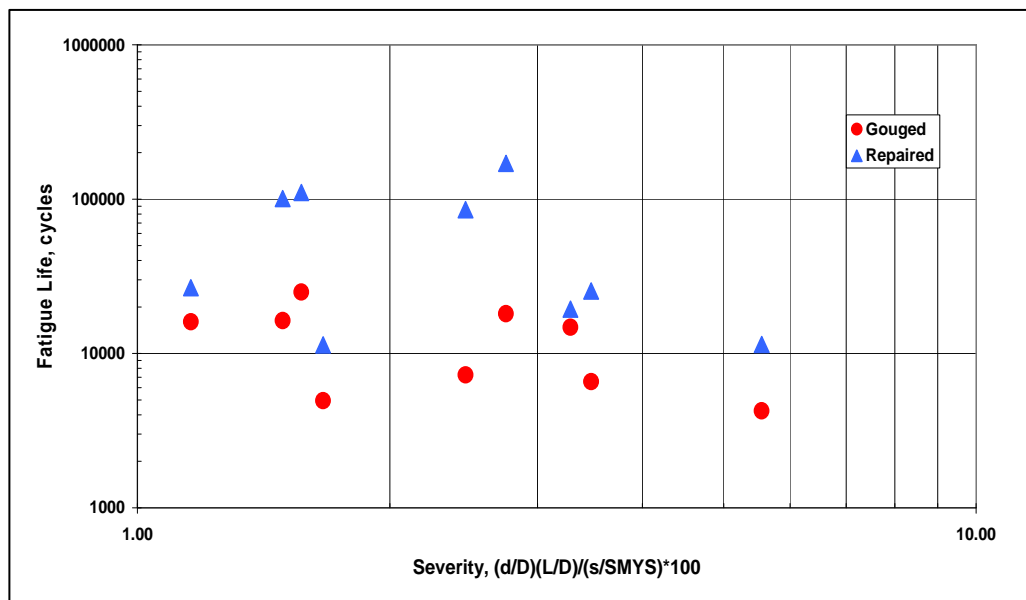
Figure 8.3 – Effectiveness of Grinding in Improving Fatigue Resistance (Kiefner, 1999)

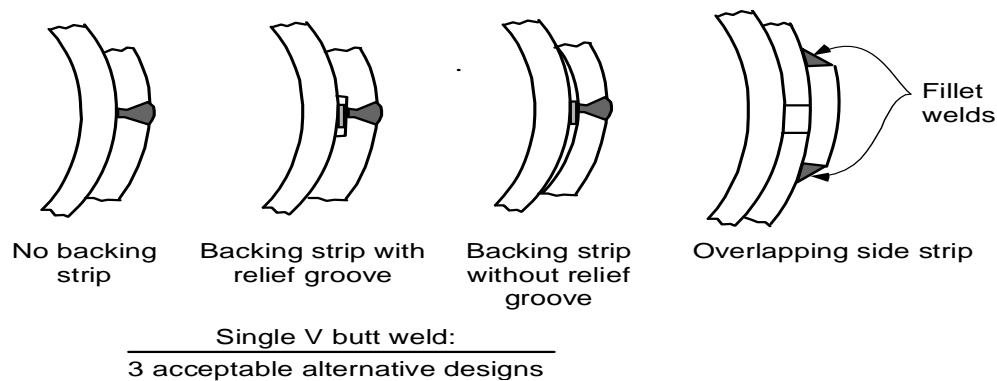
*Figure 8.4 – Weld Details for Type A Sleeve (Jaske, 2006)*

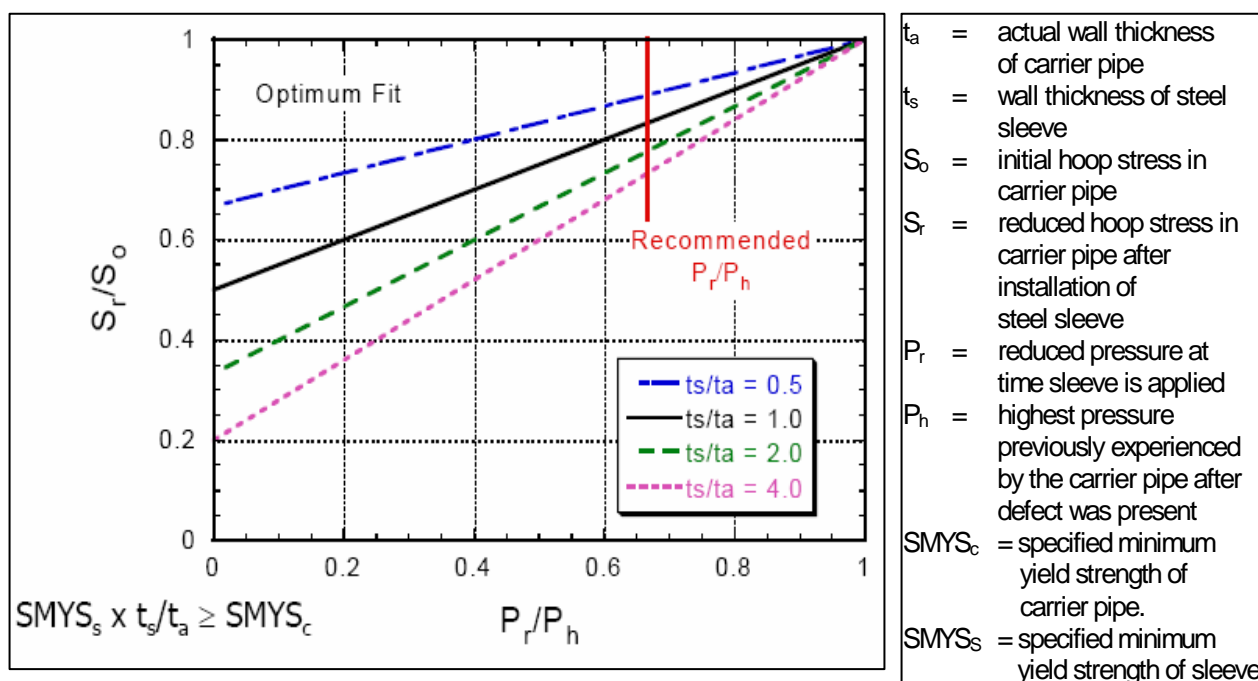
Figure 8.5 – Theoretical Relationships between Carrier Pipe Stress, Repair Pressure, and Wall Thickness. (Jaske, 2006)

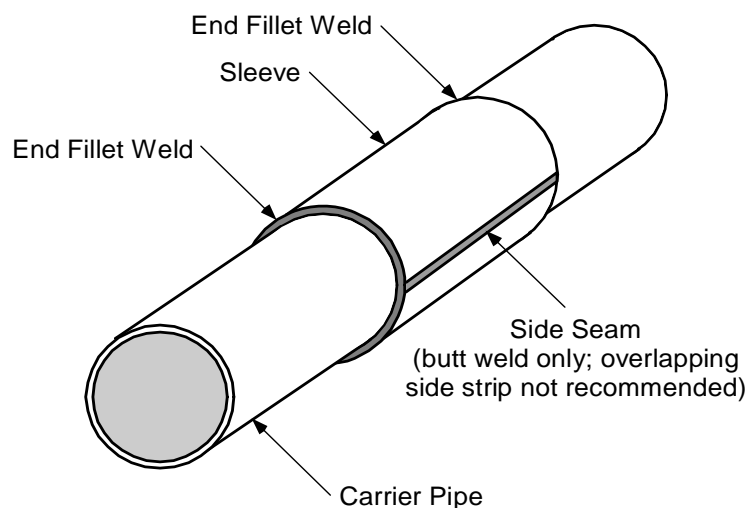
Figure 8.6 – Type B (Pressure Containing) Sleeve Illustration

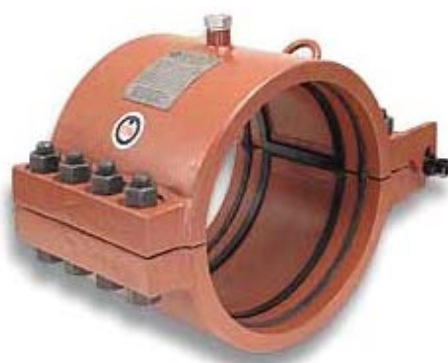
*Figure 8.7 – Typical Mechanical Bolt-On Clamp (courtesy of T. D. Williamson, Inc.).*

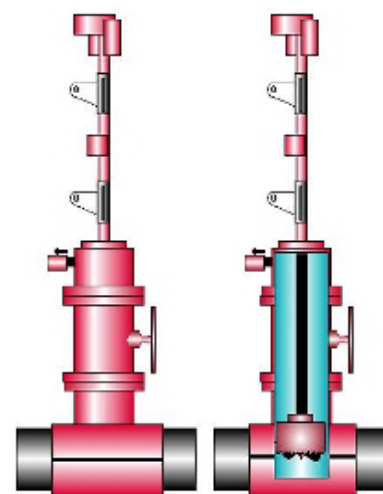
Figure 8.8 – Hot Tap Equipment Connected to Pipe (courtesy: <http://www.rafe1914.com>)

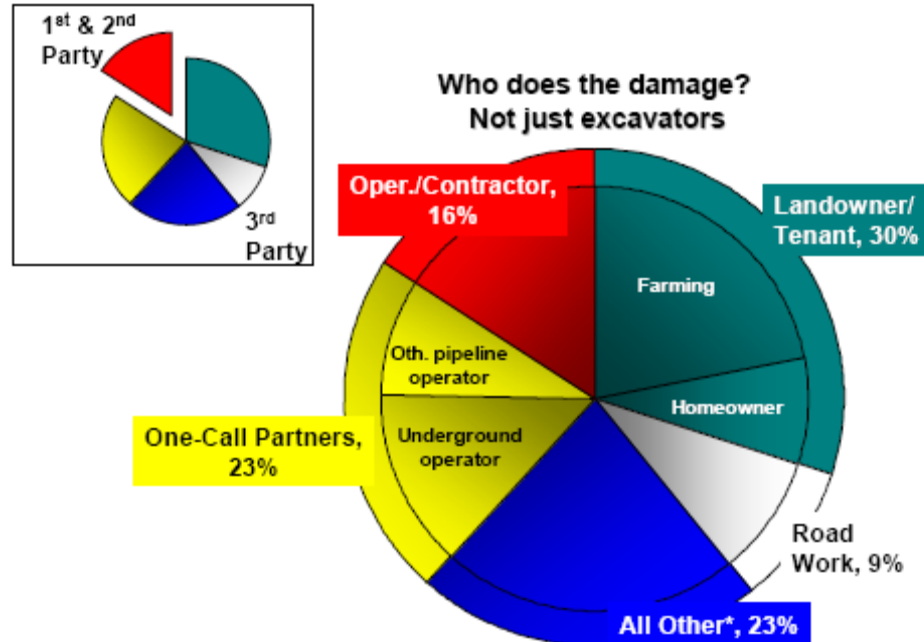
*Onshore pipeline spills where: release occurred at the time of damage, and involving 5 barrels or more, or death, fire, injury, or explosion.*

*\*\*All Other\* includes residential/commercial development, waterway, railroad, and other party or activity.*

One of the insights from PPTS was the number of incidents caused by entities that actually participate in one-call programs. In the chart below, “one-call partners” include the utility operators who pay for one-call systems – the very entities that receive shown, these entities actually caused 23 percent of the excavation damage incidents over the period from 1999-2006.
